Docket No. 272 – Development and Management Plan Inspection

Segment 1a Inspection

Date: March 26, 2007

Location: Segment 1a – Scovill Rock Switching Station to Chestnut Junction, Oxbow Junction to Beseck Switching Station (excluding Royal Oak Bypass), and Black Pond Junction to Beseck Switching Station

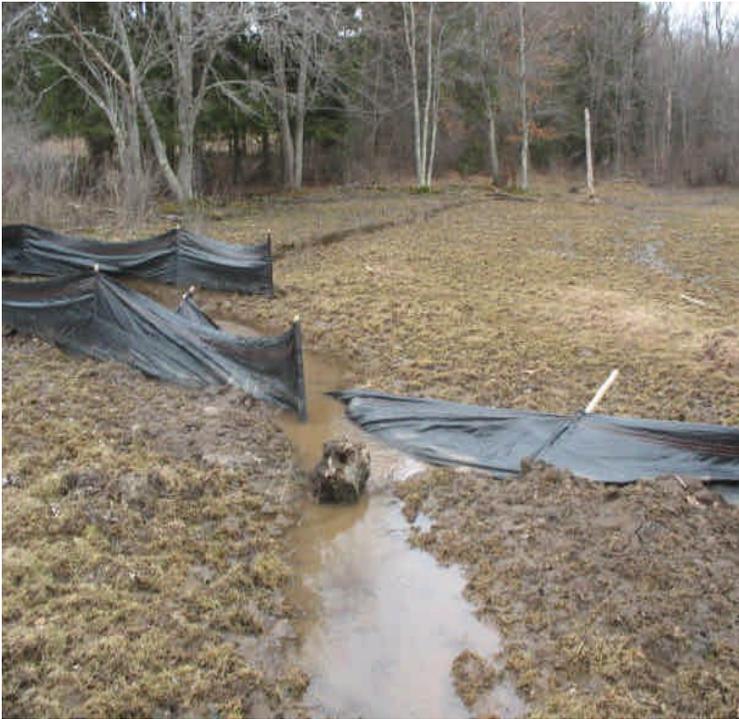
View of turbid water flowing over a degraded section of silt fence off Little Lane and Rte. 17. Repair silt fence and reinforce controls in this location.

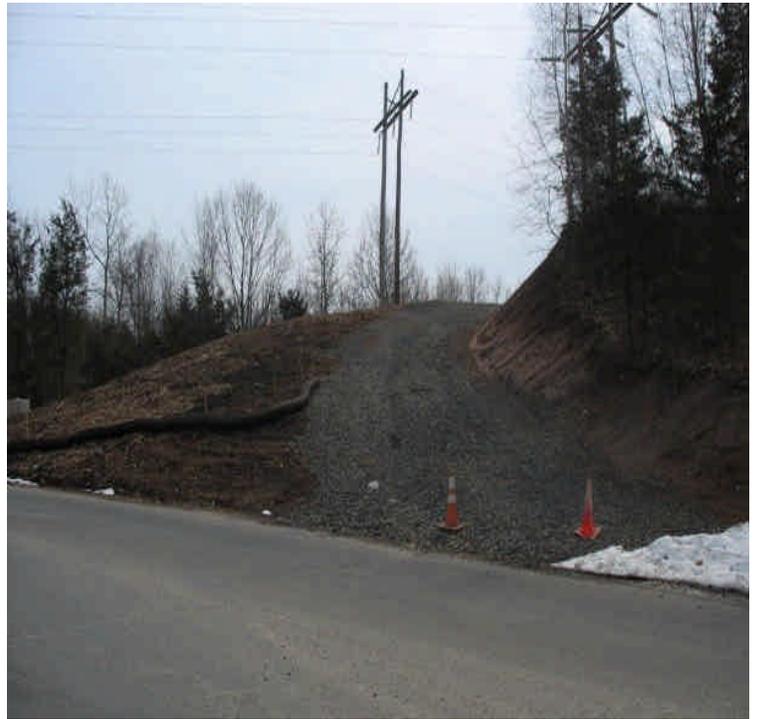
Filter socks remain along the pad and access road slope within the transfer station off Cherry Hill Rd. Ensure that controls are adequate to slow erosion.

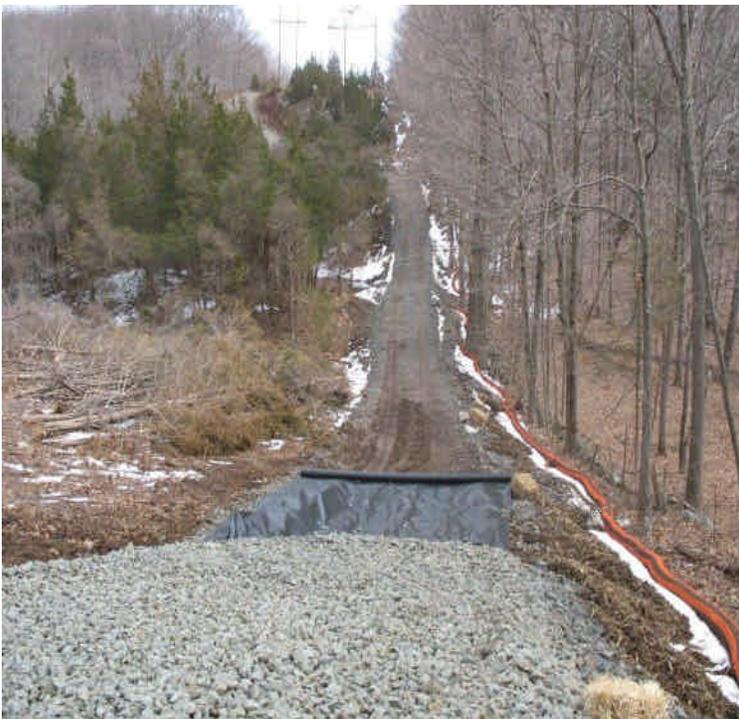
View of access road leading to the culvert area off Black Walnut Dr. Additional layers of stone were being installed over the previous access road to reduce run-off and increase stability.

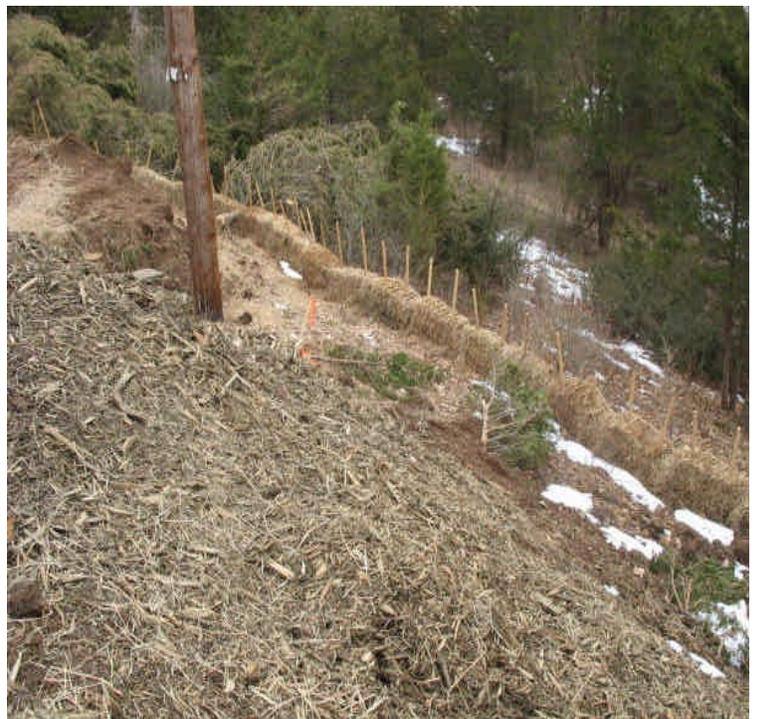
View of pad site off Black Walnut Dr. upgradient of Ball Brook. Following snow melt, the additional mulch and controls could be observed along the slope.

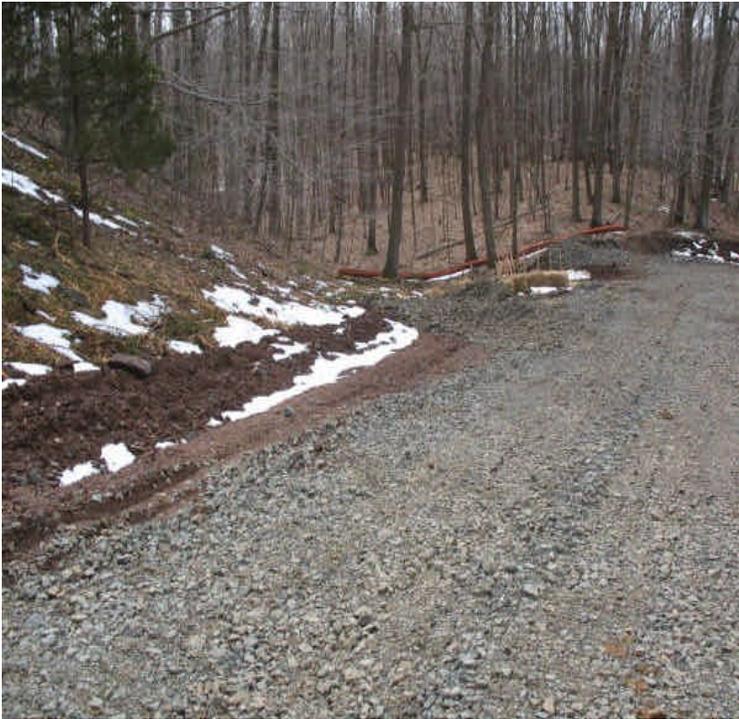
Haybales and water bars are in place along the access road off Black Walnut Dr. Continue to monitor the area during spring rain events.

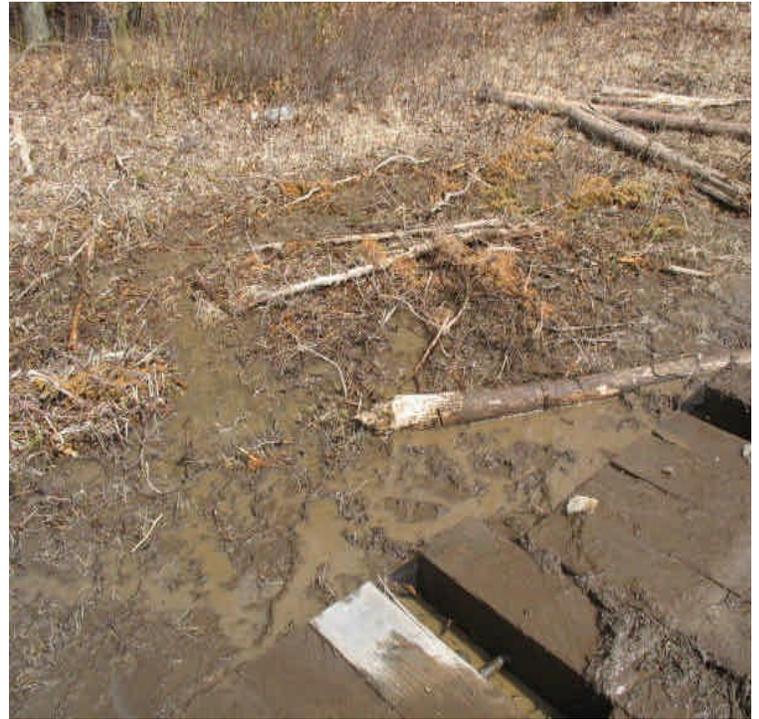
Turbid run-off starting to flow offsite at the wetland crossing off Haddam Quarter Road. Although adjacent vegetation is providing some filtration, controls should be added.

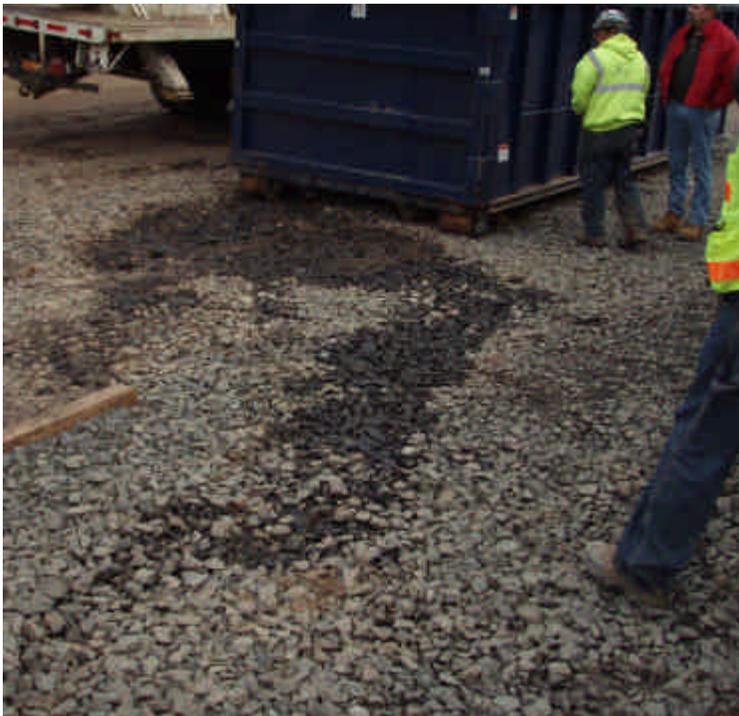
Reportable fuel spill was observed adjacent to the fuel storage tanks in the contractor receiving yard. It was estimated that 3-4 gallons of fuel had spilled on the stone pad here.

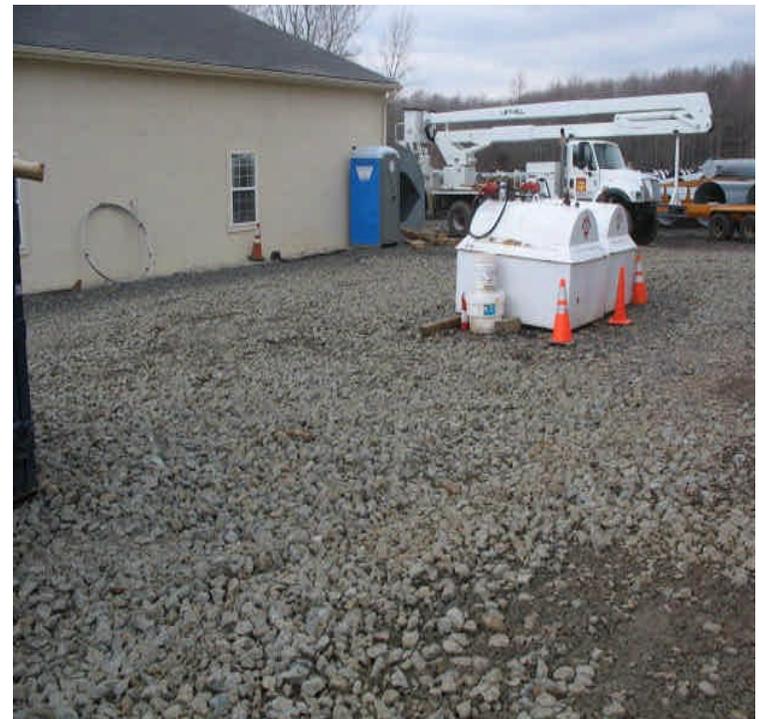
Day after the spill. Affected stone and soil were removed from the site and clean stone was added. The stone pad appeared to contain most of the spill and very little soil was affected. Appropriate paperwork was filed to report the spill.

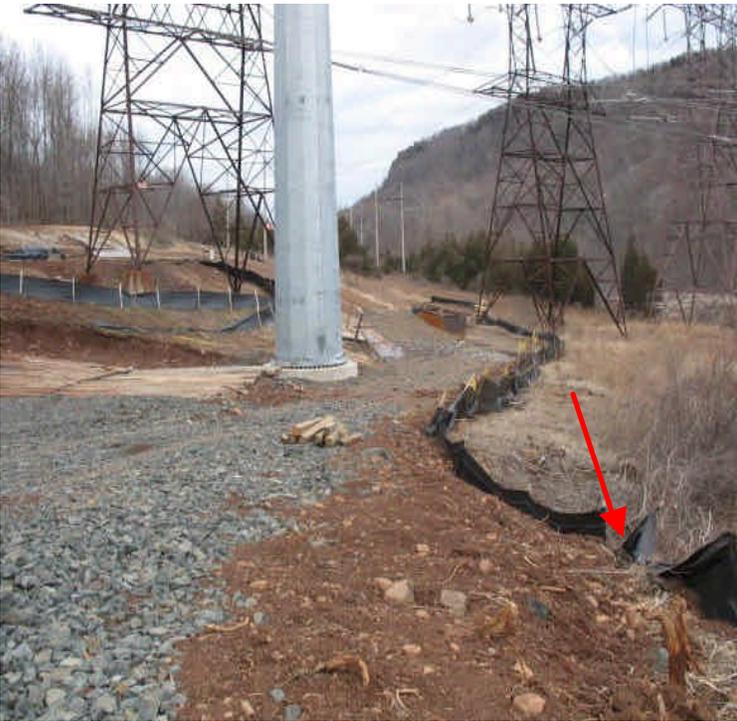
Controls remain in good shape off Black Pond. A small area of the fence was in disrepair and should be maintained. No active work in this area.

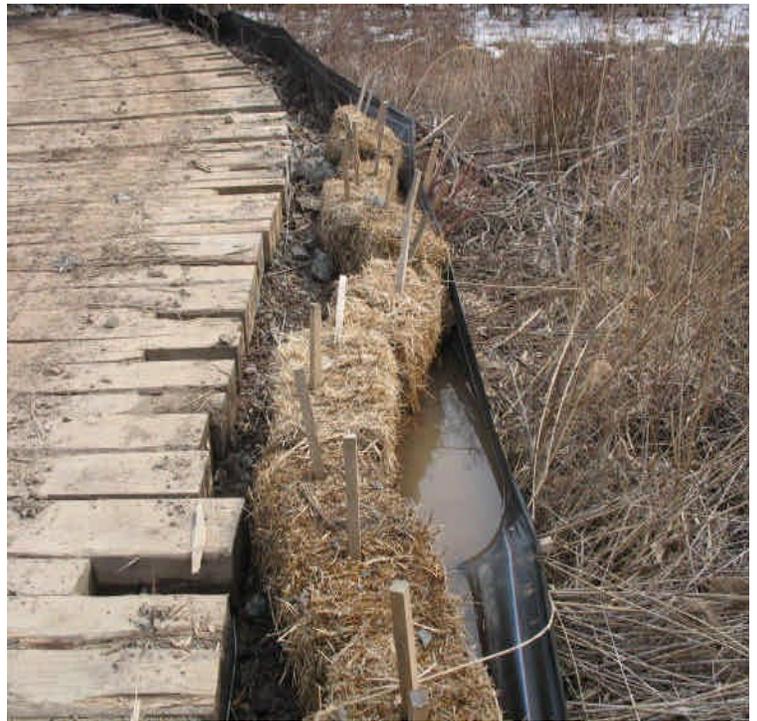
Wetland crossing off Powder Hill Road. Slightly turbid water was observed flowing from the stone crossing, despite the controls.

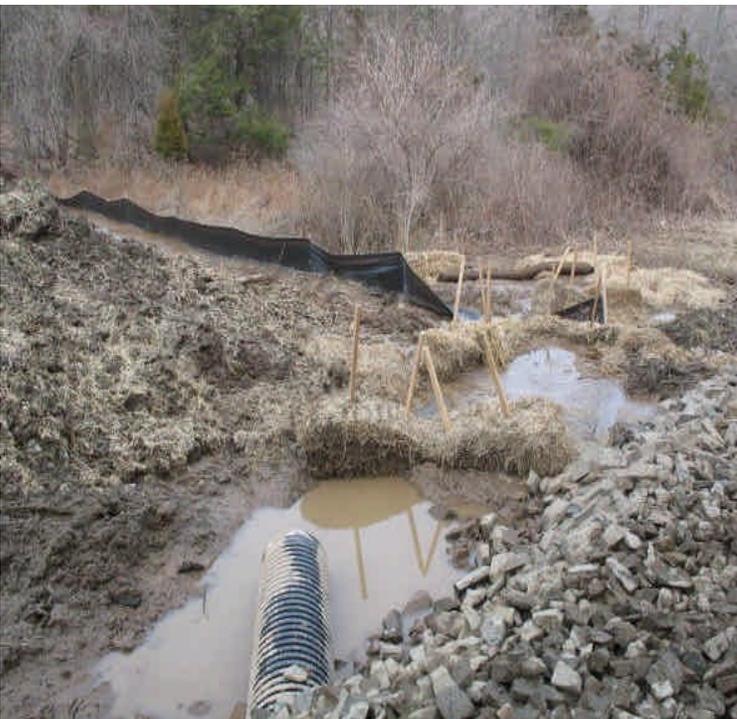
View of newly installed culvert and controls being overwhelmed by turbid run-off in the Powder Hill Rd. section. Sediment is flowing off site.

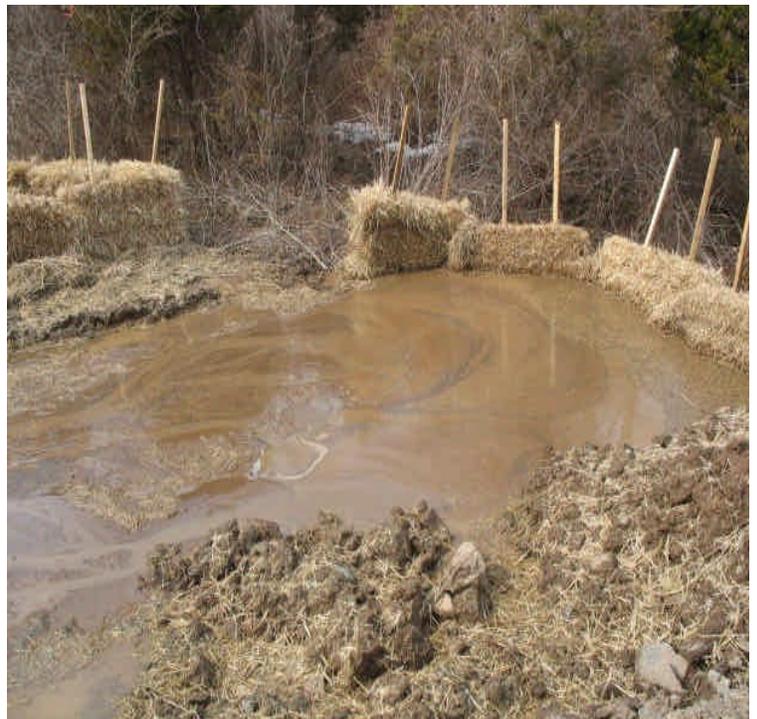
Turbid water and sediment is flowing around and through the controls in some areas located off Powder Hill Rd. Contractors were actively working to repair the problems during the inspection.

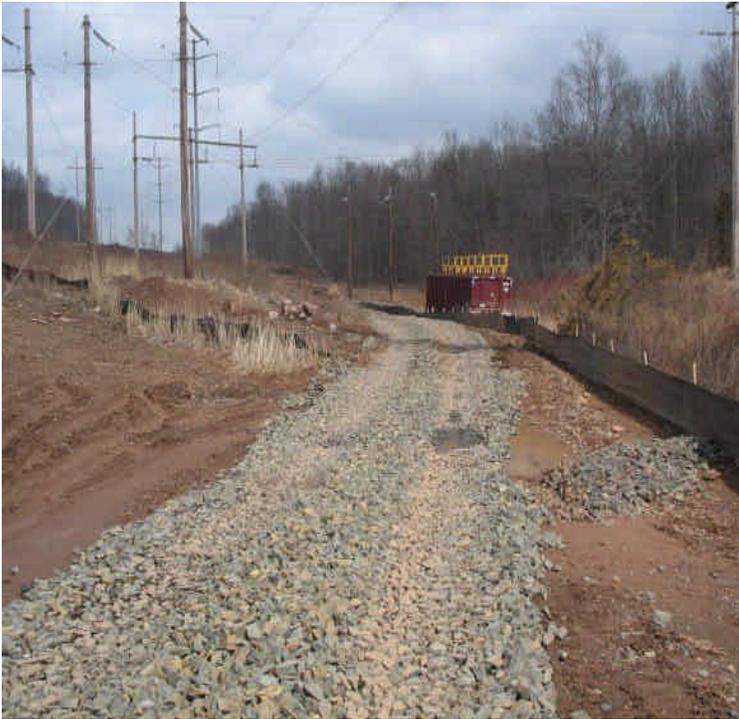
Tracking pad in place along the ROW, connecting to the Beseck SS stone pad to reduce sediment from the ROW. The frac tank seen in the background was used to settle out slurry from the foundation installed in the wetland here.

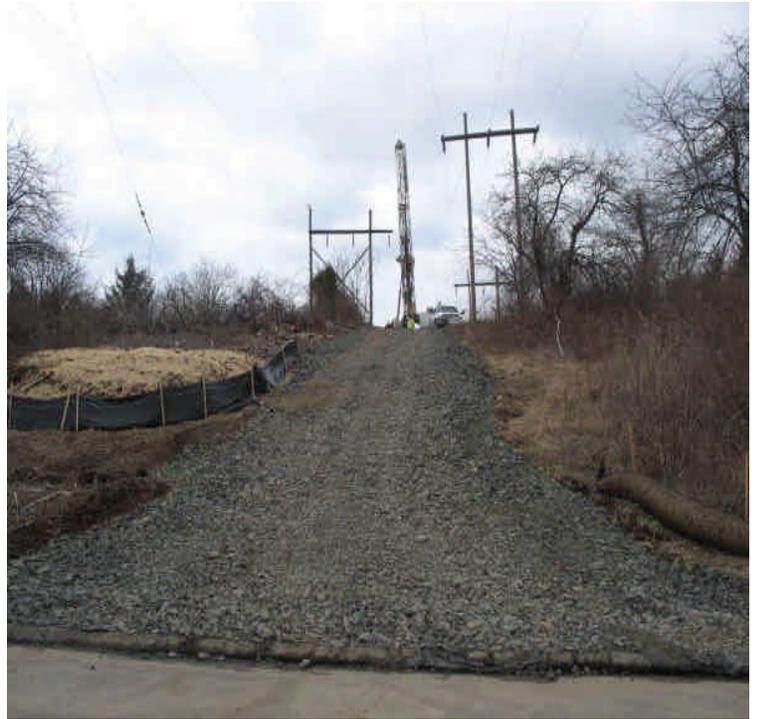
View of foundation drilling off Valley View Drive, east of Beseck SS.

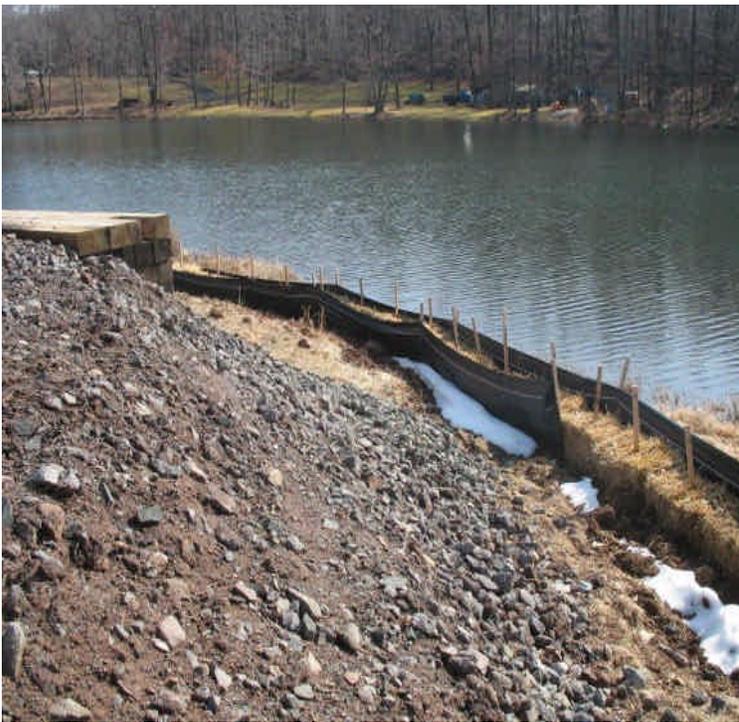
Controls remain in place along the pond north of Beseck SS to E. Meriden SS off Fleming Rd. Continue to stabilize the slope of the adjacent pad site as feasible.

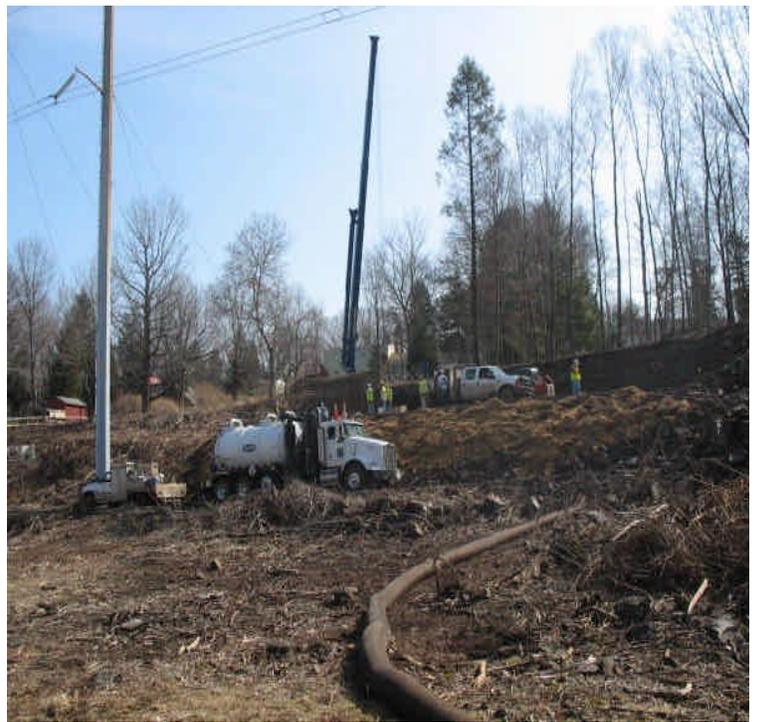
Foundation installation just south of E. Meriden SS. A slurry pit has been established with a filter bag in place. Slurry was actively being pumped to the containment area during the inspection.

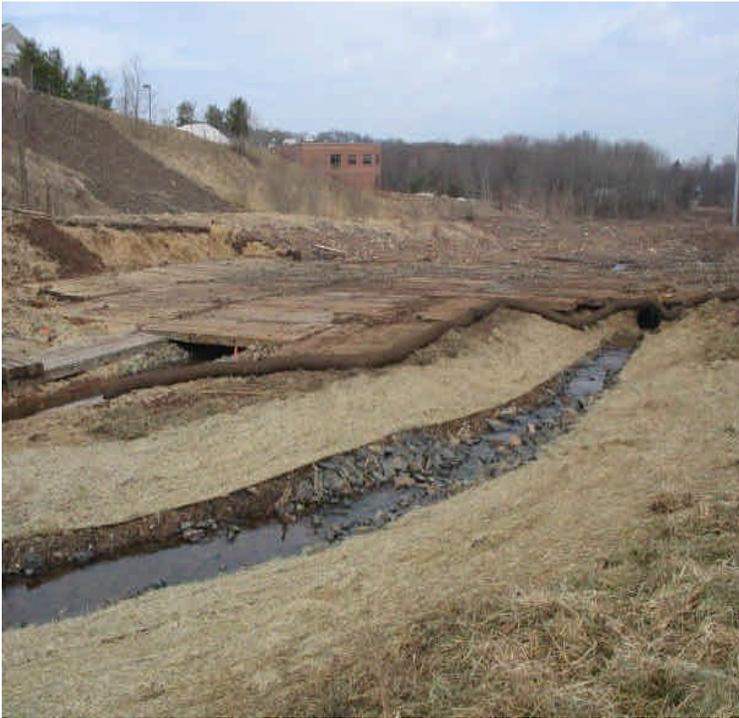
View of the stream flow diverted through the culvert and riprap channel in the ROW between E. Meriden SS to Black Pond. Water in the channel was clear. New erosion control mats had been installed to stabilize the adjacent soil.

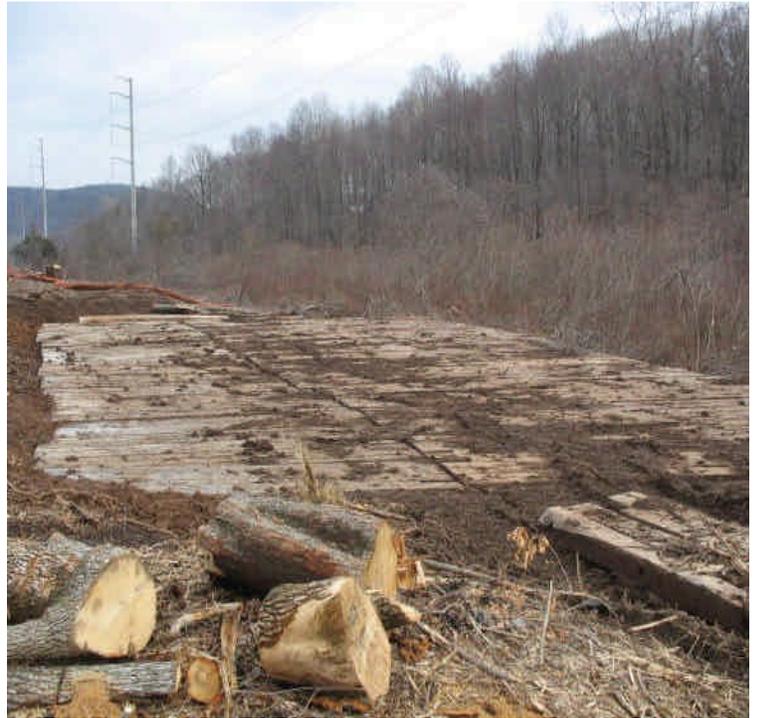
New timber mat pad area with controls installed above the stream south of High Hill Road. No run-off was noted.

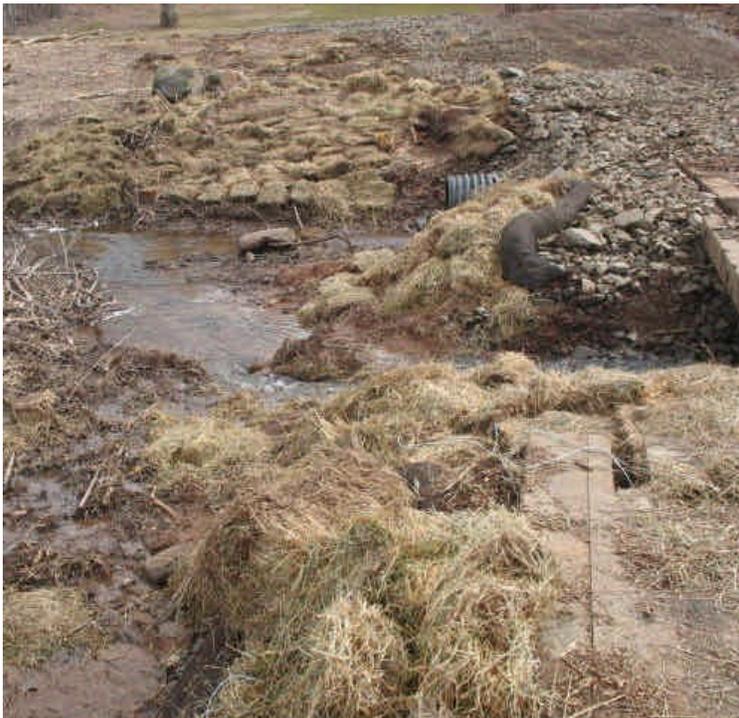
View of culverts in place under a timber mat crossing in the vicinity of High Hill Rd. Efforts were made to stabilize the adjacent soil.

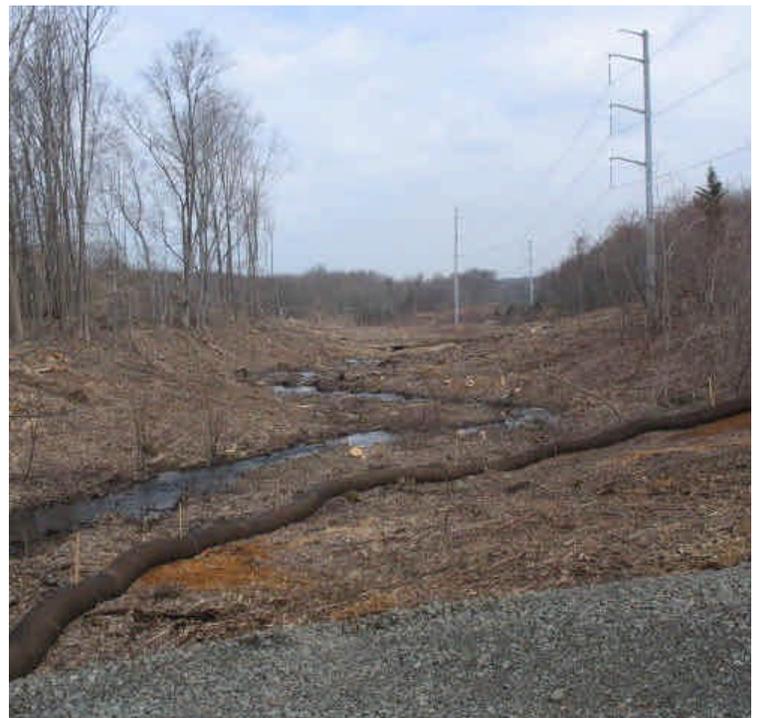
Filter socks were installed adjacent to resource areas along the ROW here. Root systems remain in place to stabilize the soil.
