Docket No. 272 – Development and Management Plan Inspection

Segment 2a Inspection

Date: March 20, 2007

Location: Segment 2a – Beseck Switching Station to Cheshire/Hamden Town Line

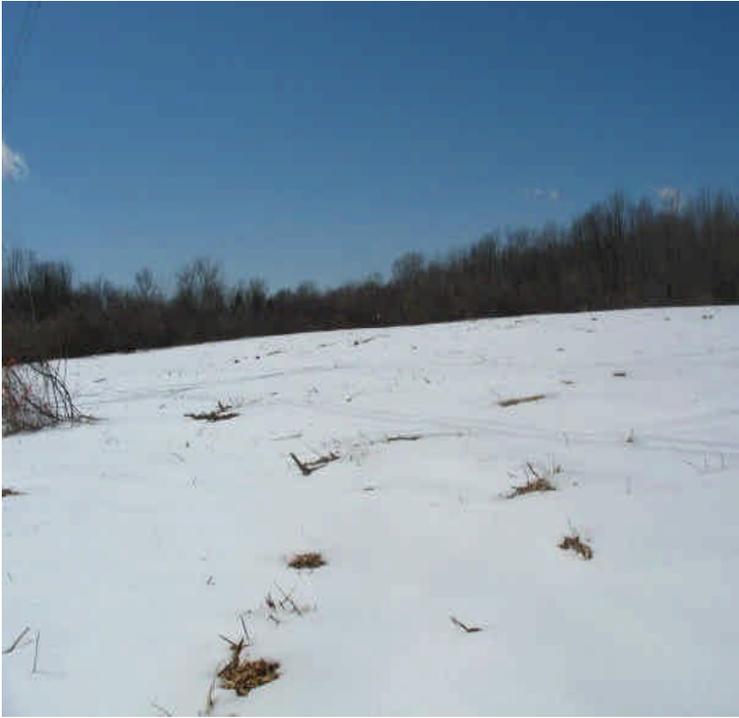
Area of the ROW that has been cleared south of Beseck SS off High Hill Rd. Low growing vegetation was retained in the wetlands here appropriately. Controls may be needed as the snow cover melts.

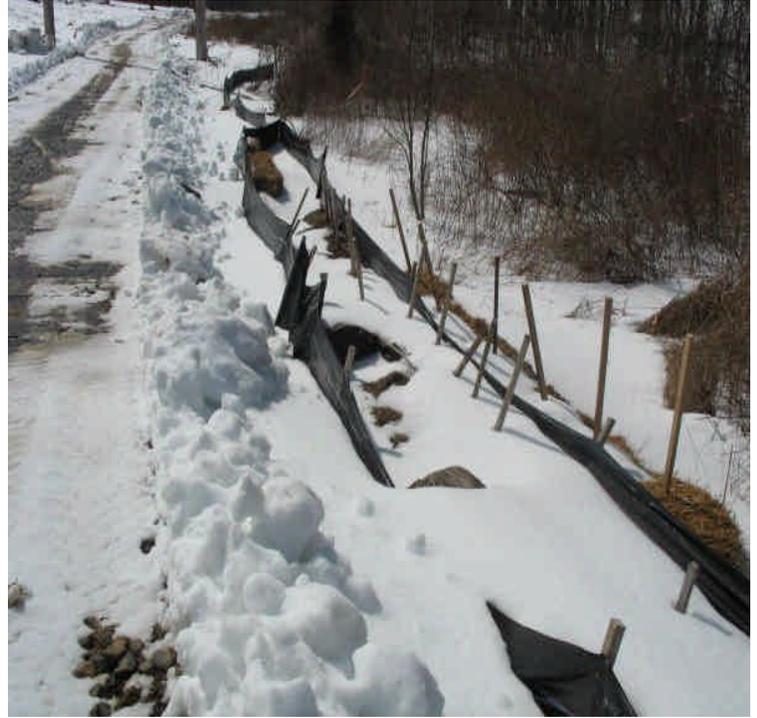
Silt fence and haybales are degraded along the access road off High Hill Rd. Haybales are in place to support degraded controls.

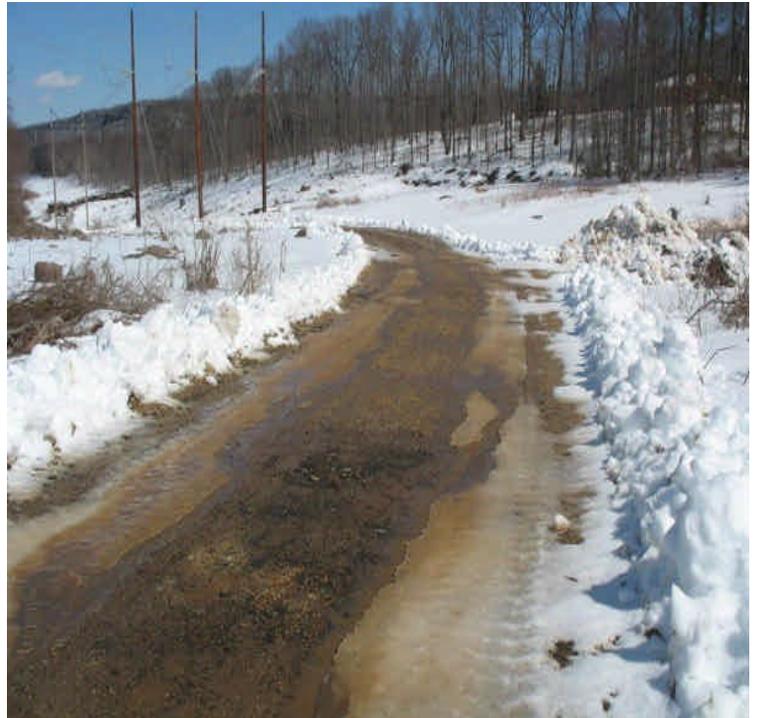
Melting snow and ground thaw resulted in sediment run-off along a slope south of Beseck SS off High Hill Road. Watch for any sedimentation if wetlands are downgradient.

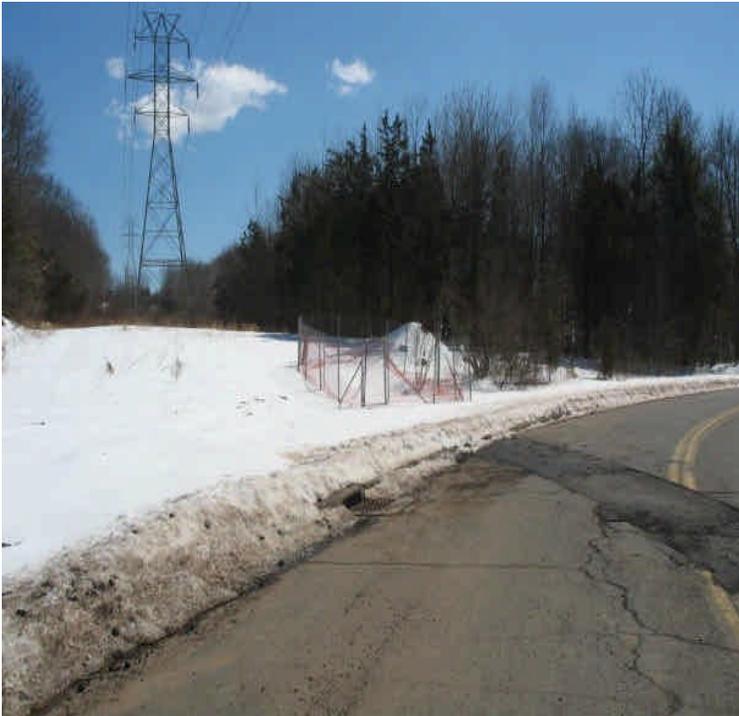
Safety fence protection was installed around an open pit located off Old Farms Road. This trench is where underground will connect with overhead lines.

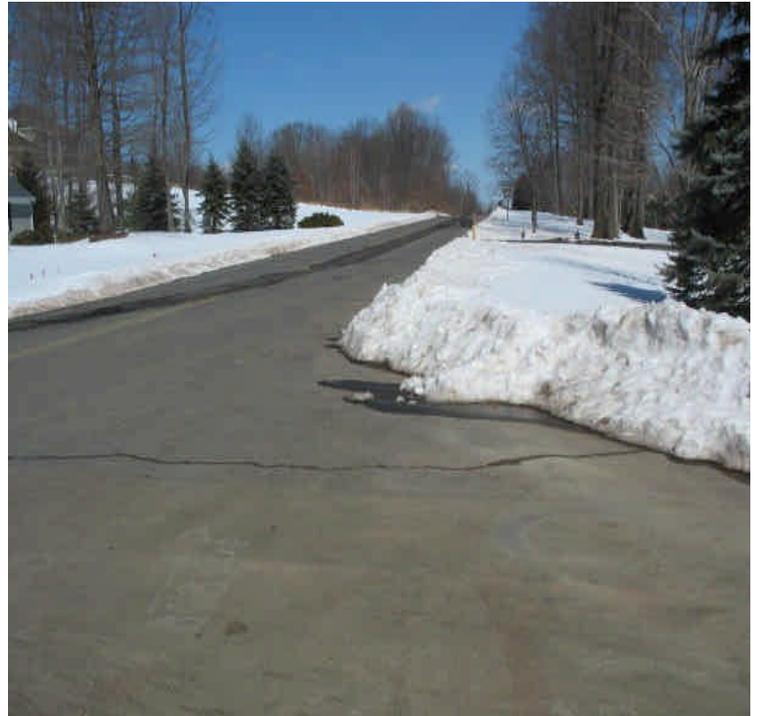
Small sediment piles remain until the snow cover along Old Farms Rd. Remove when feasible.

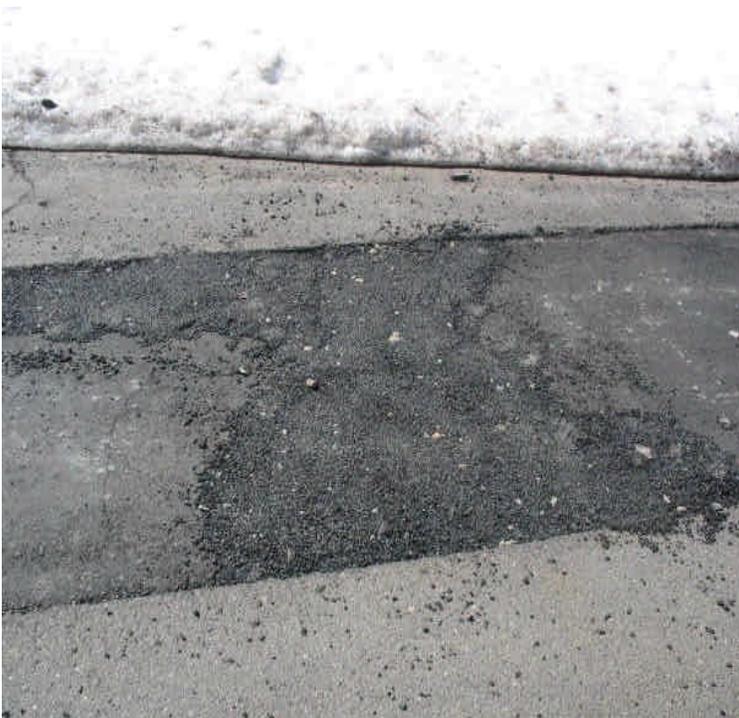
The trench was patched along Old Farms Rd. Loose pavement or "crumbling" was noted as a result of plowing and cold temperatures.

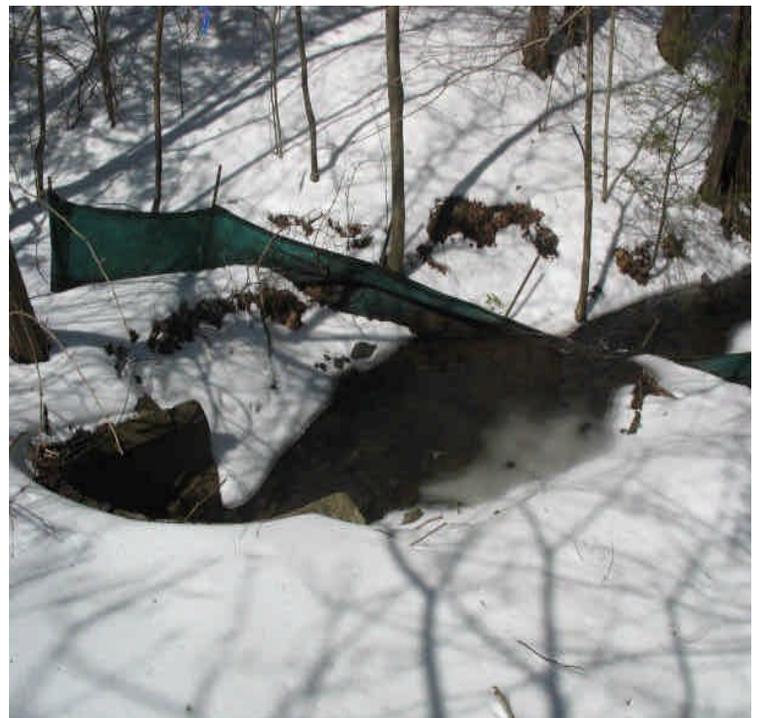
View of one of the receiving wetlands/inlets along Old Farms Rd. Turbidity related to the project was not evident in the wetland at this time. However, issues have been noted during past thaw periods. Continue to monitor.
