Docket No. 272 – Development and Management Plan Inspection

Segment 2a Inspection

Date: March 27, 2007

Location: Segment 2a – Beseck Switching Station to Cheshire/Hamden Town Line

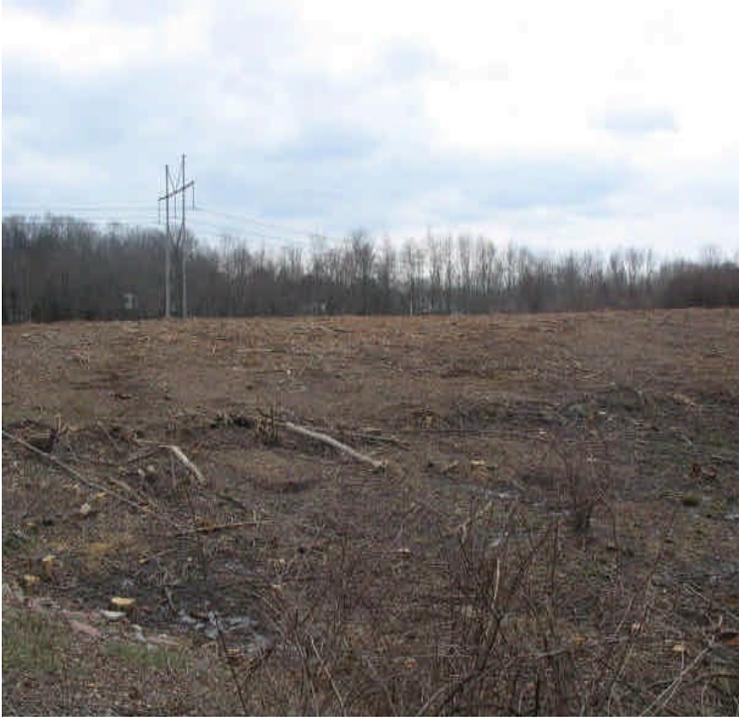
Area of the ROW that has been cleared south of Beseck SS off High Hill Rd. Low growing vegetation was retained in the wetlands here appropriately.

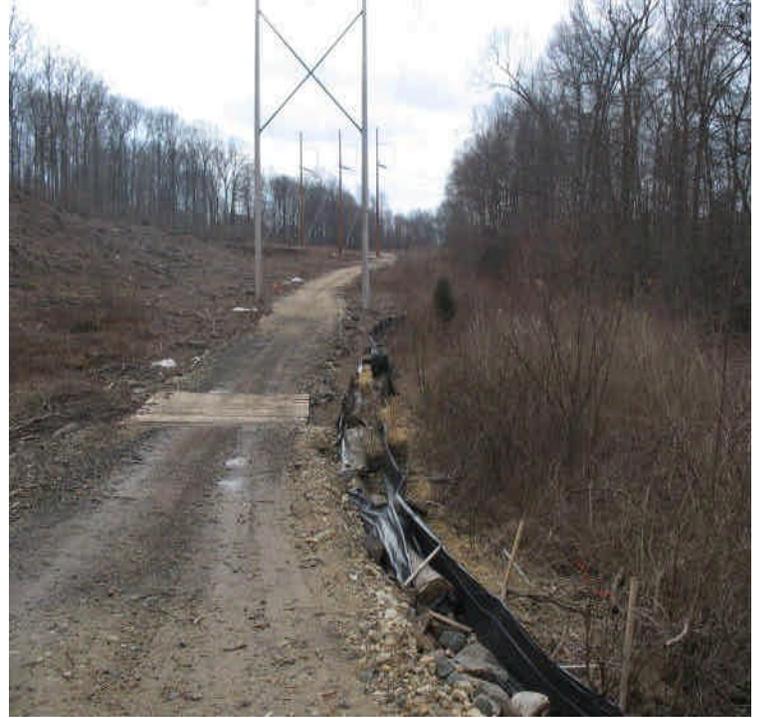
Silt fence and haybales are degraded along the access road off High Hill Rd. Haybales are in place to support degraded controls.

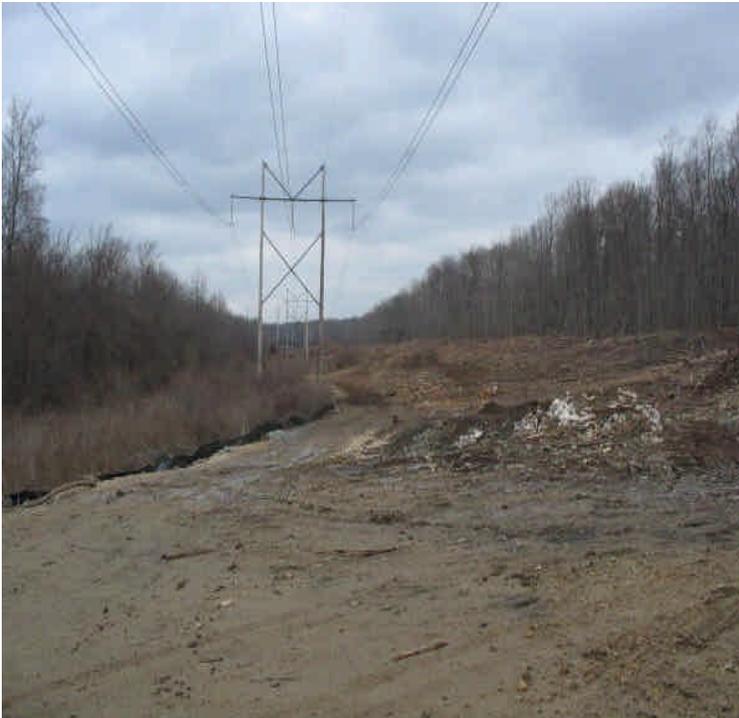
View of the cleared ROW west of High Hill Rd. heading north toward Beseck SS

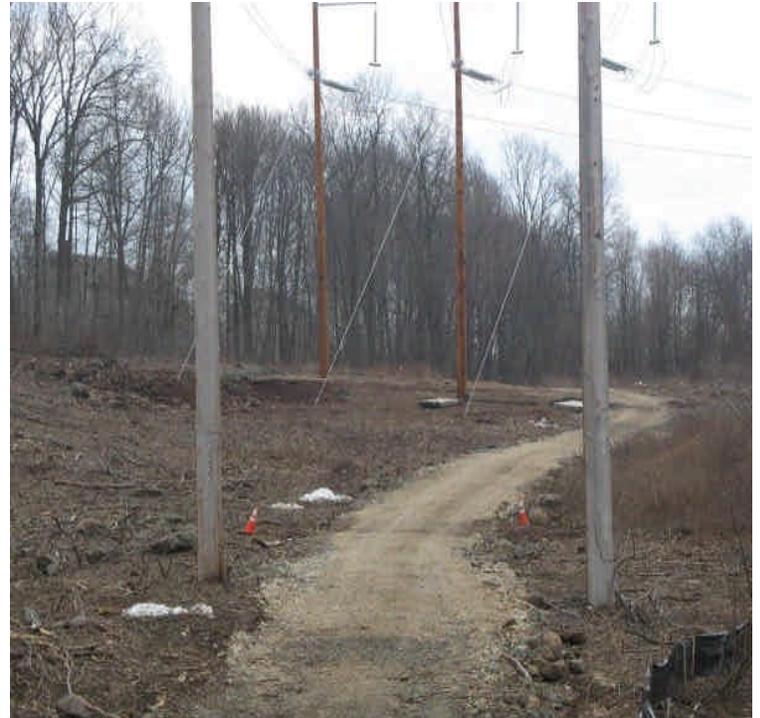
Sediment and run-off has been noted along a slope south of Beseck SS off High Hill Road. Watch for any sedimentation if wetlands are downgradient.

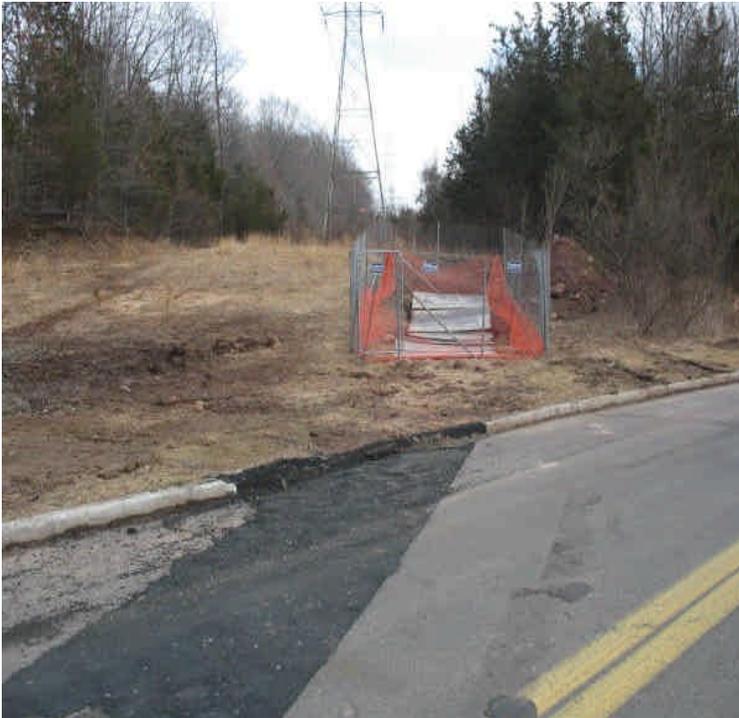
Safety fence controls remain around the open pit located off Old Old Farms Road. This trench is where the underground utility will transition with the overhead lines.

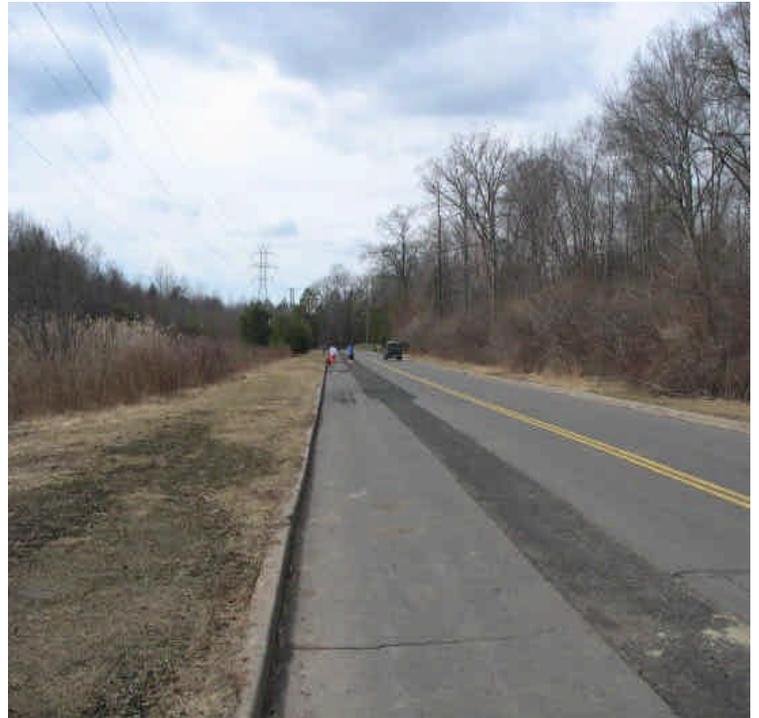
Small sediment piles have been removed along Old Farms Rd and the shoulder has been graded.

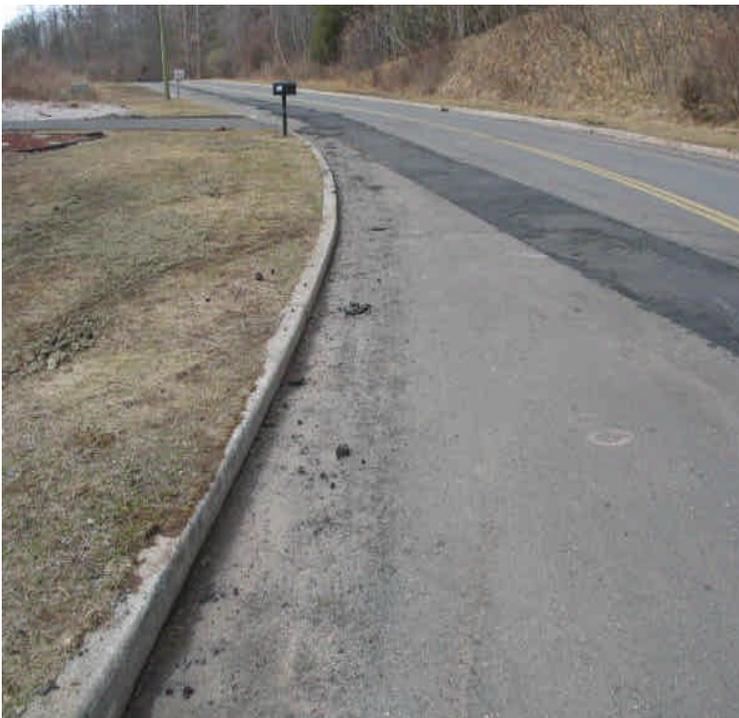
The trench was patched along Old Farms Rd. Some loose asphalt or “crumbling” was noted along the edge of the roadway.

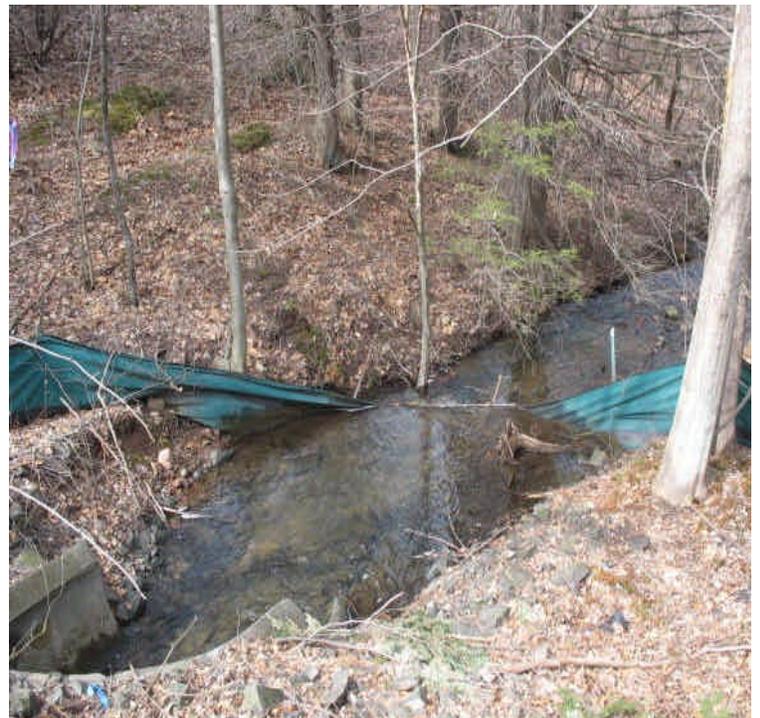
View of one of the receiving wetlands/inlets along Old Farms Rd. Turbidity related to the project was not evident in the wetland at this time. However, issues have been noted during past thaw periods. Continue to monitor.
