Docket No. 272 – Development and Management Plan Inspection

Segment 3 Underground Line

Date: March 15, 2007

Location: East Devon Substation to the Housatonic River Crossing

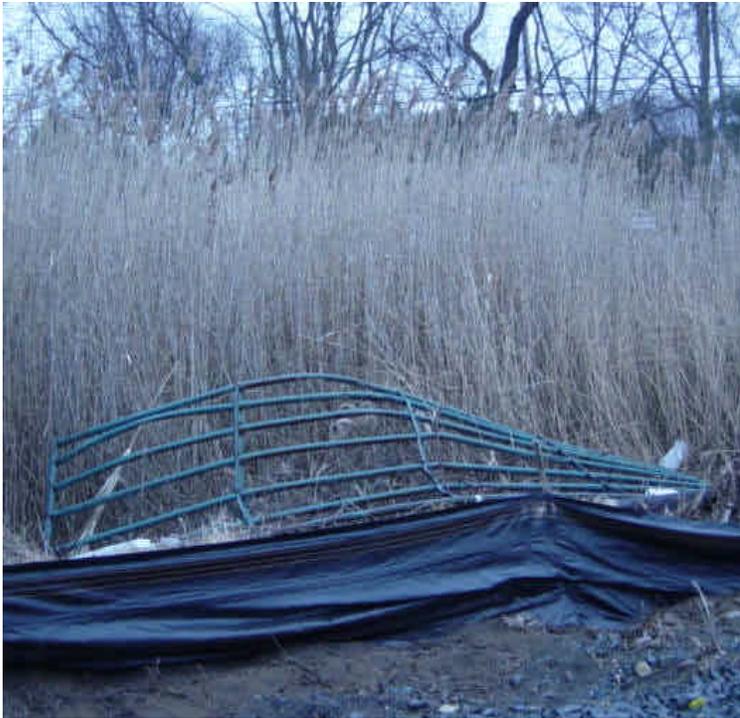
Access road gate near Naugatuck Avenue has been removed and is being stored in the adjacent resource area

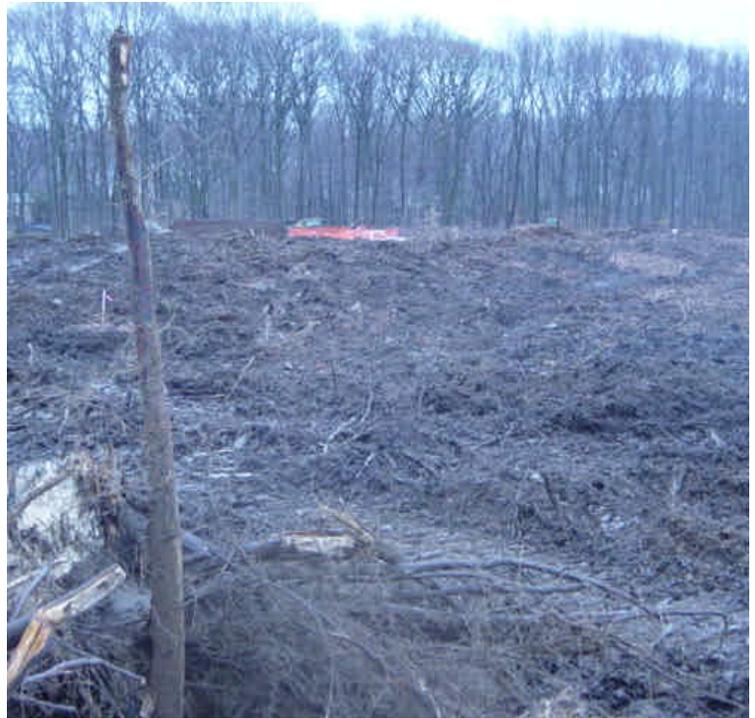
An area of approved wetland clearing was noted near station #1117 and 1118 as part of the East Devon substation activities.

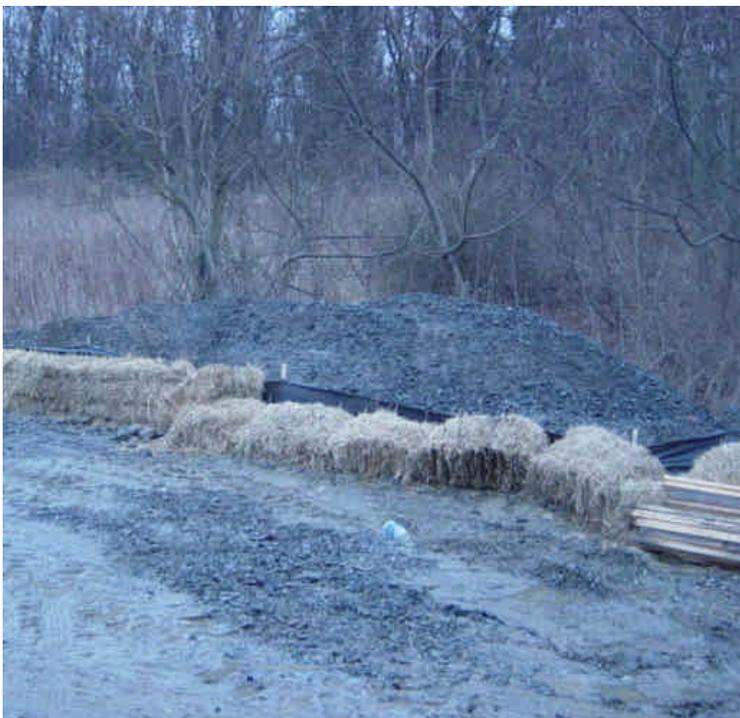
Stockpiled material was being stored on the incorrect side of the perimeter controls at the Shelland St. contractor yard. It should be removed and placed within the yard.

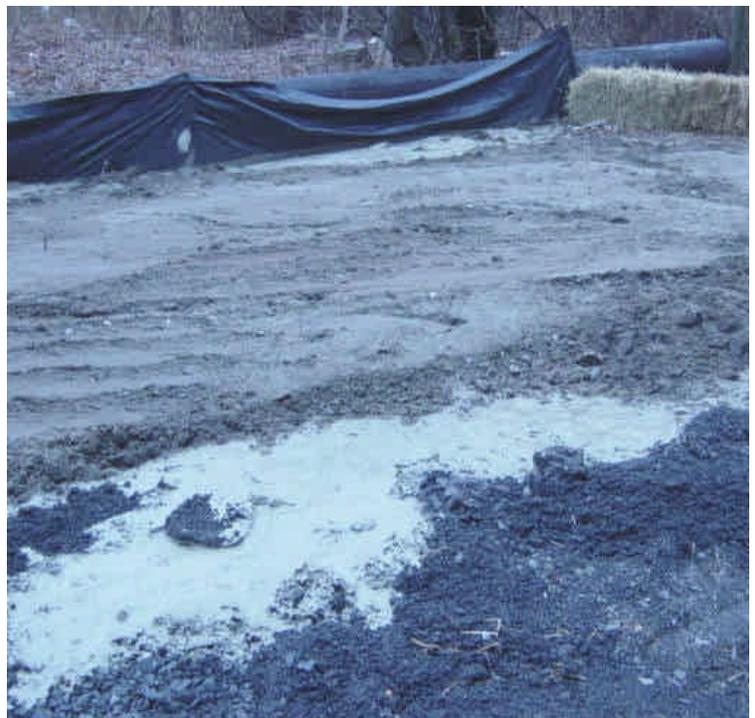
Evidence of concrete washout was observed near station #1016. Concrete should be removed and all future washouts should be contained appropriately.
