Docket No. 272 – Development and Management Plan Inspection

Segment 3 Underground Line

Date: March 27, 2007

Location: East Devon Substation to the Housatonic River Crossing

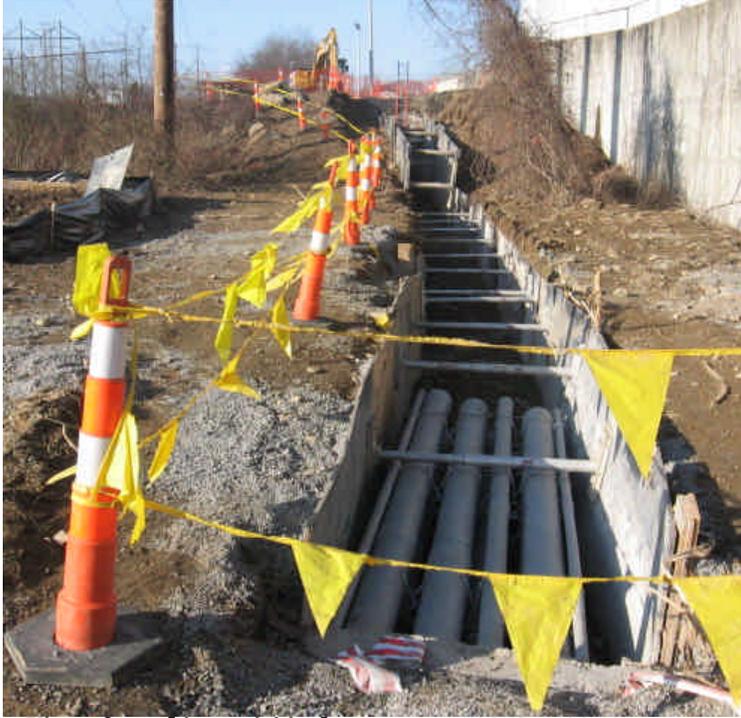
View of trenching activities between sta. #1072 to 1074.

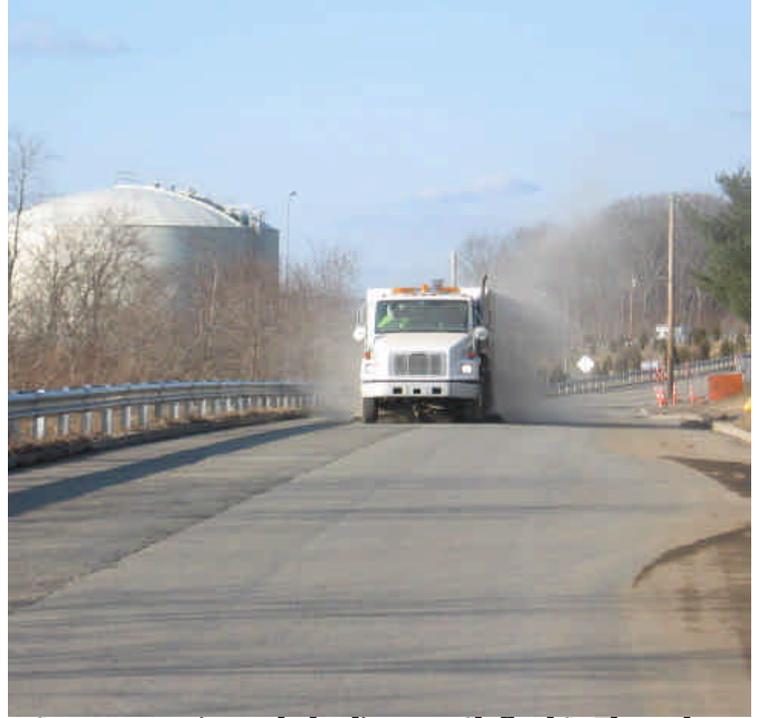
Sweeper removing tracked sediment on Shelland St. The truck may have run out of water in the process of sweeping, as a large amount of dust was being generated.

Areas of Inspection	Observation	Recommended Action	Corrected Action
Access Roads and Adjacent Roadways	A cross-country access road is being used for trenching activities at station #1065 to 1073. A stone entrance pad is in place at station #1053, where the paved way intersects the cross-country route. 3/27/07	Continue to maintain construction pads as necessary. 3/27/07	Not Applicable (NA)
	No sediment tracking was noted on Naugatuck Ave. from the cross-country route. 3/27/07	Continue to sweep the roadway on a regular basis. 3/27/07	No major issues noted, but needs regular attention.
	All catch basins that are downgradient of adjacent to construction activities have been protected. 3/27/07	Continue to monitor and maintain controls as necessary and keep up with sawcut slurry when it is produced. 3/27/07	NA
Shelland St	A street sweeper was observed sweeping the roadway in the vicinity of the East Devon Sub and the contractor yard, during the inspection. A large amount of dust was being generated. 3/27/07	Continue to sweep the street regularly and attend to any dust issues. 3/27/07	The street was being swept; Needs regular attention

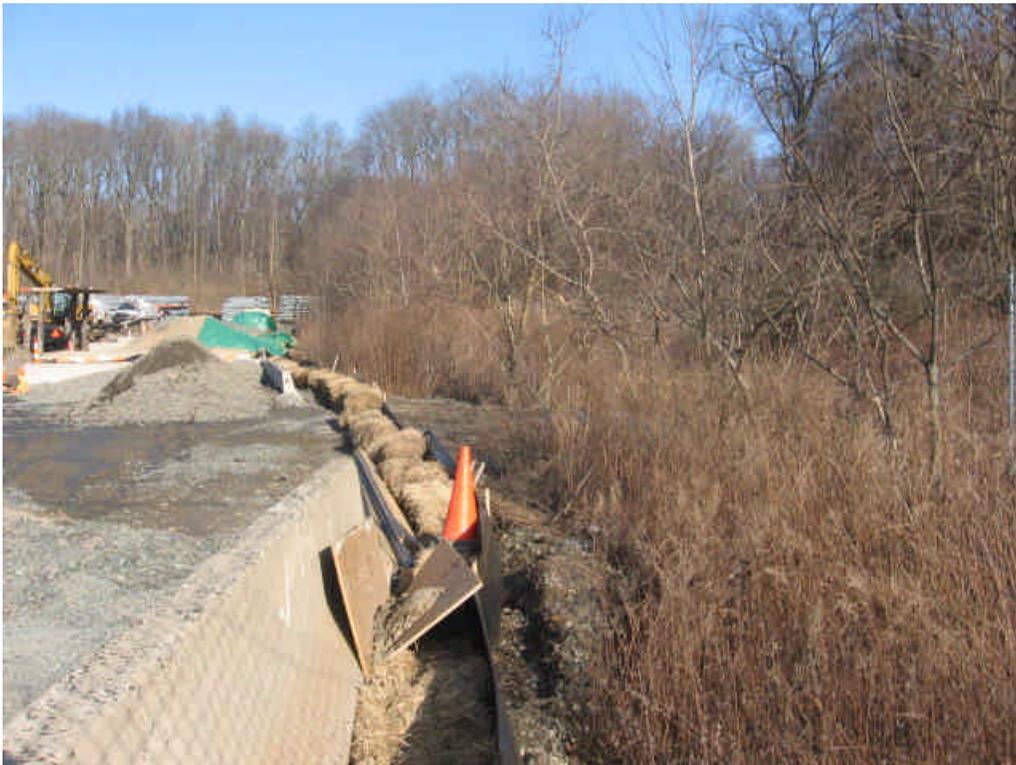
Areas of Inspection	Observation	Recommended Action	Corrected Action
	<p>Additional stone is in place throughout the yard to reduce mud and subsequent tracking. 3/27/07</p> <p>The stone that was noted on the wrong side of the perimeter controls near the south side of the Shelland St. contractor yard (3/15) still remains. It appears to be the result of snow plowing over the fence. Most of the snow has melted. 3/27/07</p>	<p>Continue to monitor until snow has completely melted to determine the extent of gravel, and determine if mitigation (stone removal) is required. 3/27/07</p>	<p>Needs evaluation</p>
<p>Soils</p>	<p>Soils are exposed as part of the excavation for trench, vault, and utility work. 3/27/07</p>	<p>Soils appear to be handled appropriately. 3/27/07</p>	<p>NA</p>
<p>State species of concern, threatened and endangered species.</p>	<p>According to the D&M plan, state-listed species are not located in this work area.</p>	<p>None</p>	<p>NA</p>

Location of former material/snow pile located beyond the perimeter controls at the Milford lay-down yard. A small amount of material remains now that most of the snow has melted. Evaluate the area to determine if the stone/sediment should be removed.
