Docket No. 272 – Development and Management Plan Inspection

Segment 4a Underground Line

Date: March 6, 2007

Location: Singer Substation to Fairfield/Westport Town Line

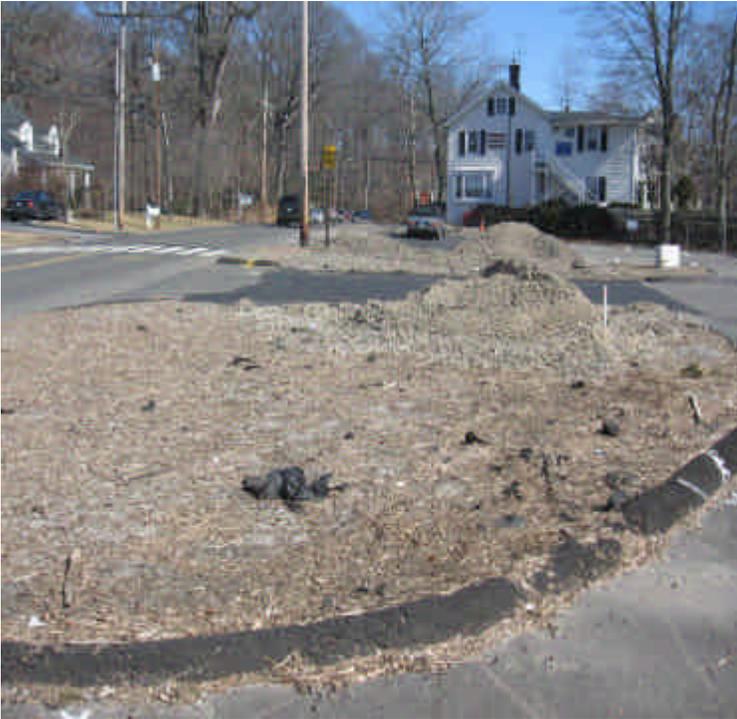
Photo of Vault #28 location. Aggregate piles have been placed over the hard pack soil. Evaluate whether these areas are prone to tracking and require aggregate, or should be restored to more original conditions.

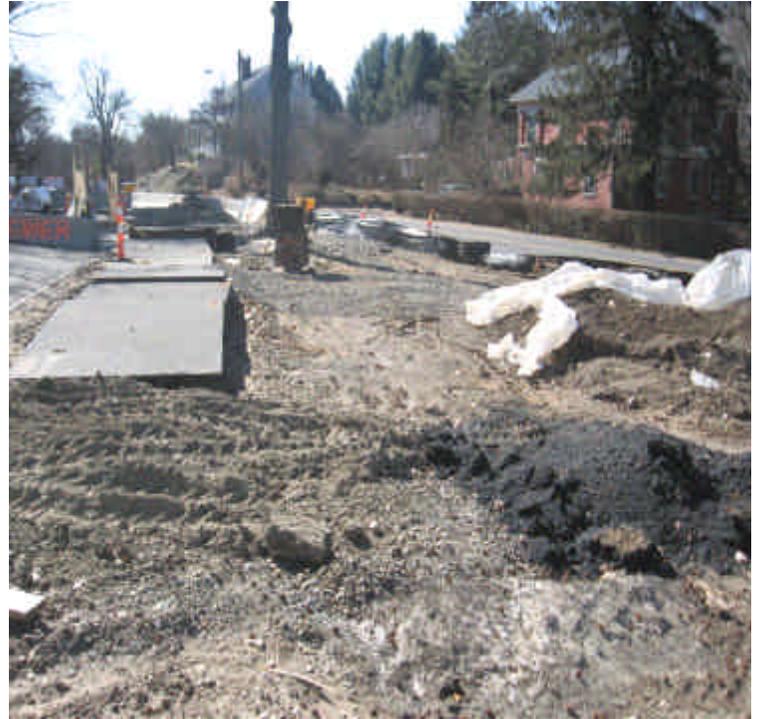
Sections of the perimeter controls along Pequot Ave. are in disrepair and should be maintained.

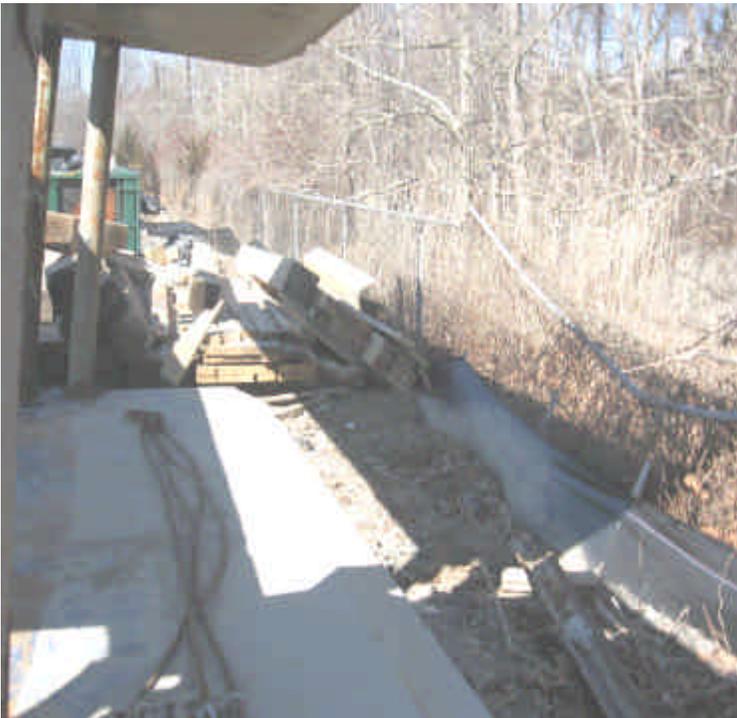
Material stockpile within the Kings Highway lay-down yard has compromised erosion controls. Pull materials back and restore the silt fence.

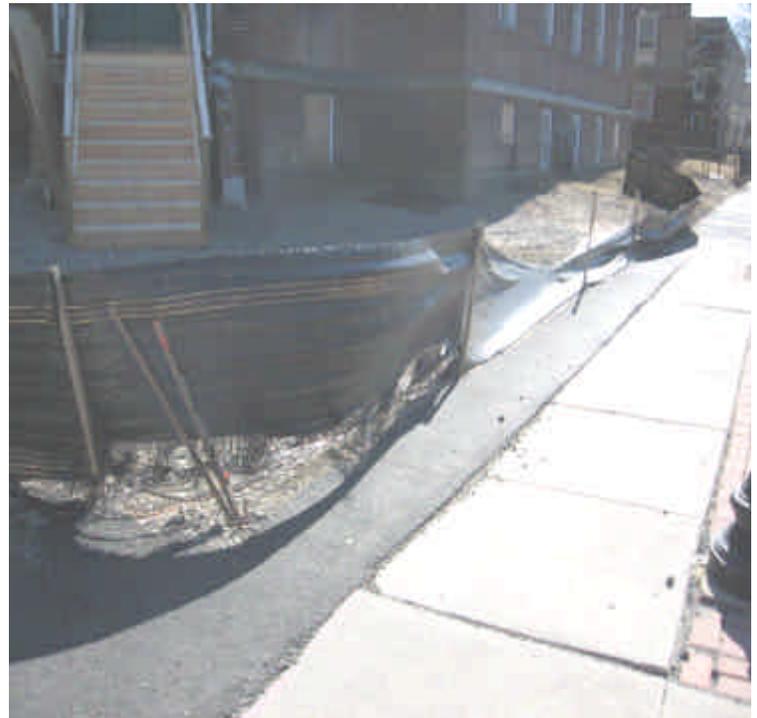
Perimeter controls at Vault #41 are degraded and should be maintained when feasible.

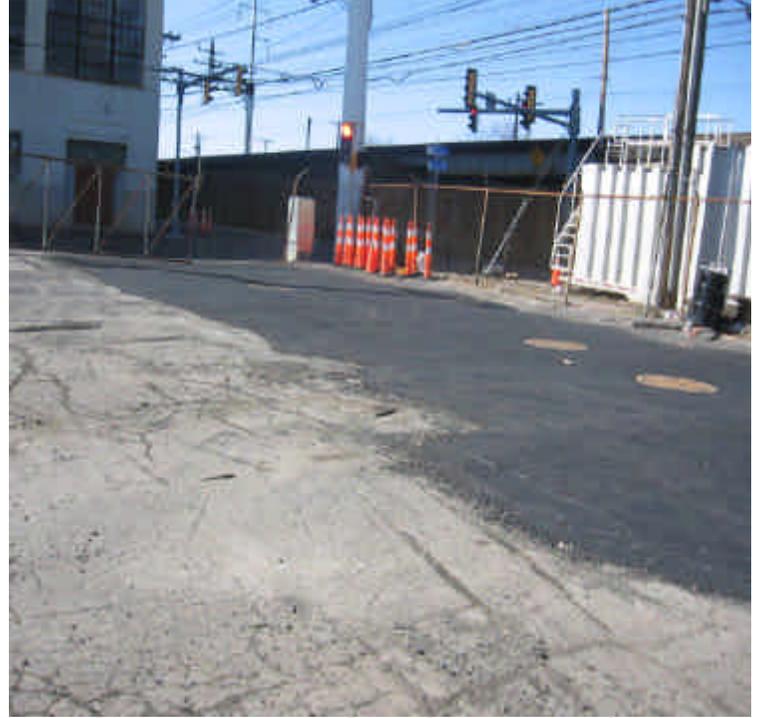
Trenching activities are complete at the intersection of Railroad Ave. and Howard Ave. The area has been restored.

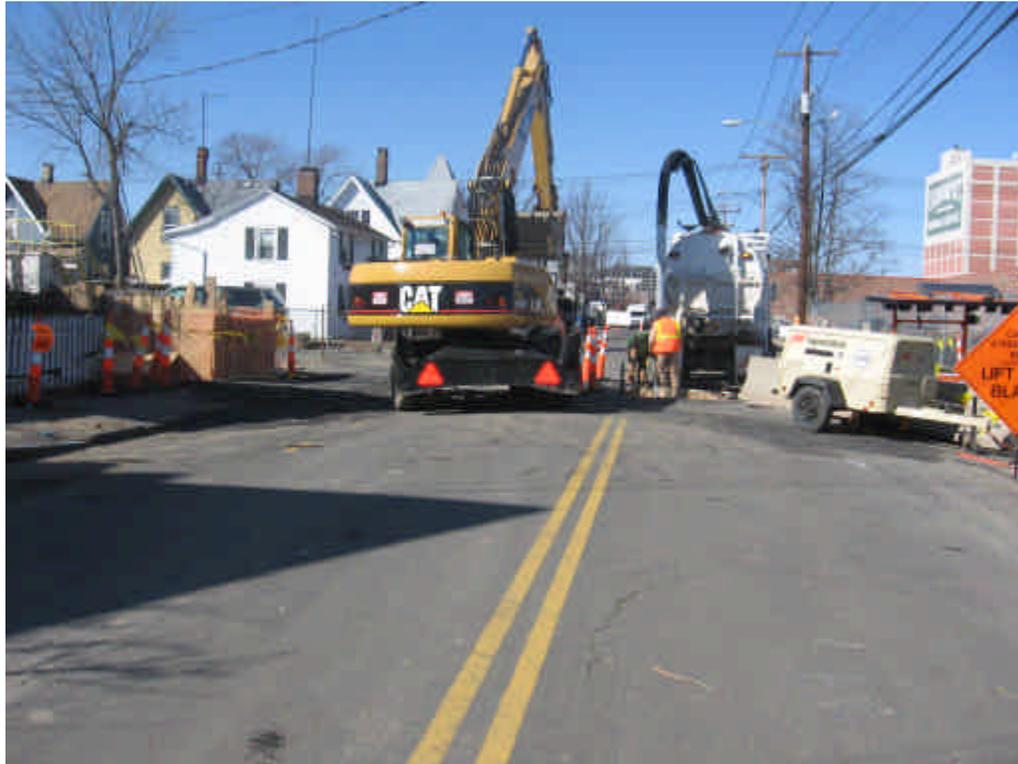
View of trenching activities on Main St. Sediment tracking was reduced this week. Continue to sweep the roadway regularly.
