Docket No. 272 – Development and Management Plan Inspection

Segment 4a Underground Line

Date: March 27, 2007 (evening inspection)

Location: Singer Substation to Fairfield/Westport Town Line

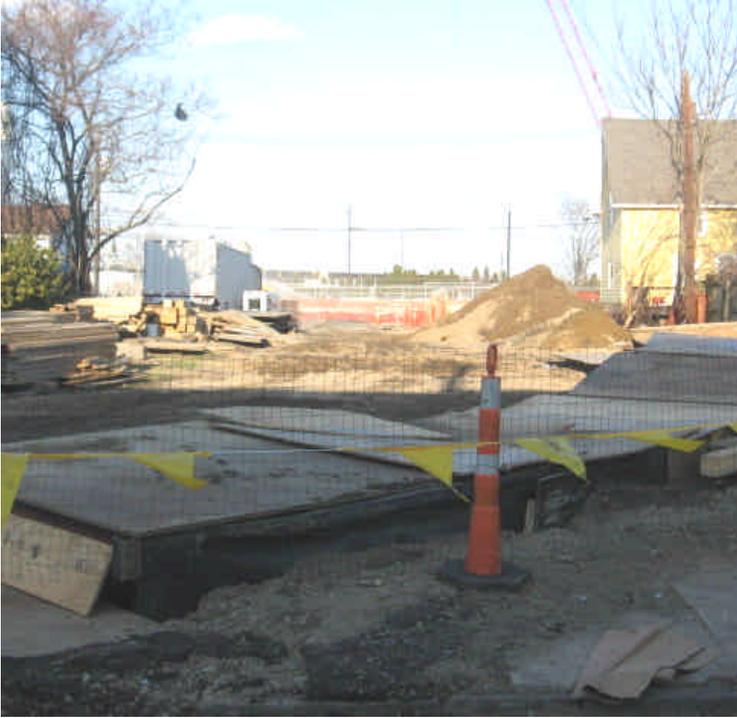
Trenching activities from sta. #810 to 813, between Broad St and Main St.

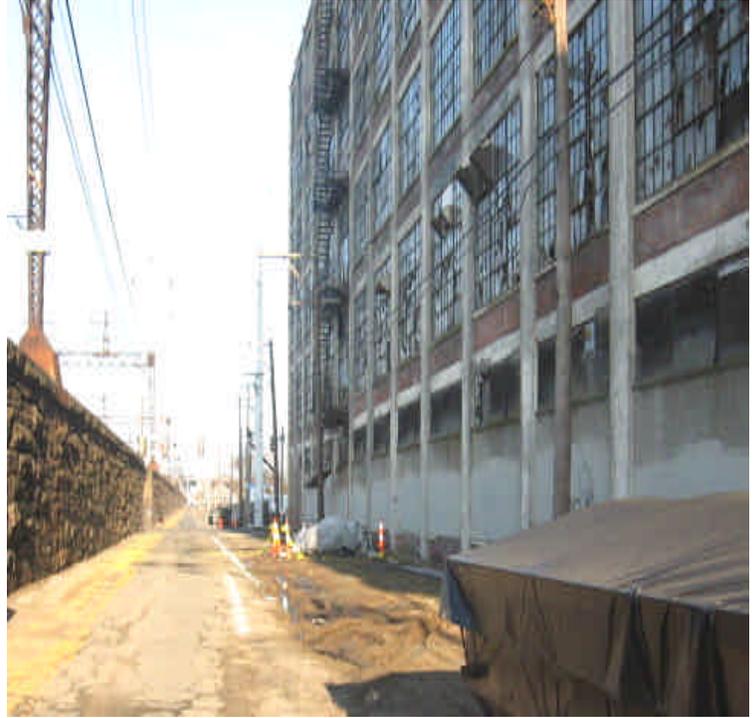
Three empty storage containers remain along Railroad Ave. near its intersection with Howard Ave.

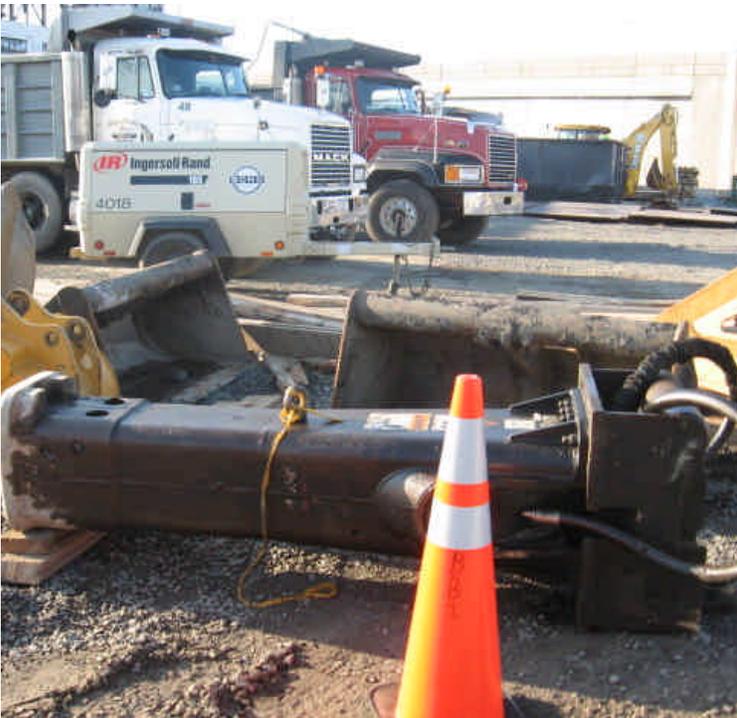
One piece of fluid filled equipment located within the Bostwick Ave. lay-down yard (in Bridgeport), was not contained. It should be placed on a liner or similar in case of leaks.

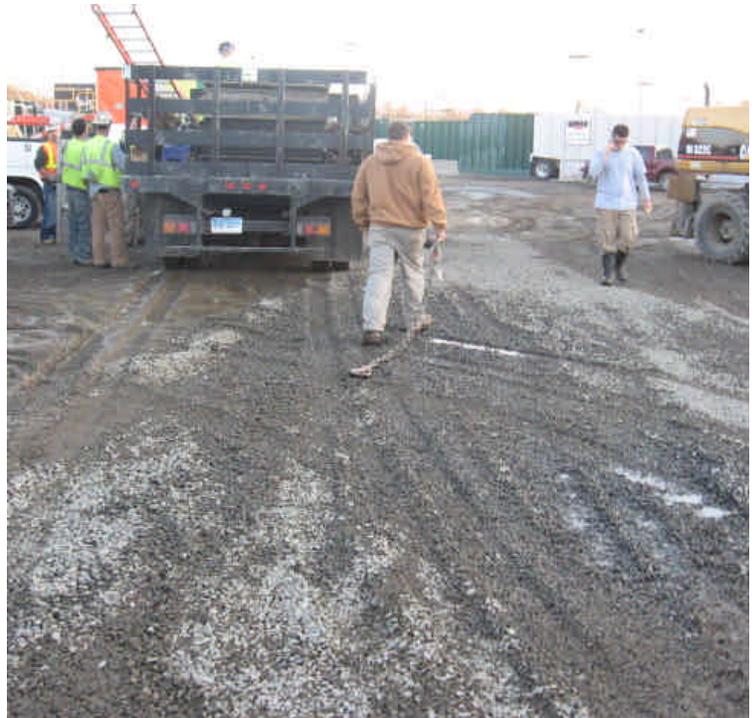
Stone has been added in areas of heavy mud throughout the King's Highway contractor yard, in order to reduce tracking.

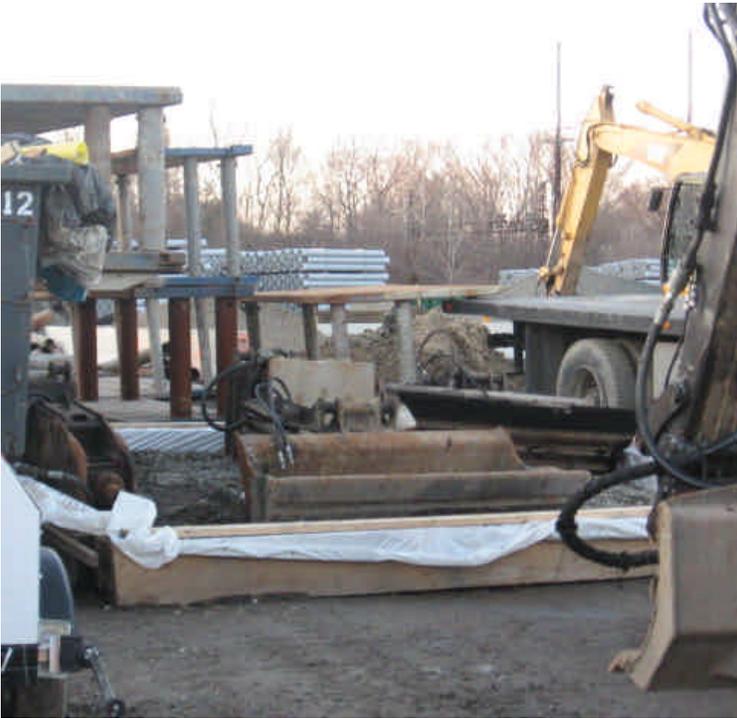
An additional containment area was constructed for fluid filled equipment in the King's Highway yard. 3/27/07	Continue to use and monitor the storage area. 3/27/07	A containment area has been provided for equipment.
Additional Observations	None 3/27/07	None 3/27/07	NA

An additional containment area for fluid-filled equipment has been constructed within the King's Highway lay-down yard.

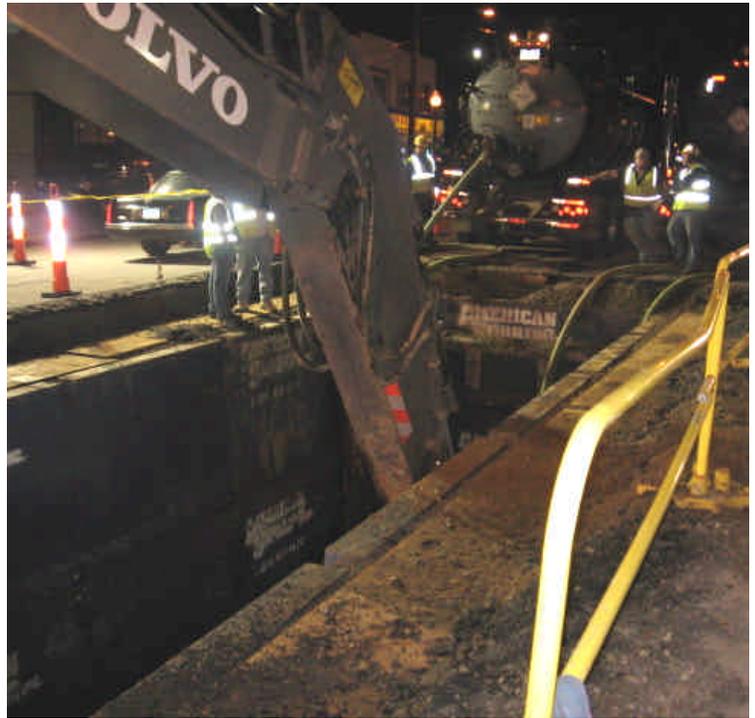
Areas of Inspection	Observation	Recommended Action	Corrected Action
	the D&M Plan. 3/27/07		
Dewatering	Dewatering activities were observed during this week's inspection at vault #43. Three vac trucks were necessary to keep up with the water. 3/27/07	Continue to appropriately contain or filter water from the excavations. 3/27/07	Vac trucks were being used appropriately.
Spills and Material Storage	Spill cleanup materials/kits were observed in the storage yards. 3/27/07	Ensure that spill kits are also present with each vehicle during active construction 3/27/07	NA
	A concrete washout was observed in an uncontained location, immediately adjacent to the railroad on Railroad Ave. between Rt. 1 and Bostwick Ave. 3/15-3/27/07	Remove and properly dispose of concrete. Concrete washouts should only be released in an approved, contained location. 3/15-3/27/07	Needs attention
	Fluid-filled equipment was not contained to a liner, within the Bostwick Ave. yard and has the potential to leak. 3/27/07	Store fluid filled equipment within a lined containment area, or place an absorbent pad under the equipment for short-term storage. 3/27/07	Needs proactive attention

View of excavation activities for Vault #43. Three vac trucks were needed to dewater the work area.

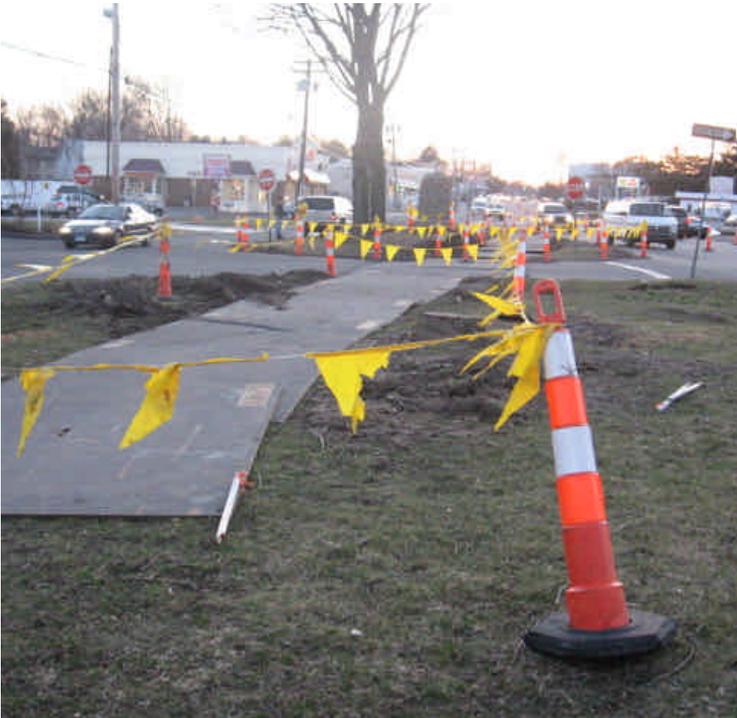
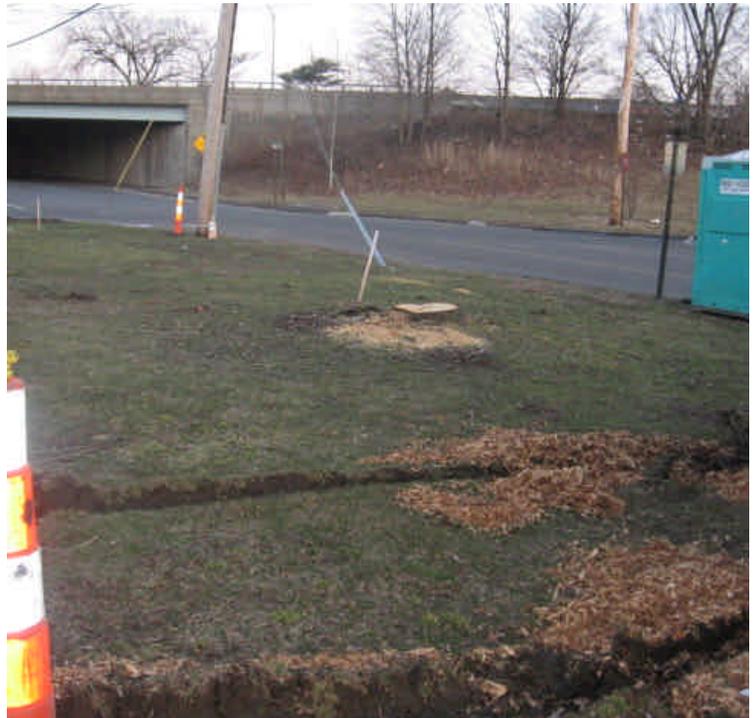
Both photo are of trenching activities from sta. #457 to 462 along Rt 1 in Fairfield. Two trees were removed to accommodate the required trench work. This vegetation removal was conducted in accordance with the D&M plan.
