Docket No. 272 – Development and Management Plan Inspection

Segment 4b Underground Line

Date: March 1, 2007

Location: Fairfield/Westport Town Line to Westport Avenue in Norwalk

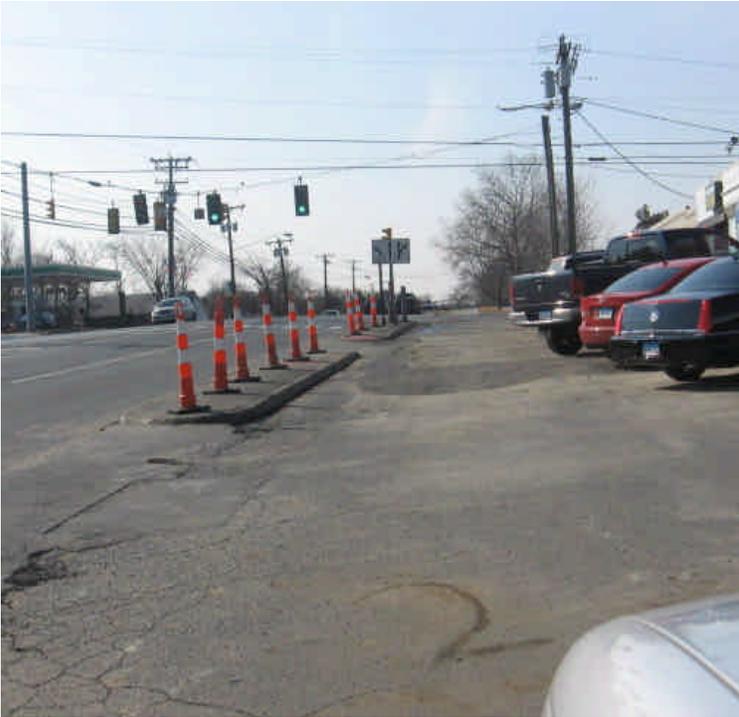
Vault #24 is being constructed within a parking area. Adjacent catch basins have been protected and the area is stable.

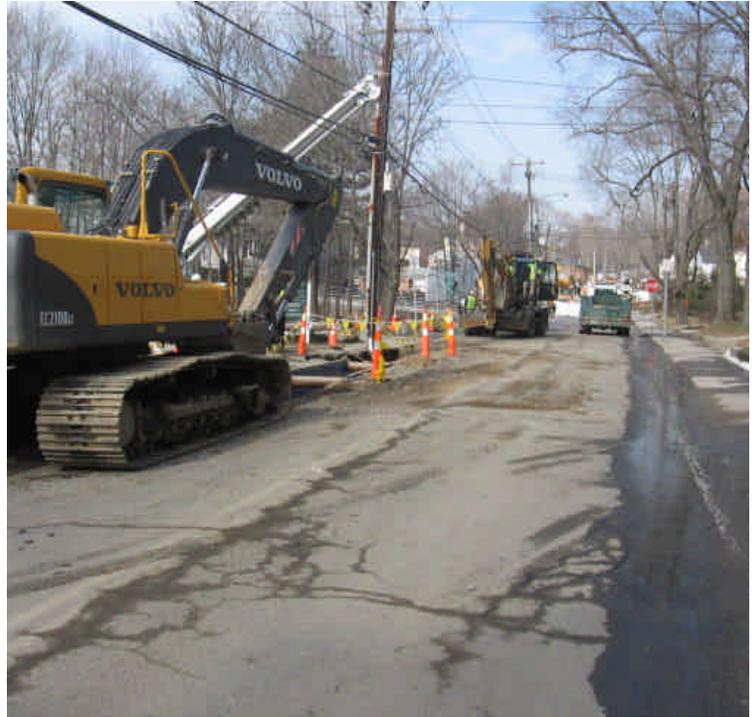
Imperial Ave. trenching activities continue; No issues noted but continue to provide regular attention to sediment tracking.

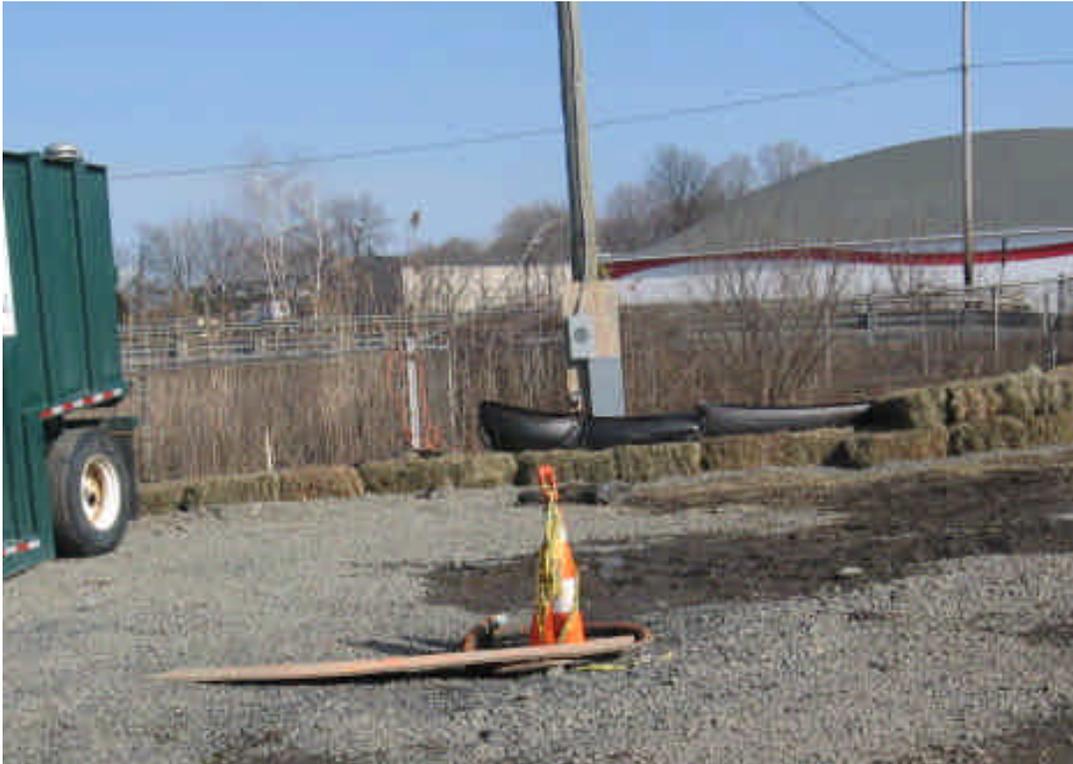
Perimeter erosion controls have been re-established proactively in the King Highway lay-down yard.
