Docket No. 272 – Development and Management Plan Inspection

The Connecticut Light and Power Company Certificate of Environmental Compatibility and Public Need for the construction of a new 345-kV electric transmission line and associated facilities between Scovill Rock Switching Station in Middletown and Norwalk Substation in Norwalk, Connecticut, including reconstruction of portions of existing 115-kV and 345-kV electric transmission line, the construction of Beseck Switching Station in Wallingford, East Devon Substation in Milford, (and Singer Substation in Bridgeport), modifications at Scovill Rock Switching Station and Norwalk Substation, and the reconfiguration of certain interconnections.

Segment 4b Underground Line

Date: March 15, 2007

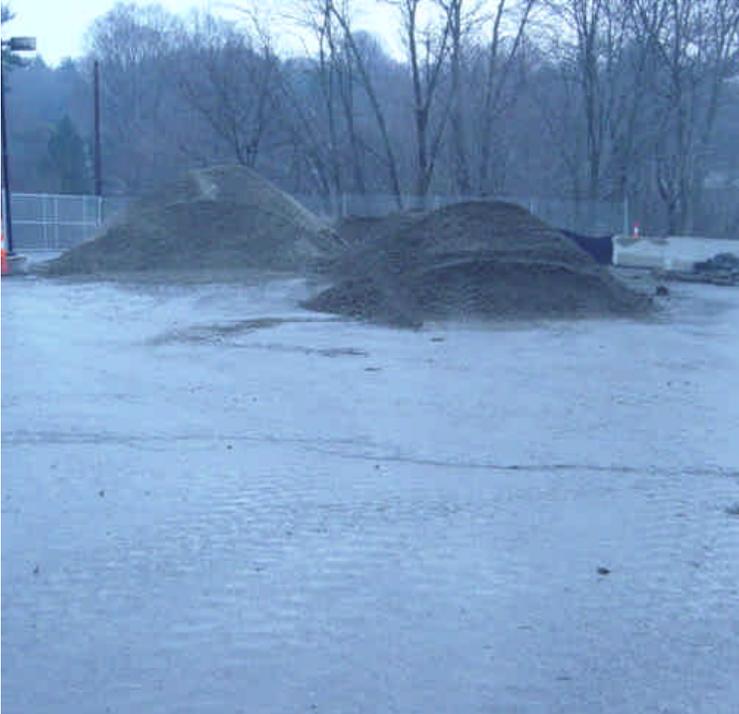
Materials are being stockpiled within the Imperial Ave. lay-down yard. Piles are contained within the yard at this time. Continue to monitor for stability if they are to remain.

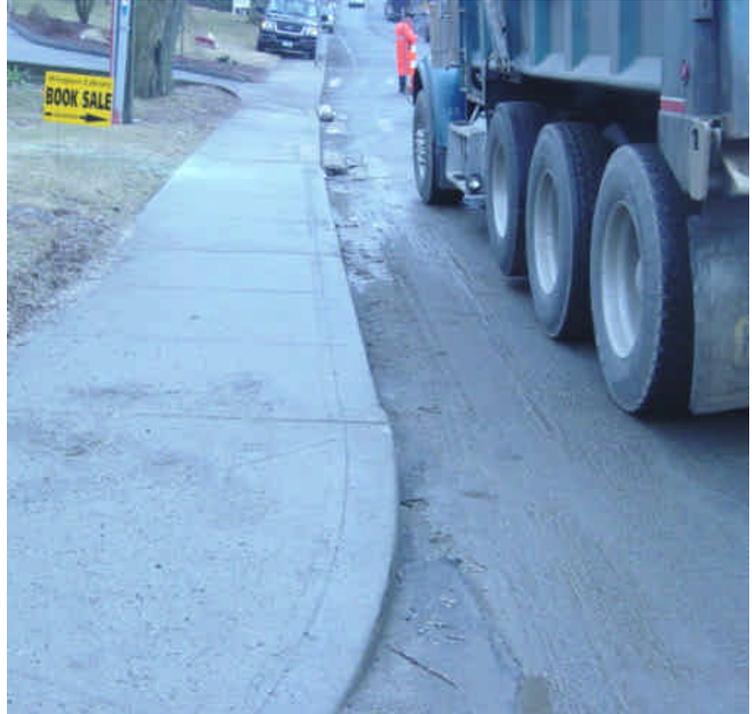
Sediment has accumulated in the gutter of the roadway near an area of active work on Imperial Ave. Sediment should be removed (swept by hand if necessary) and properly disposed of.

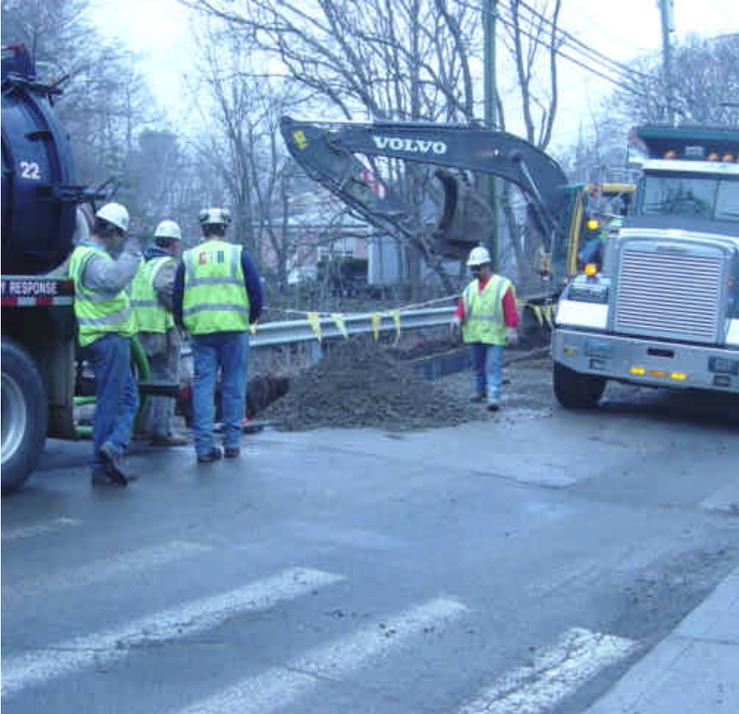
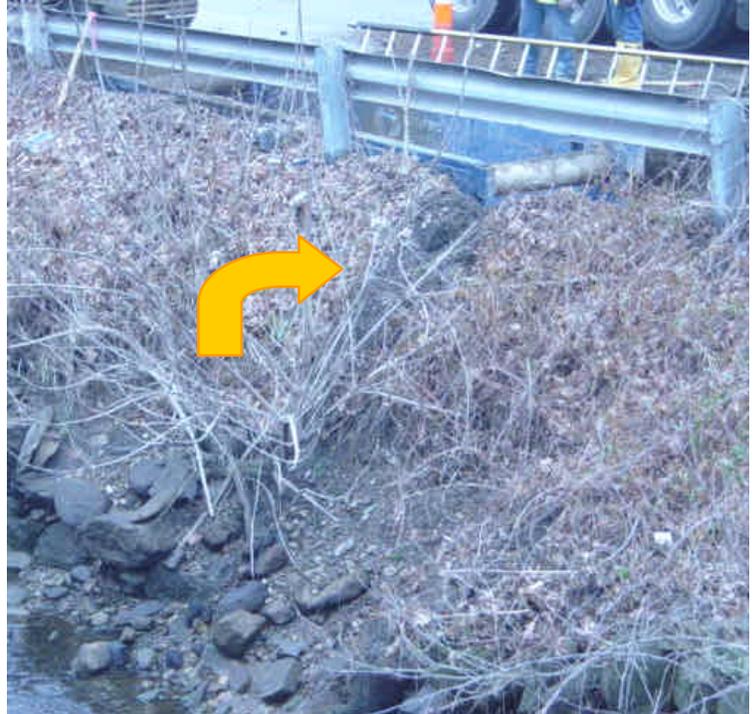
Both photos show trenching along Imperial Ave. immediately adjacent to the Dead Man's Creek (approximately station #260+00). Material/sediment from the trenching activities is falling down the bank towards the creek. Erosion controls should be installed along the slope to contain sediment and protect the resource area. Attempt to carefully remove materials that have migrated.

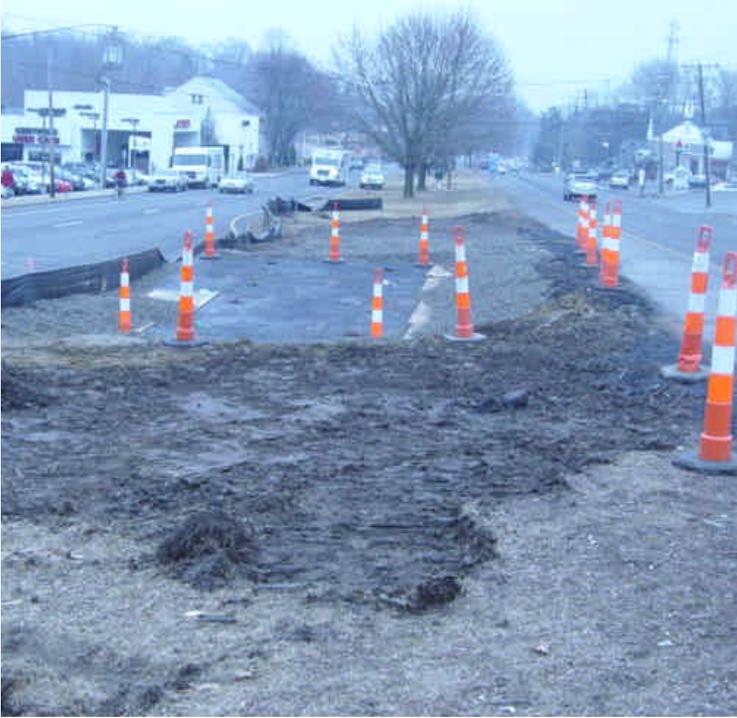
View of Vault #19 following installation. Any remaining exposed soils should be temporarily stabilized upon completion of construction activities

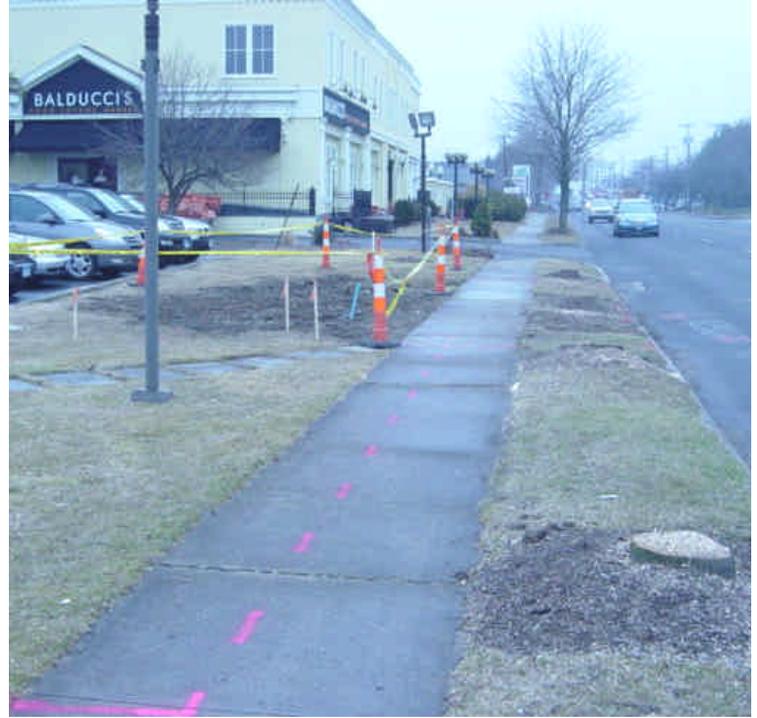
The location for Vault #23 was being prepared for construction. This included removing five trees approximately 14" inches in diameter, and staking the construction area.

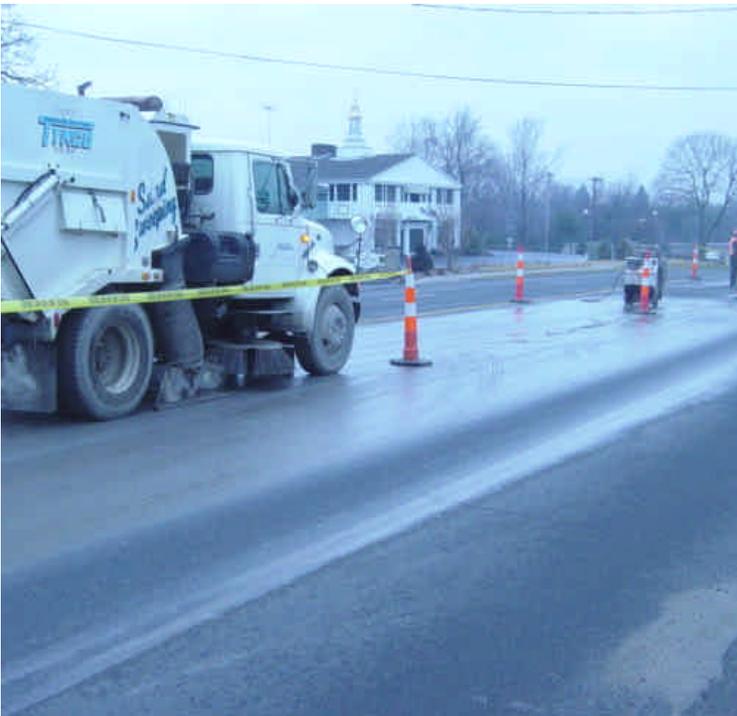
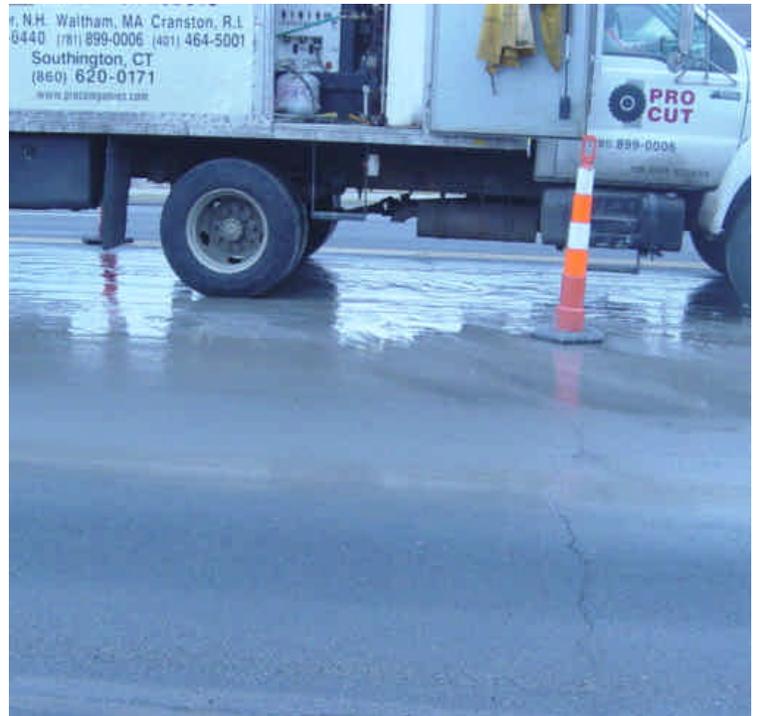
Both photos show saw cutting activities within Rt.1 between S. Maple Ave. and George St. A portion of the saw cutting route has been swept (photo on left), and a portion has not been swept (photo on right). The remaining slurry has migrated into a traffic area, resulting in extensive tracking. Slurry from saw cutting should be followed immediately with a sweeper as it is produced.
