Docket No. 272 – Development and Management Plan Inspection

Segment 4b Underground Line

Date: March 22, 2007

Location: Fairfield/Westport Town Line to Westport Avenue in Norwalk

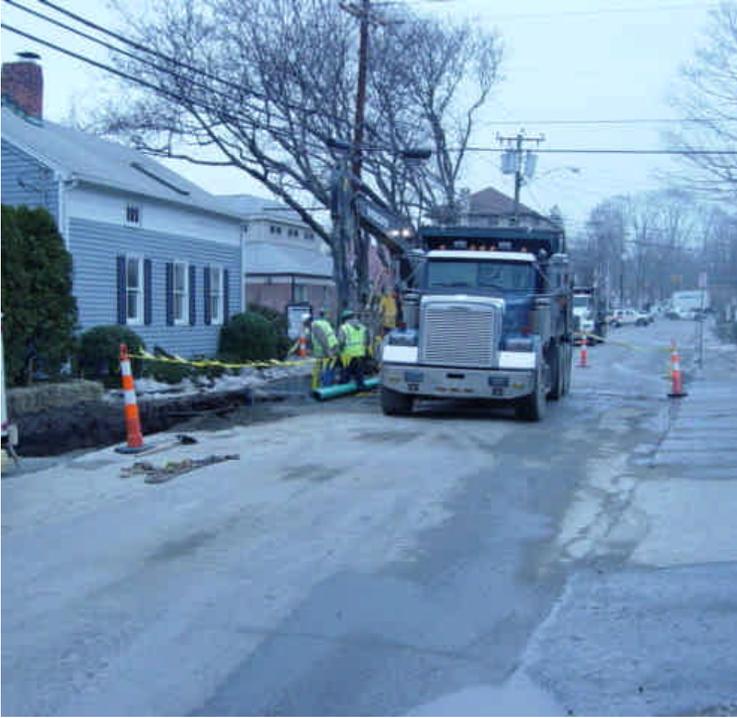
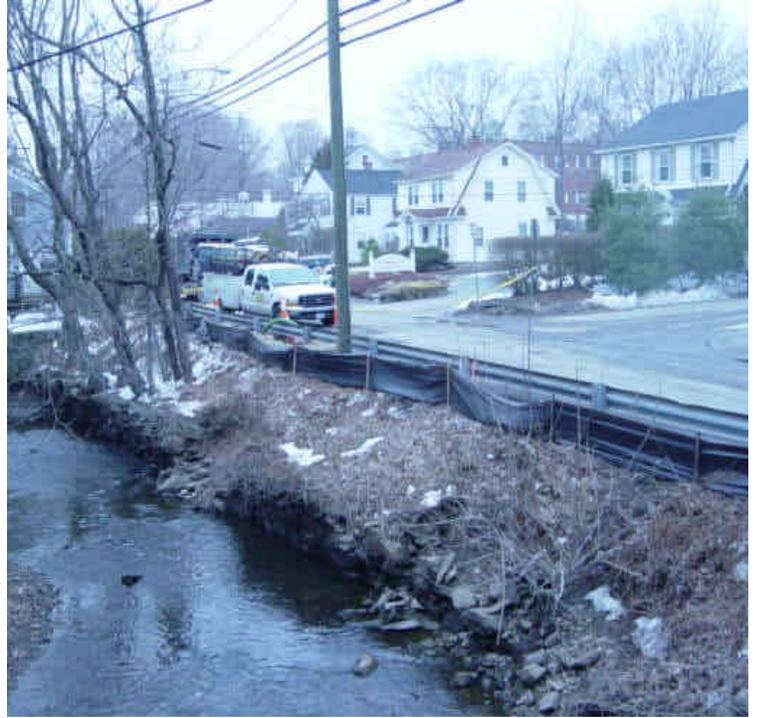
Both photos show trenching along Imperial Ave. immediately adjacent to Dead Man's Creek (approximately station #260+00). Silt fence and haybales have been installed along the edge of the bank to prevent sediment from entering the resource area.

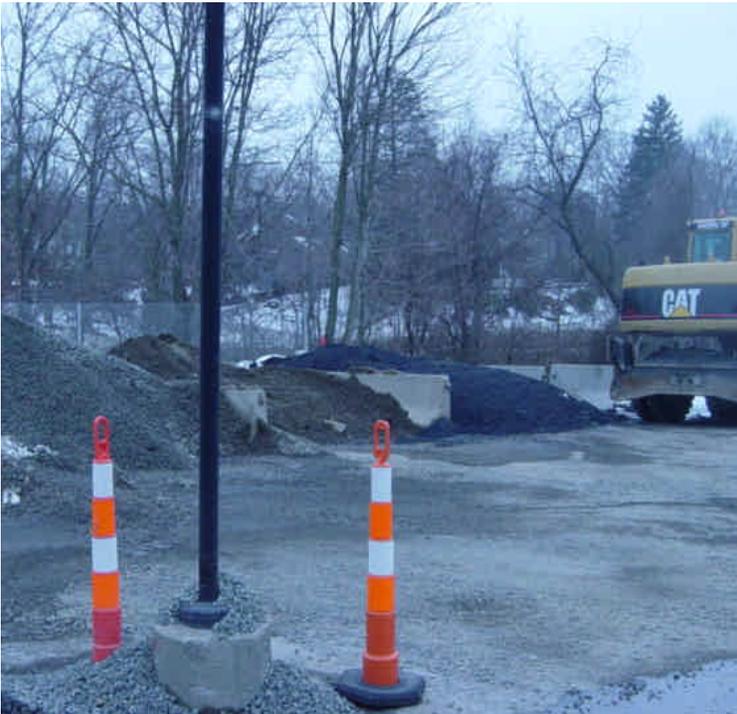
Materials are being stockpiled within the Imperial Ave. lay-down yard. Continue to monitor piles to ensure stability and that they stay contained to the yard if they are to remain.

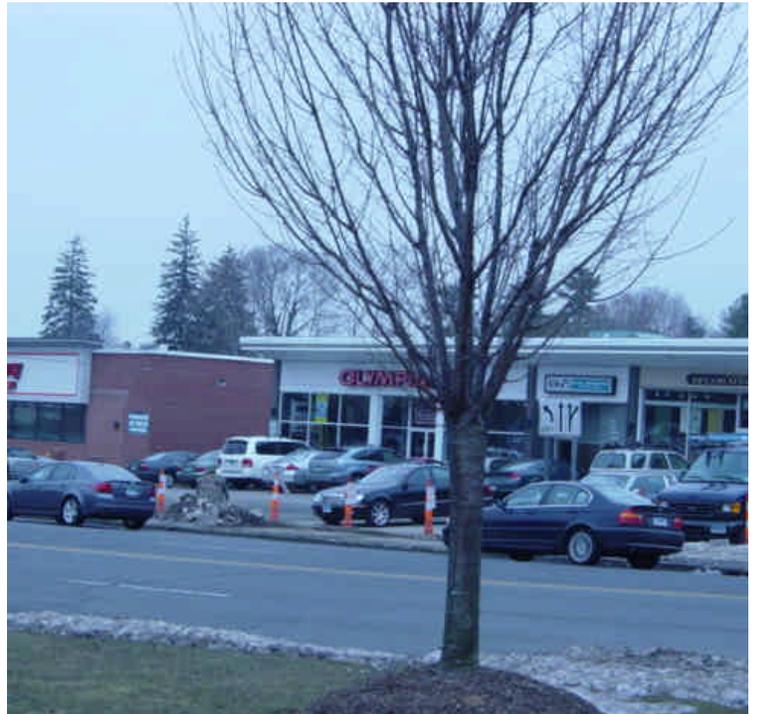
A tree has been removed in preparation for the installation of vault #17.
