Docket No. 272 – Development and Management Plan Inspection

Beseck Switching Station Inspection

Date: May 22, 2007

Location: Beseck Switching Station

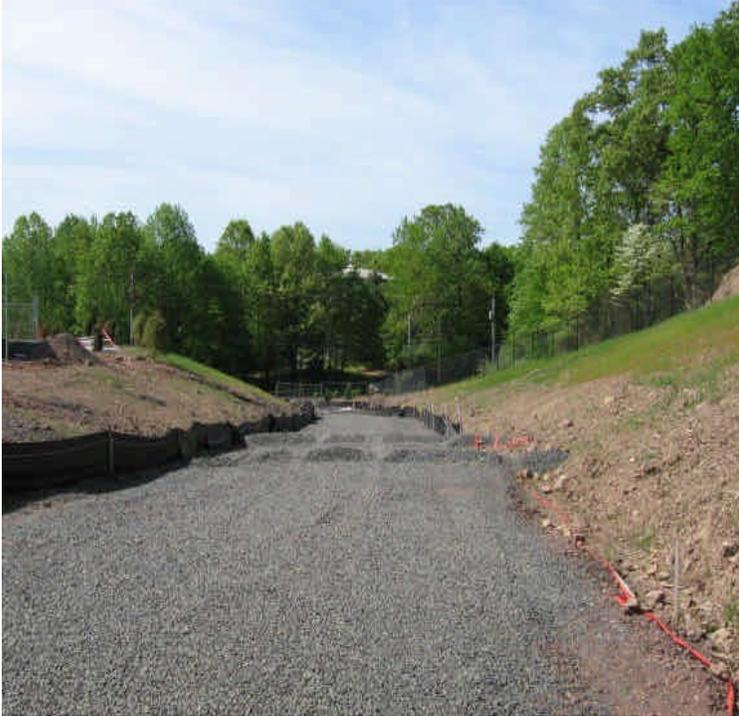
Site entrance off Carpenter Lane is at final grade. Stone base and stone check dams remain in place

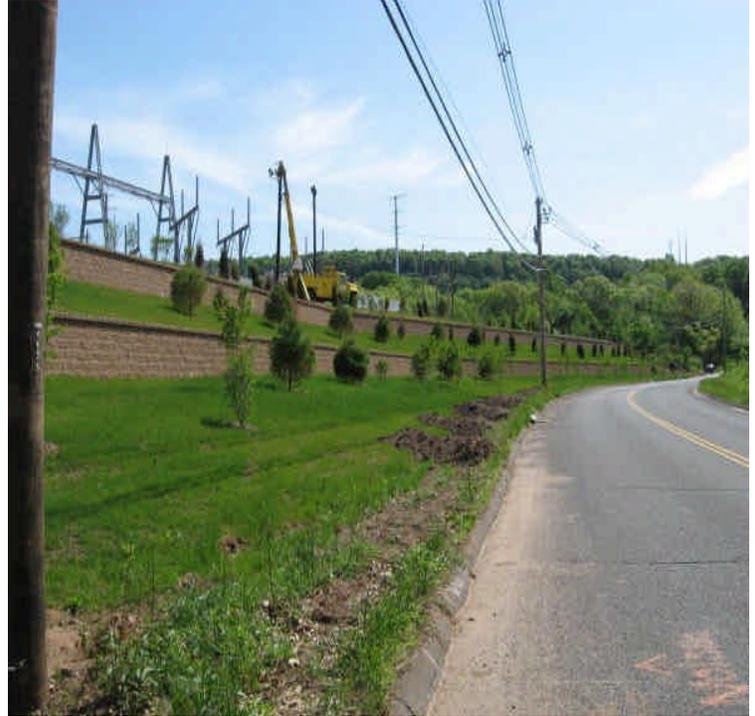
Silt fence was removed along Carpenter Lane. Apply seed to any exposed soil resulting from the removal.

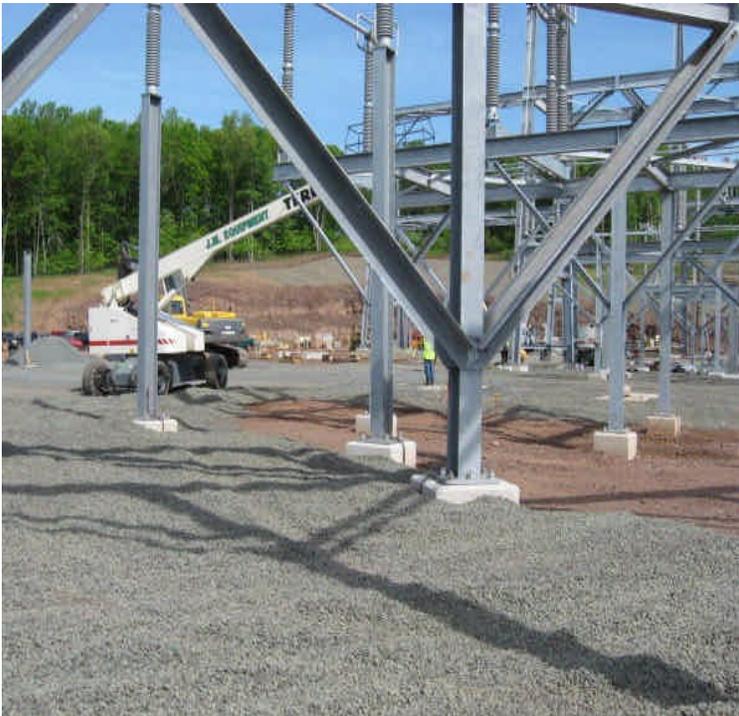
View of the entire site from the southeast corner looking north. Stone is being spread at completed areas for further stabilization.

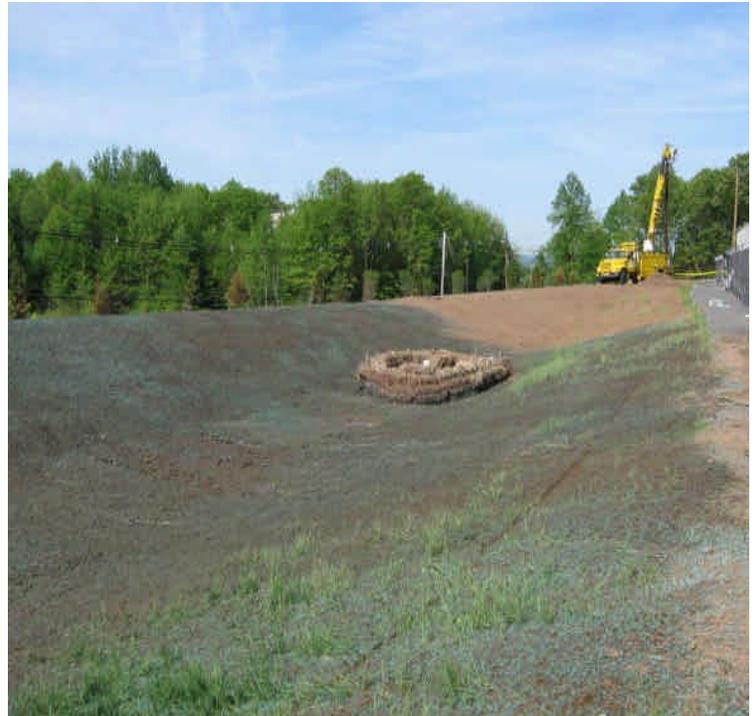
Haybales and controls remain in place at the inlet of the detention basin. Sediment from run-off has been graded. Crews have started to hydroseed exposed surfaces for final stabilization.

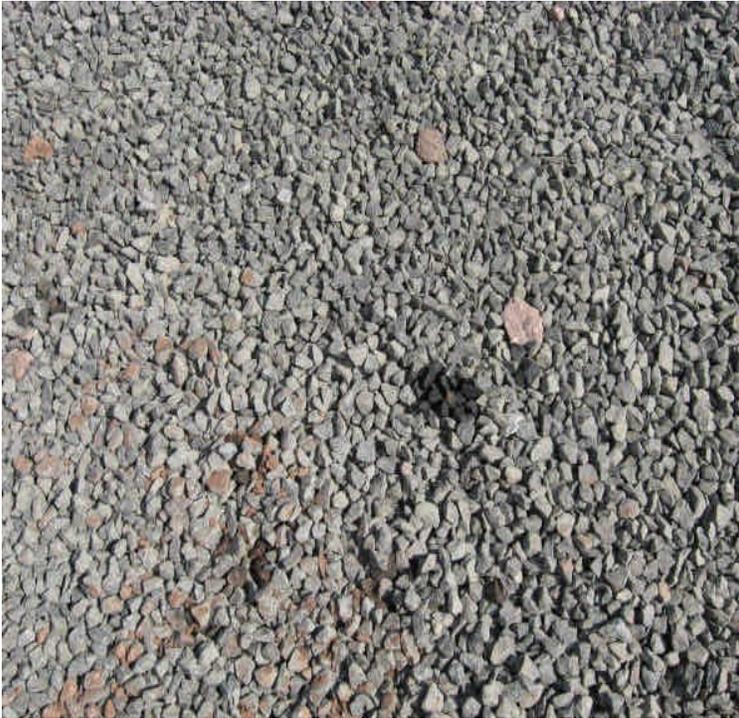
Minor equipment drip stains were noted on the stone near the trails.

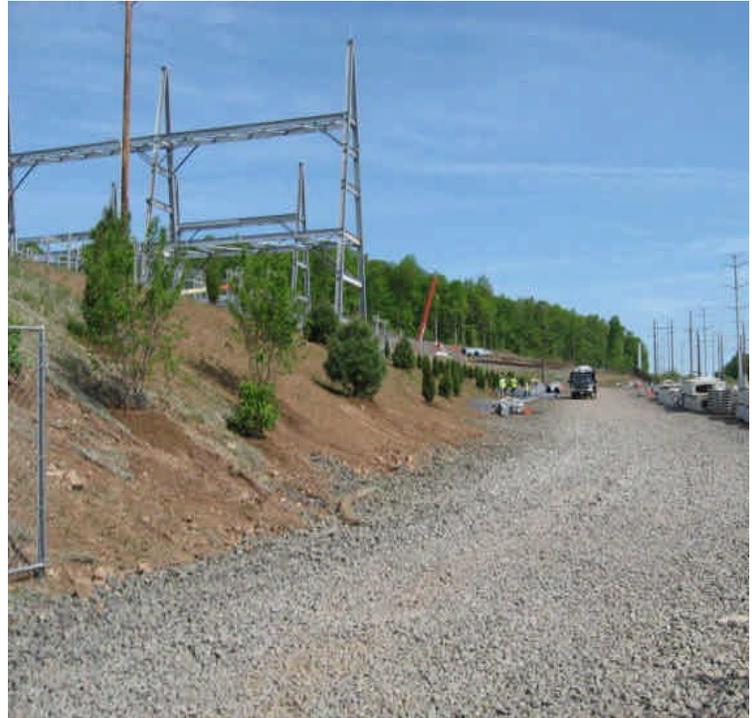
View of the eastern site exit and the new shrubs being planted along the slope. Consider adding more seed for ground cover as well.

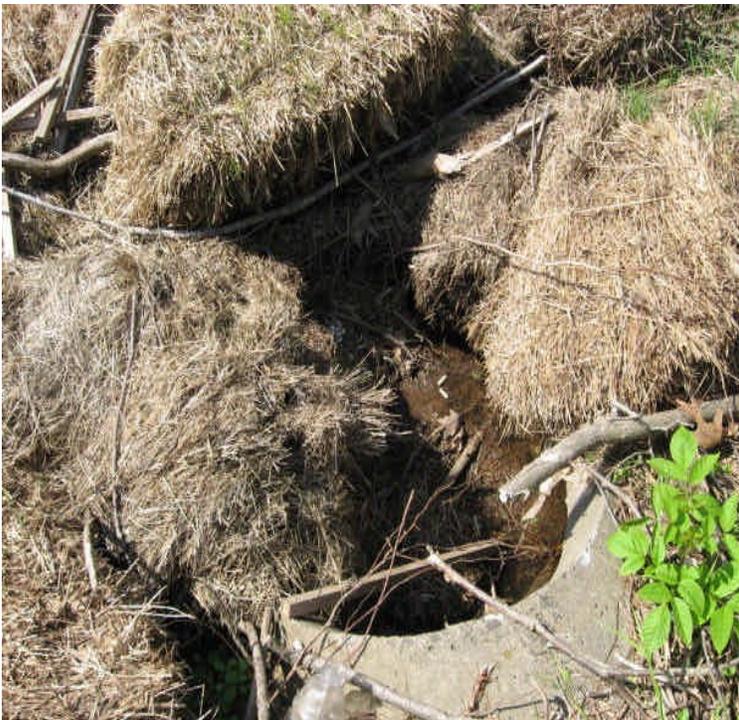
Storm drain outlet across Carpenter Lane has clear water flowing through the haybales. Degraded haybales should be removed and replaced.

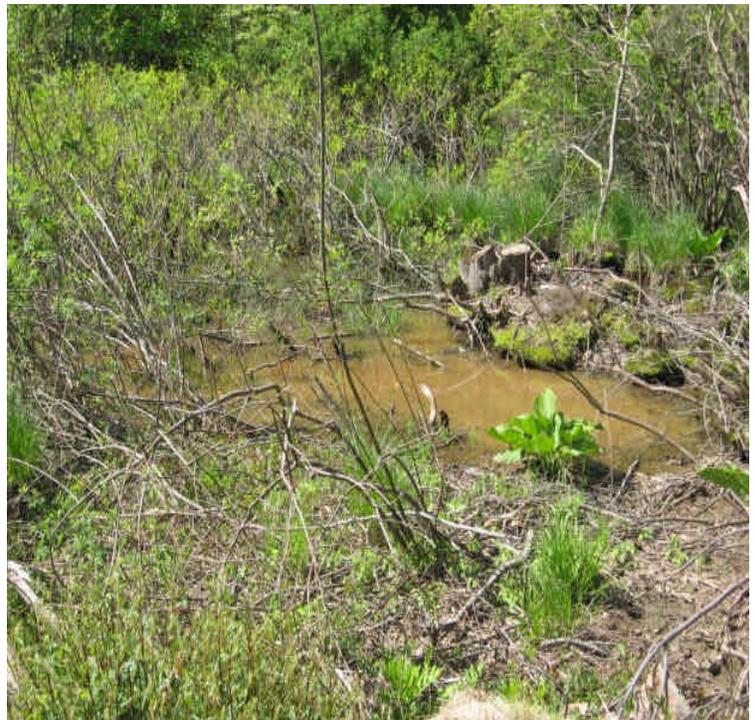
Clear water was observed leaving the haybales but turbid water was noted ponding within the wetlands. Evaluate whether the amount of sediment accumulation justifies the minor disturbance needed to remove it, once the water subsides.
