Docket No. 272 – Development and Management Plan Inspection

Beseck Switching Station Inspection

Date: June 12, 2007

Location: Beseck Switching Station

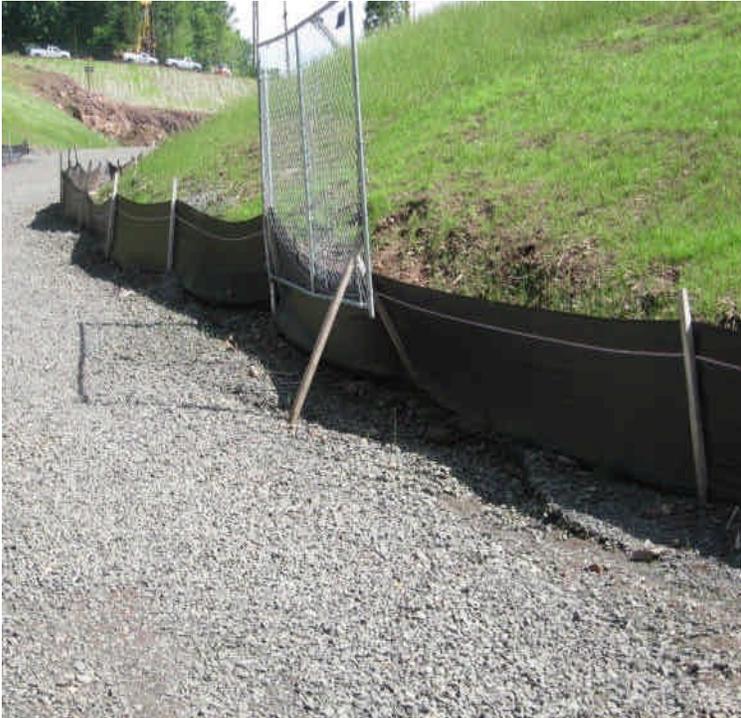
Silt fence at entrance off Carpenter Lane has been toed back in.

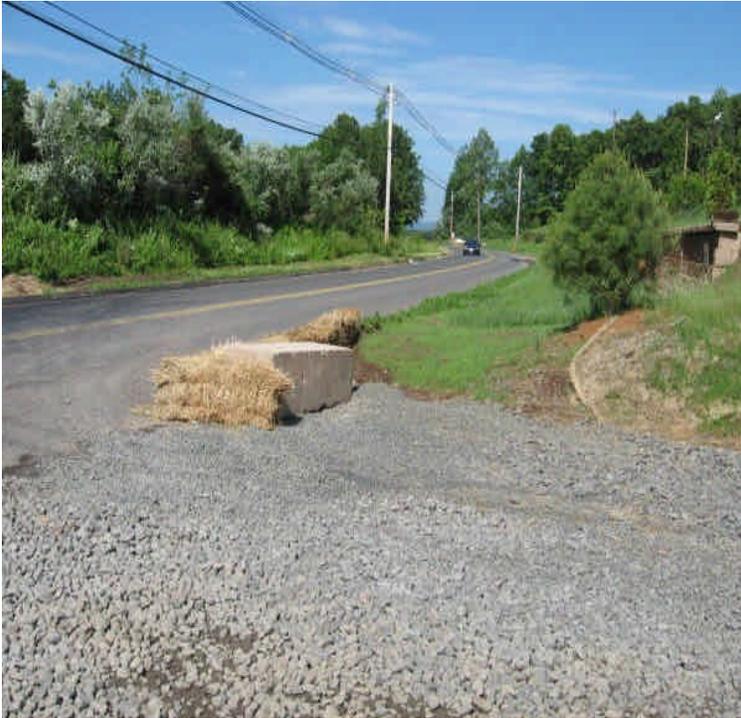
View of the eastern site exit at Carpenter Lane. Haybales and a concrete block were installed at the corner of the drive in an effort to contain run-off.

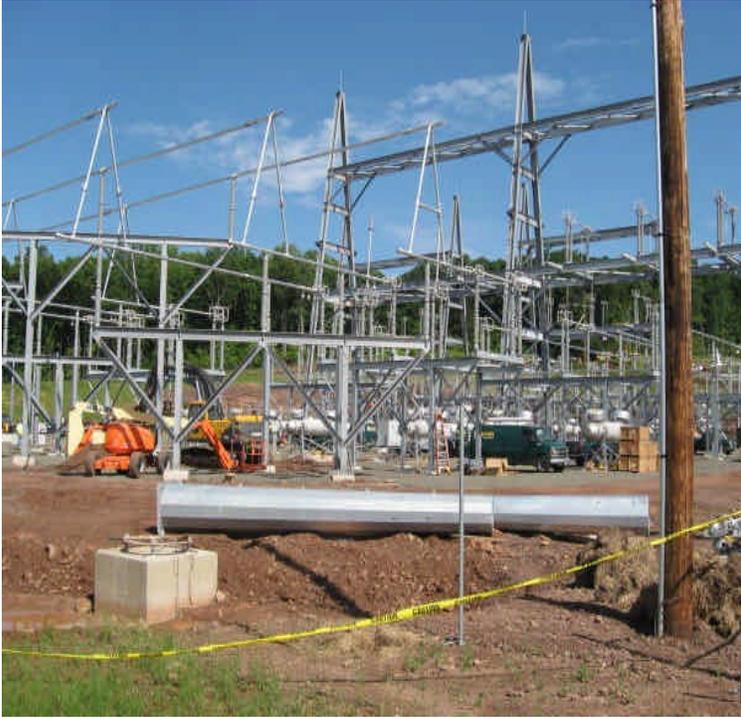
View of the entire site from the southeast corner looking north. Stone is being spread at completed areas for further stabilization.

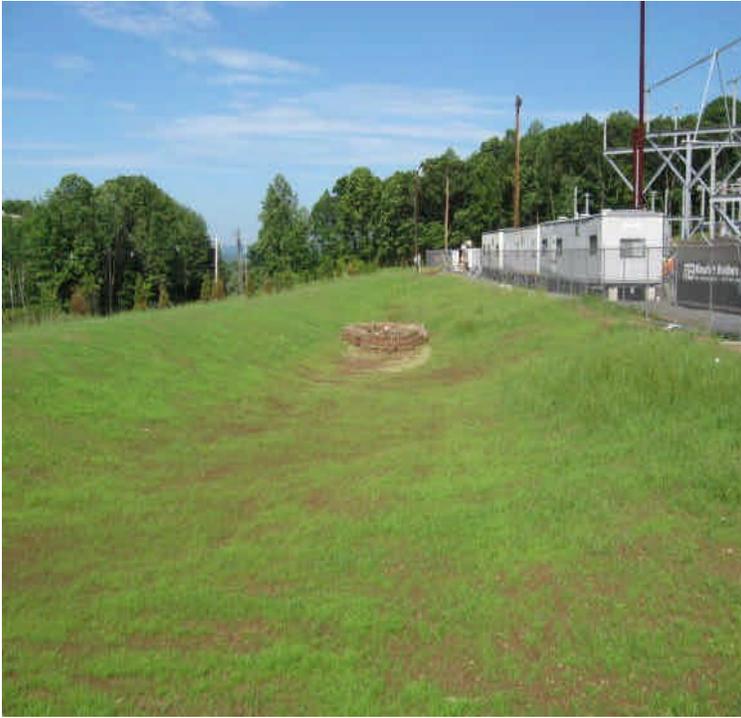
Haybales and controls remain in place at the inlet of the detention basin. Grass cover continues to establish well in the recently hydro-seeded areas.

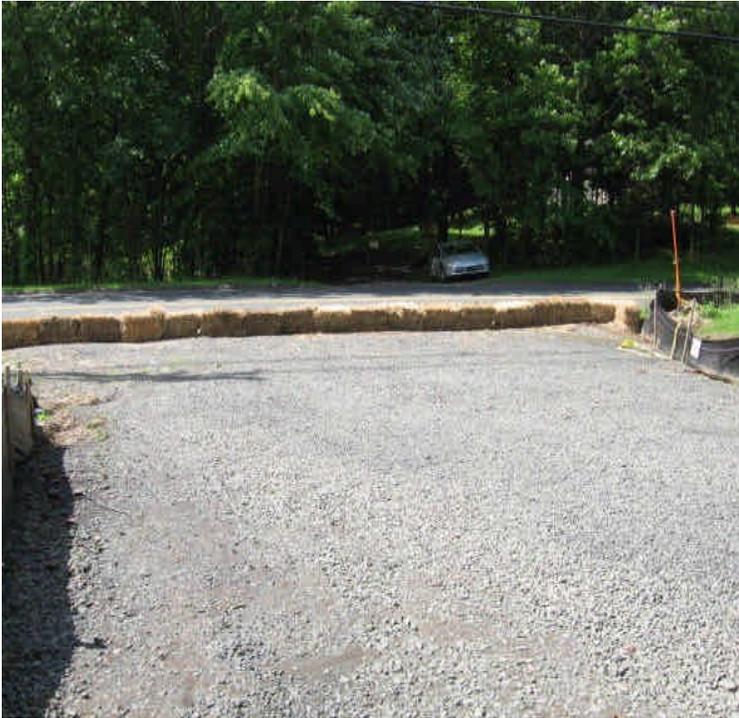
New haybales were installed across the site entrance at Carpenter Lane.

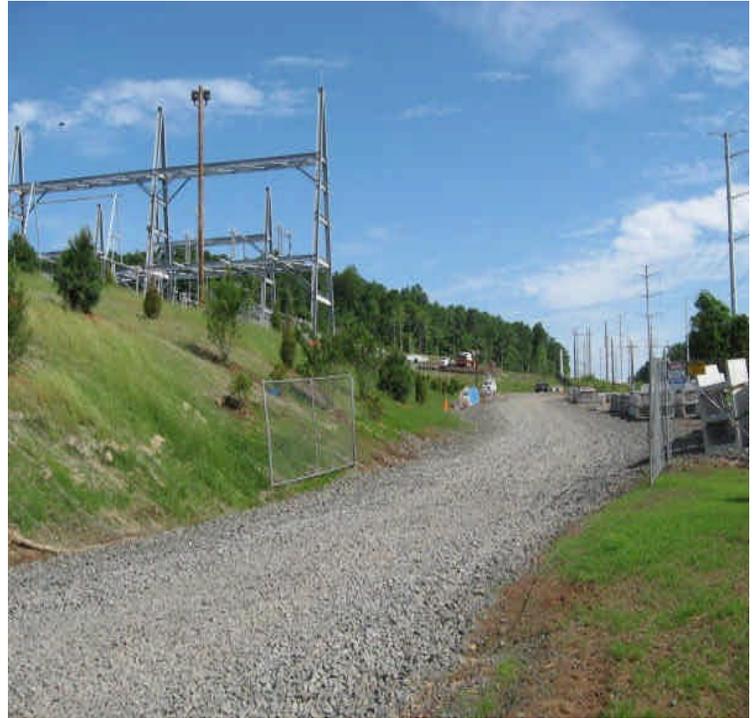
View of the eastern site exit and shrubs in place along the slope. Grass cover also continues to increase here.

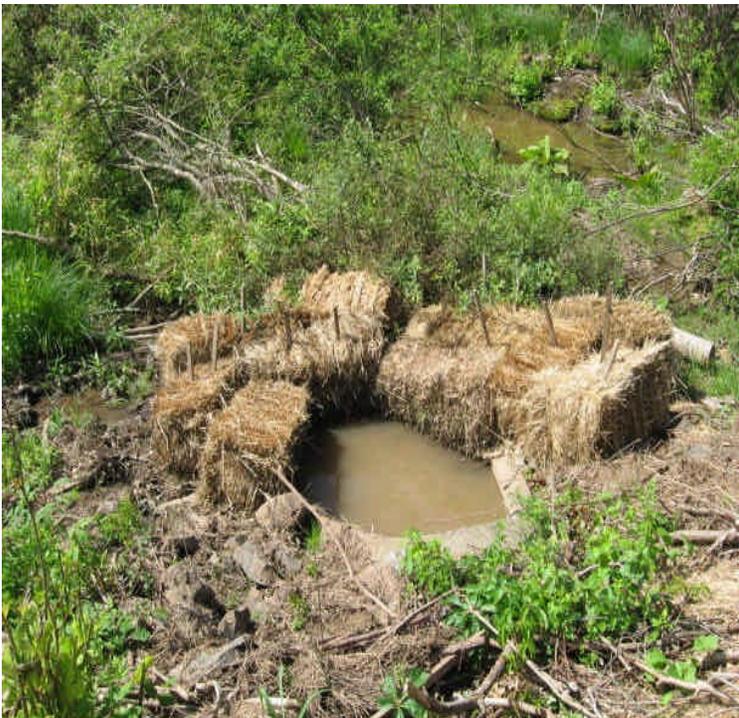
Storm drain outlet across Carpenter Lane has standing turbid water.

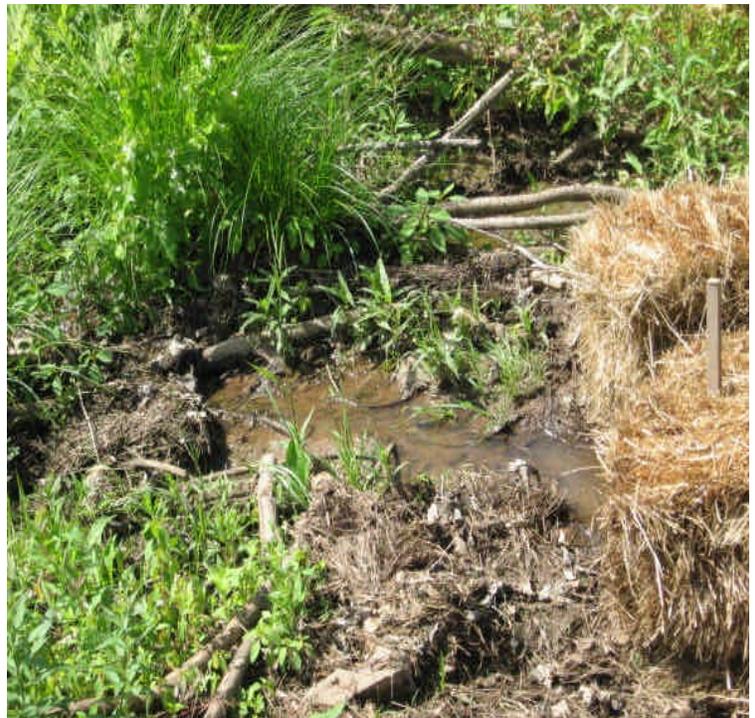
Mostly clear water was observed leaving the haybales and entering the wetlands. The new haybales helped to filter out the sediment. Evaluate whether the amount of sediment accumulation justifies the minor disturbance needed to remove it, once the water subsides.
