**Docket No. 272 – Development and Management Plan Inspection**

**East Devon Substation Inspection**

**Date:** June 15, 2007

**Location:** East Devon Substation

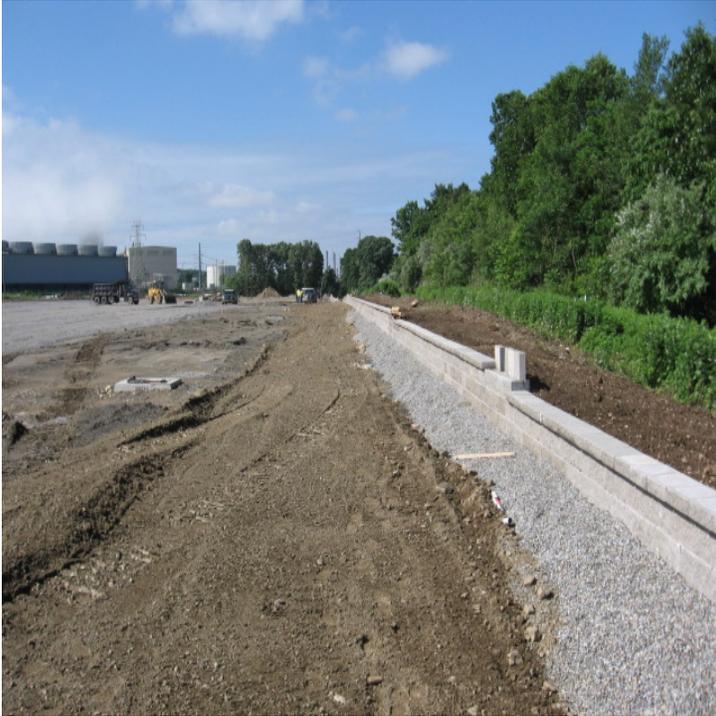
View of the retaining wall constructed along the western site boundary. Backfilling is complete here.

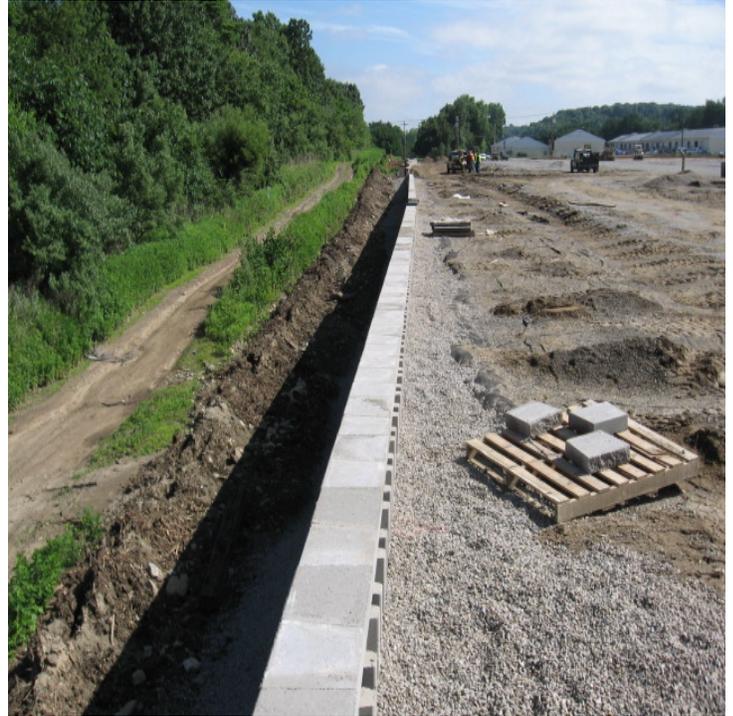
View of the retaining wall looking north towards Plains Road. Jersey barriers have been removed, but wood chips remain as a perimeter control.

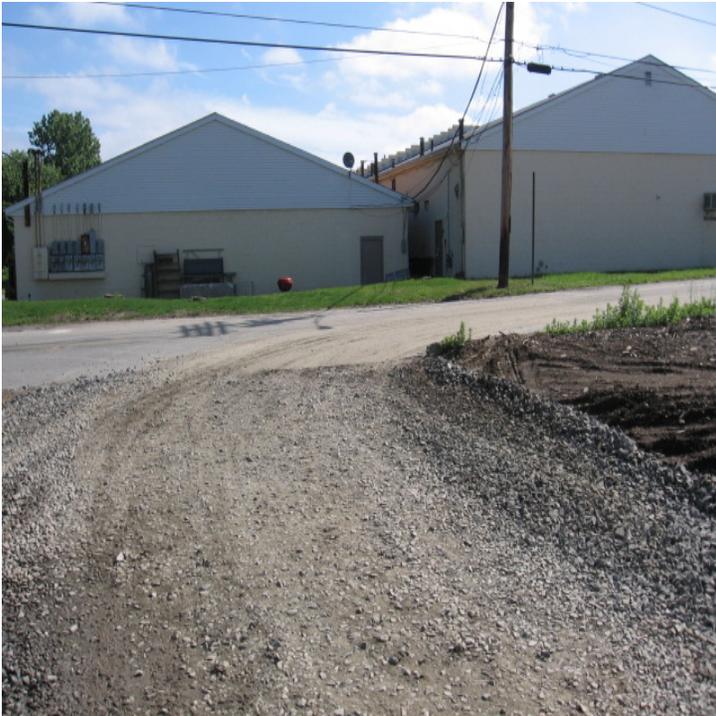
Minor sediment tracking was noted on Plains Road this week.

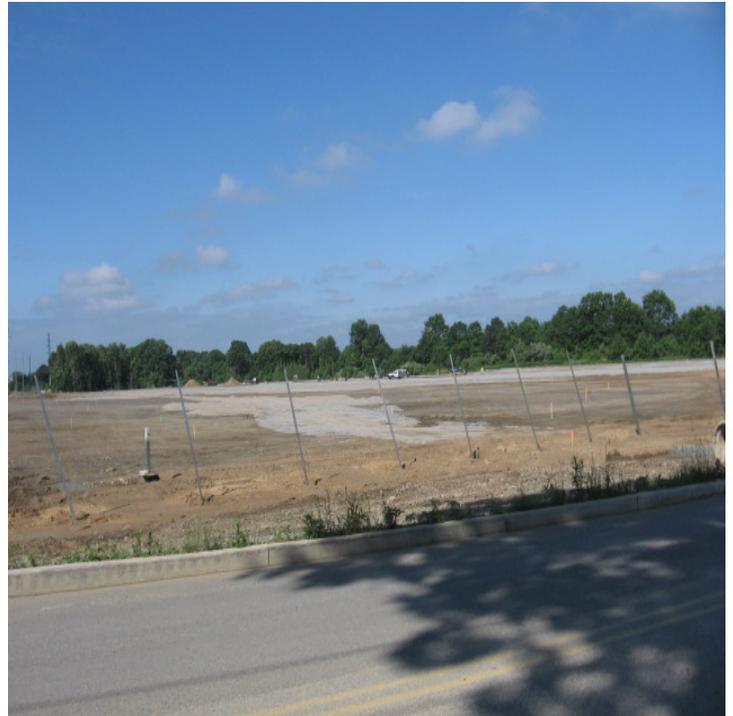
View of the East Devon Substation site from Plains Road. Perimeter fence installation had begun this week.

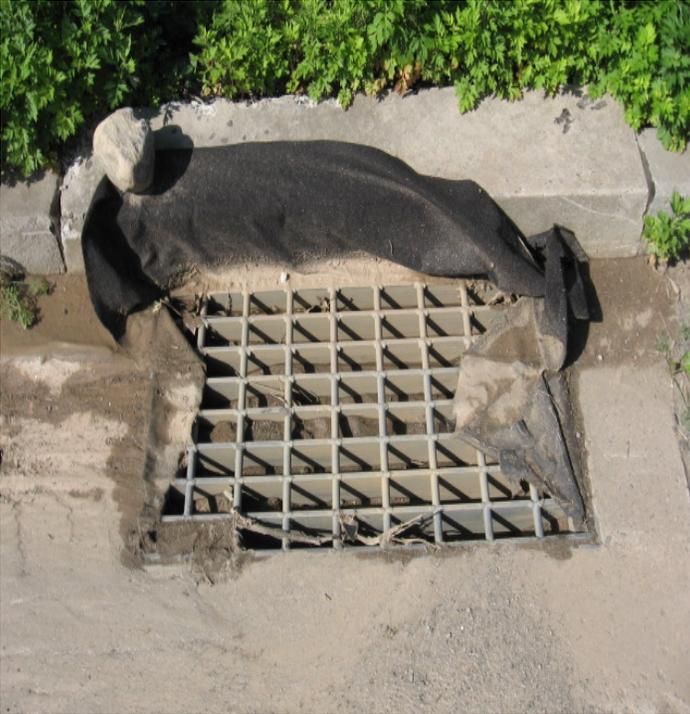
“Silt saks” remain intact within the catch basins on Plains Road. Curb drop inlet protection is provided for catch basins located immediately adjacent to the access roads.

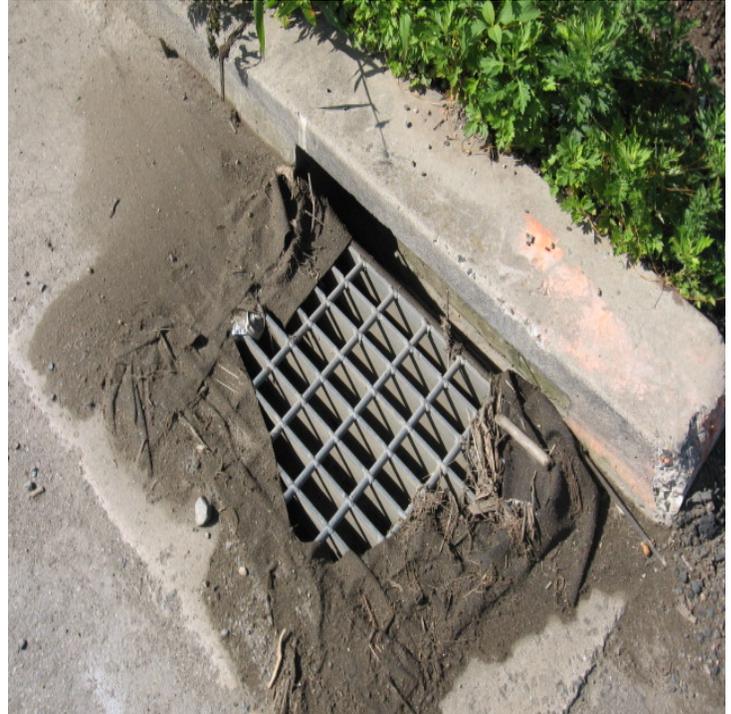
Curb inlet protection was not provided for some catch basins along Plains Road.

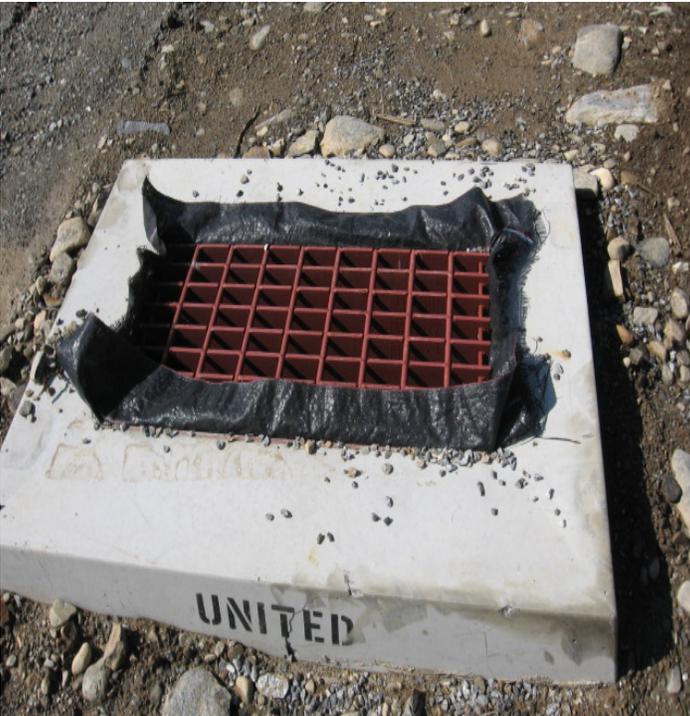
“Silt-saks” were installed proactively within the raised catch basins on site.

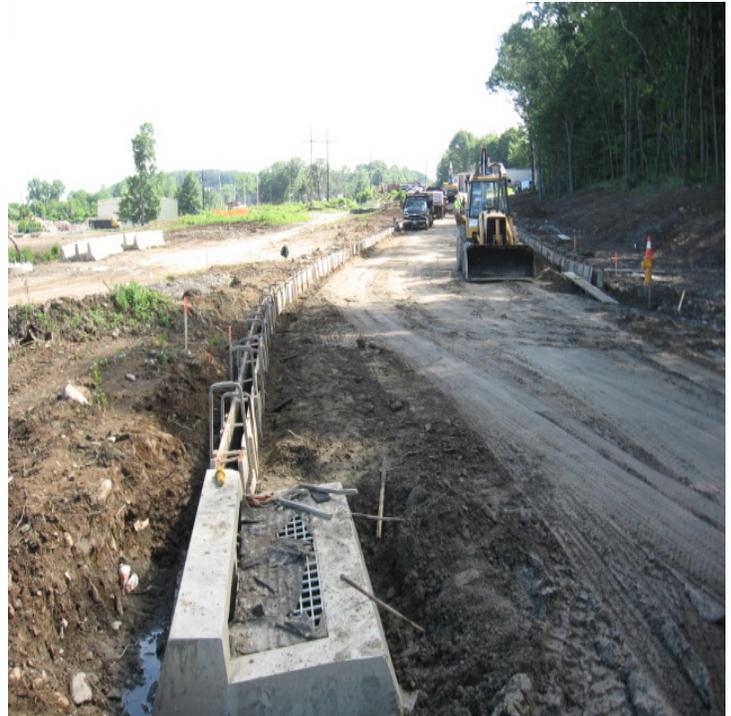
Work associated with the relocation of Shelland Street continues. Curb construction/installation has begun.

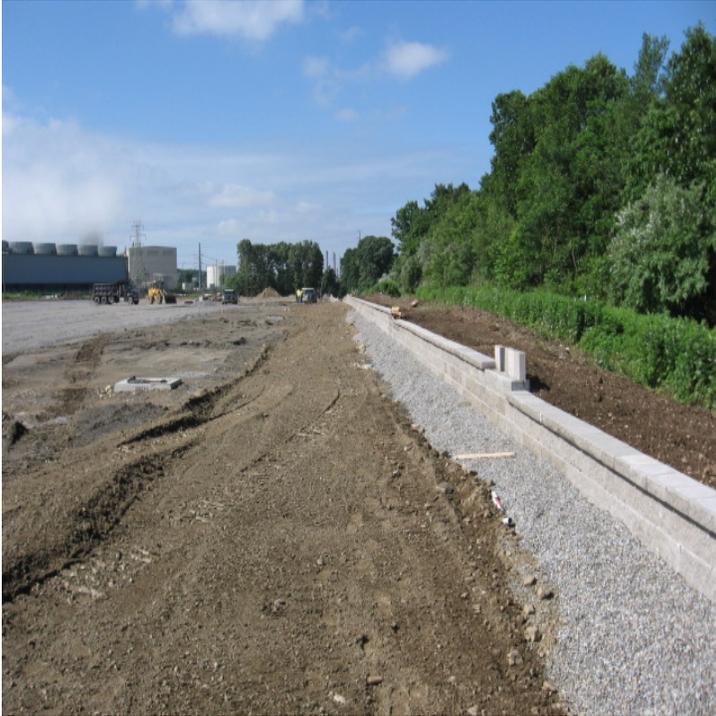
View of the retaining wall constructed along the western site boundary. Backfilling is complete here.

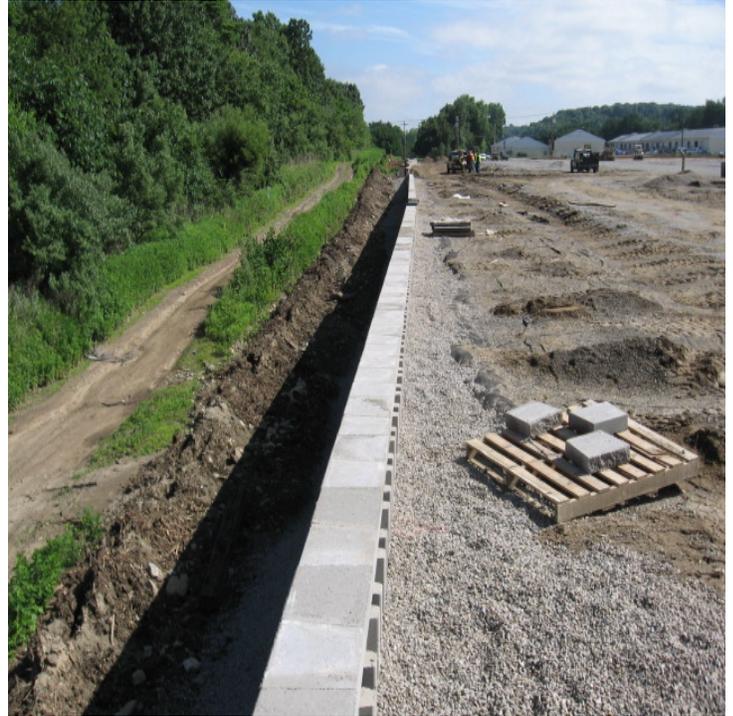
View of the retaining wall looking north towards Plains Road. Jersey barriers have been removed, but wood chips remain as a perimeter control.

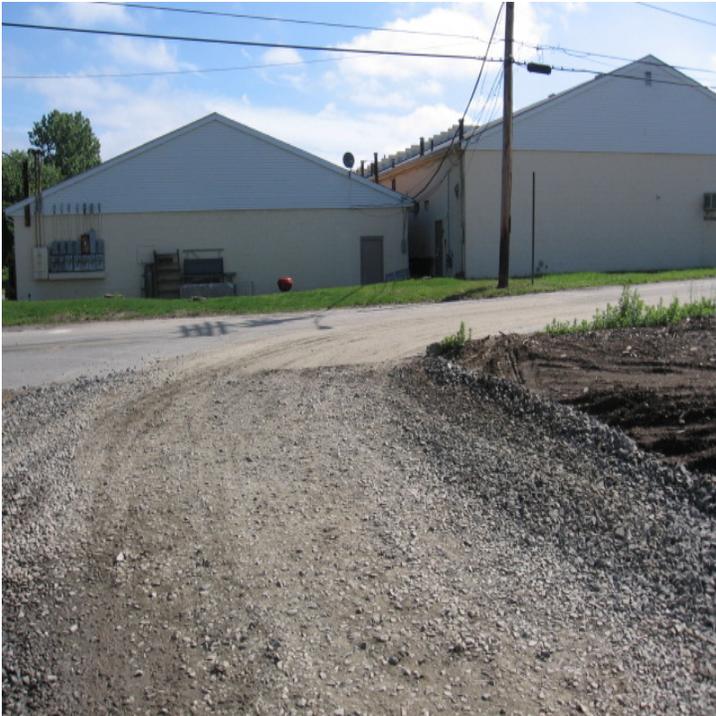
Minor sediment tracking was noted on Plains Road this week.

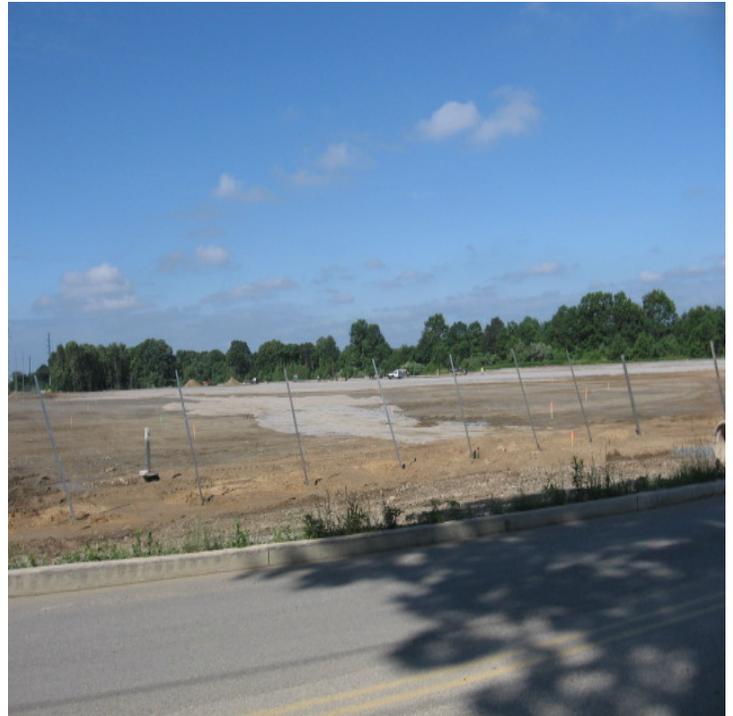
View of the East Devon Substation site from Plains Road. Perimeter fence installation had begun this week.

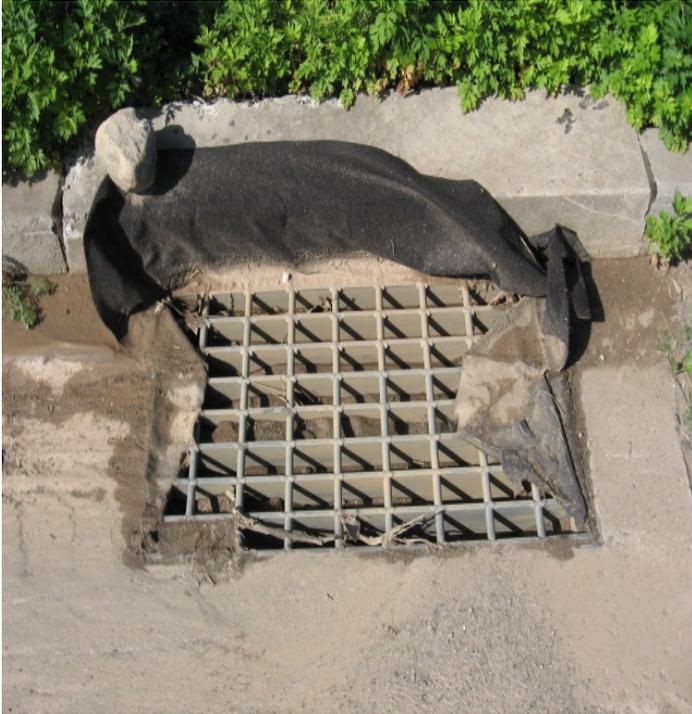
“Silt saks” remain intact within the catch basins on Plains Road. Curb drop inlet protection is provided for catch basins located immediately adjacent to the access roads.

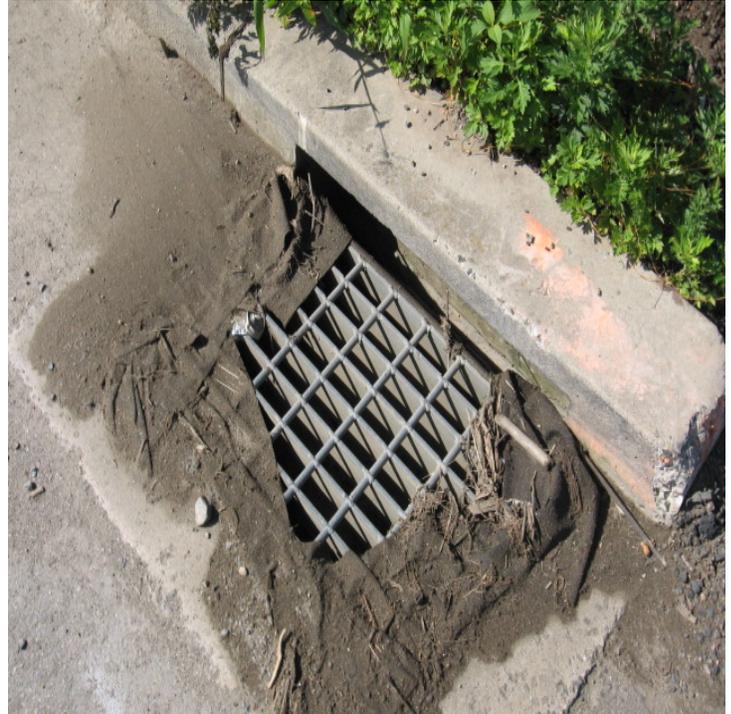
Curb inlet protection was not provided for some catch basins along Plains Road.

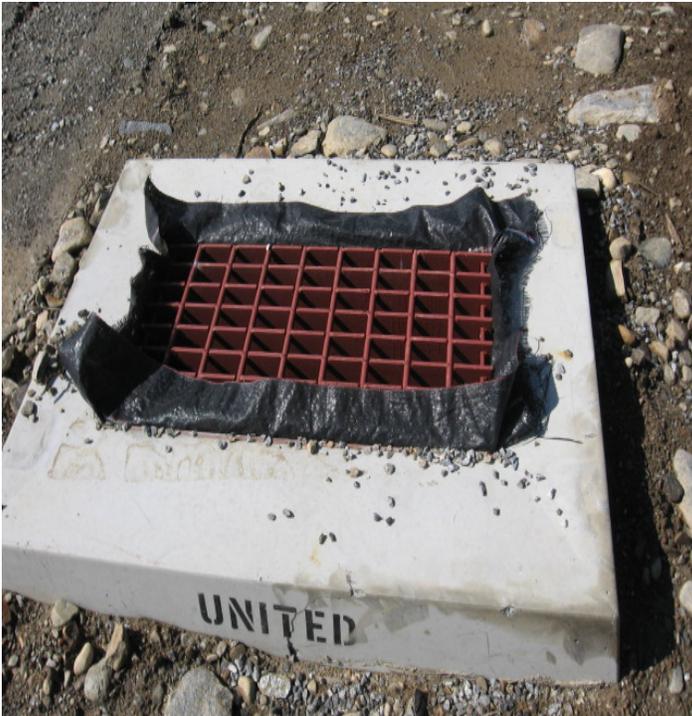
“Silt-saks” were installed proactively within the raised catch basins on site.

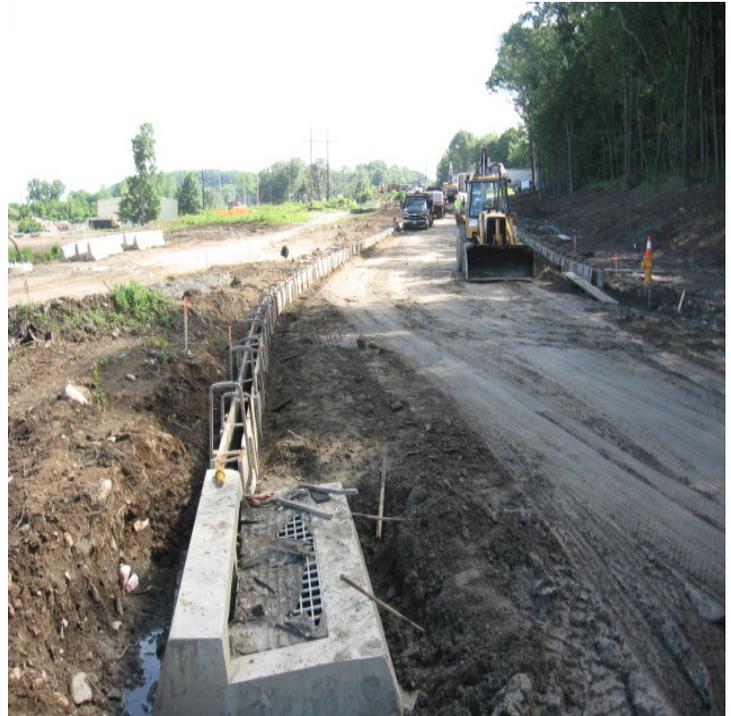
Work associated with the relocation of Shelland Street continues. Curb construction/installation has begun.
