**Docket No. 272 – Development and Management Plan Inspection**

**East Devon Substation Inspection**

**Date:** June 22, 2007

**Location:** East Devon Substation

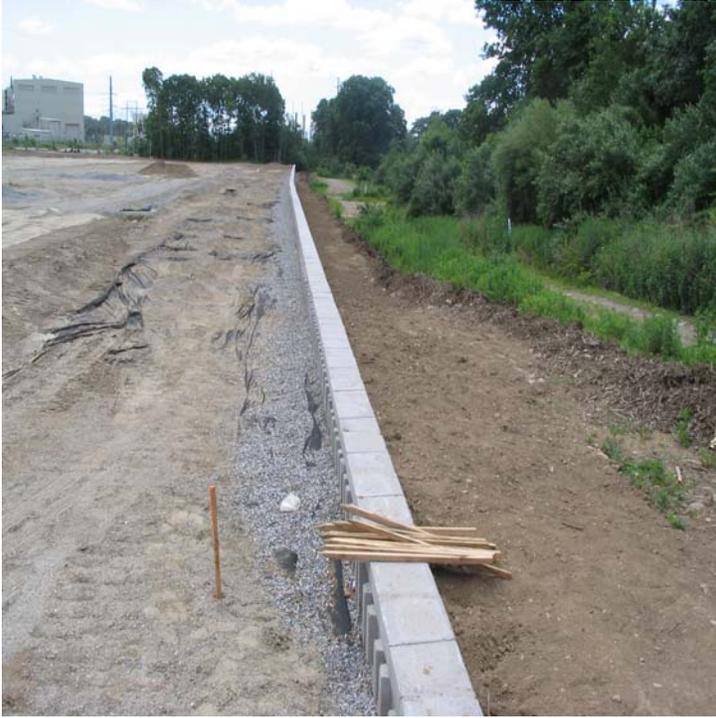
View of the retaining wall along the western boundary site boundary. The mulch berm remains as a perimeter control here.

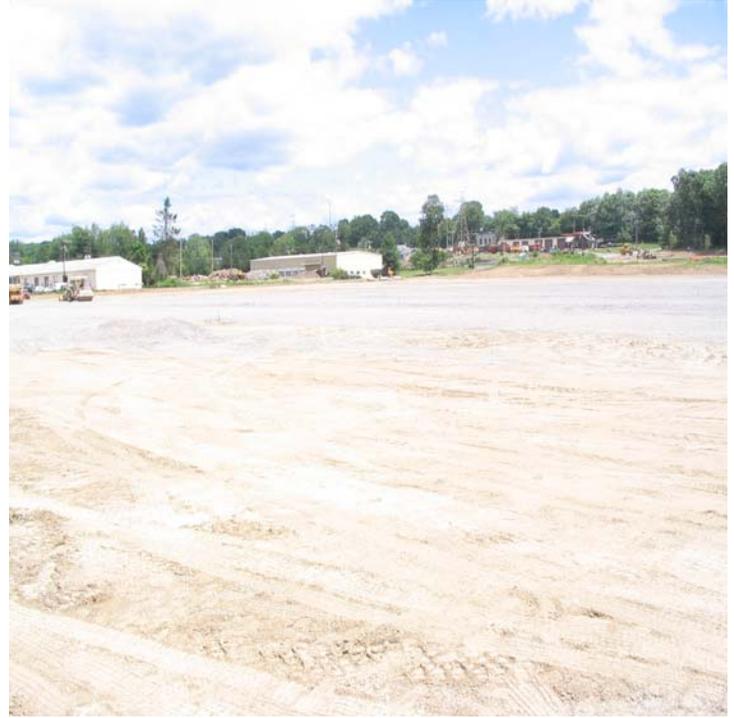
Overall view of substation work.

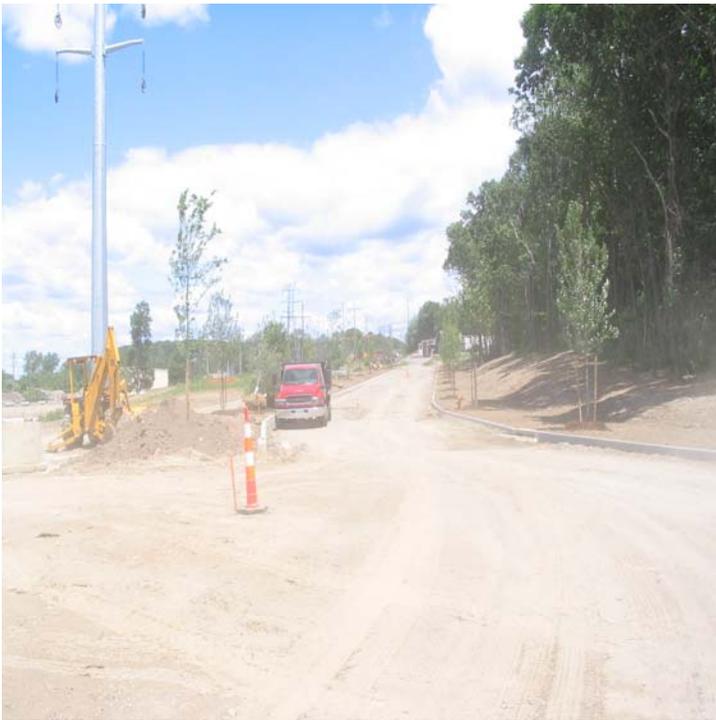
Active work continues along the re-located Shelland Street. Tree plantings were noted this week.

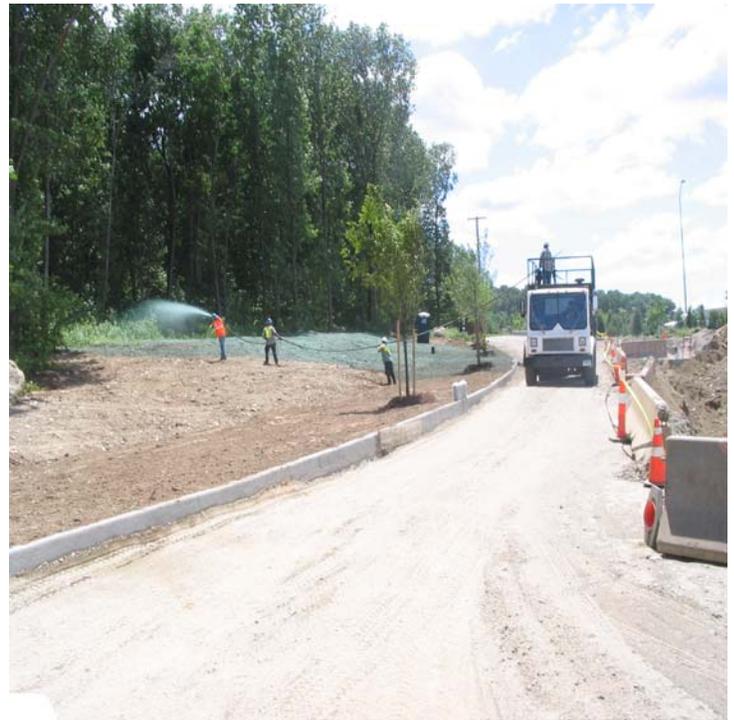
Hydro-seed was applied to disturbed soils here (Shelland). Curb installation appears to be complete.
