Docket No. 272 – Development and Management Plan Inspection

Segment 1a Inspection

Date: May 14, 2007

Location: Segment 1a – Scovill Rock Switching Station to Chestnut Junction, Oxbow Junction to Beseck Switching Station (excluding Royal Oak Bypass), and Black Pond Junction to Beseck Switching Station

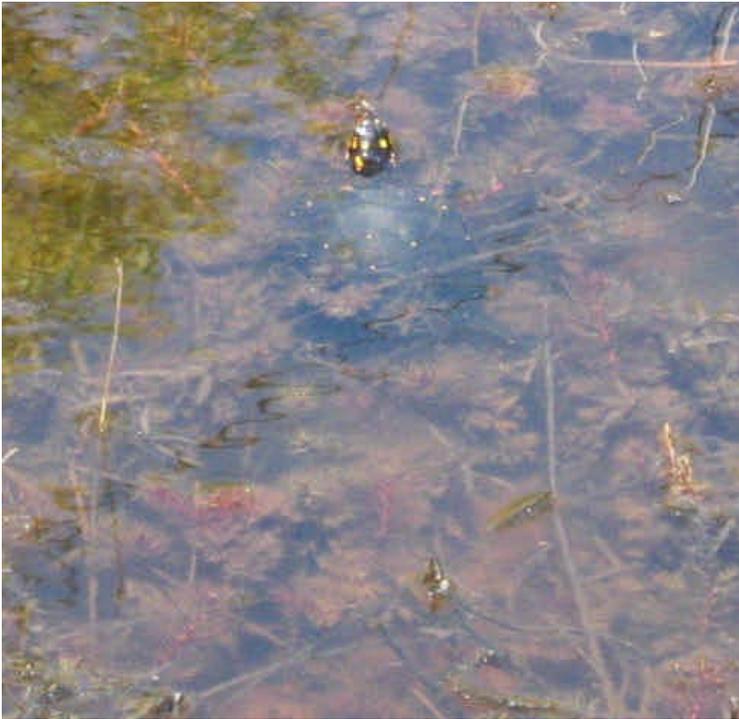
Spotted turtle noted in the wetland off the access road off Freeman Rd. Although not a state listed species, be mindful during equipment movement in this area.

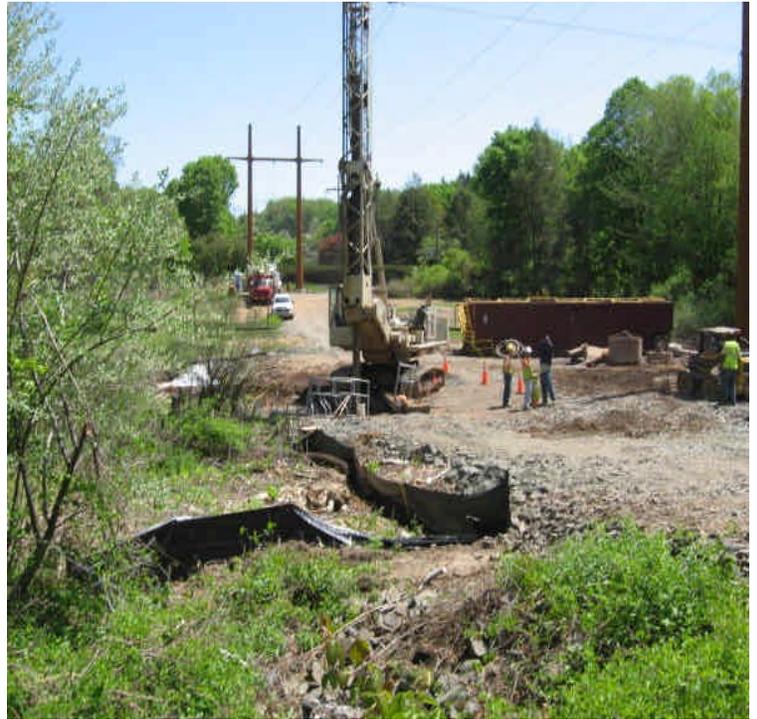
View of foundation drilling off Little Lane.

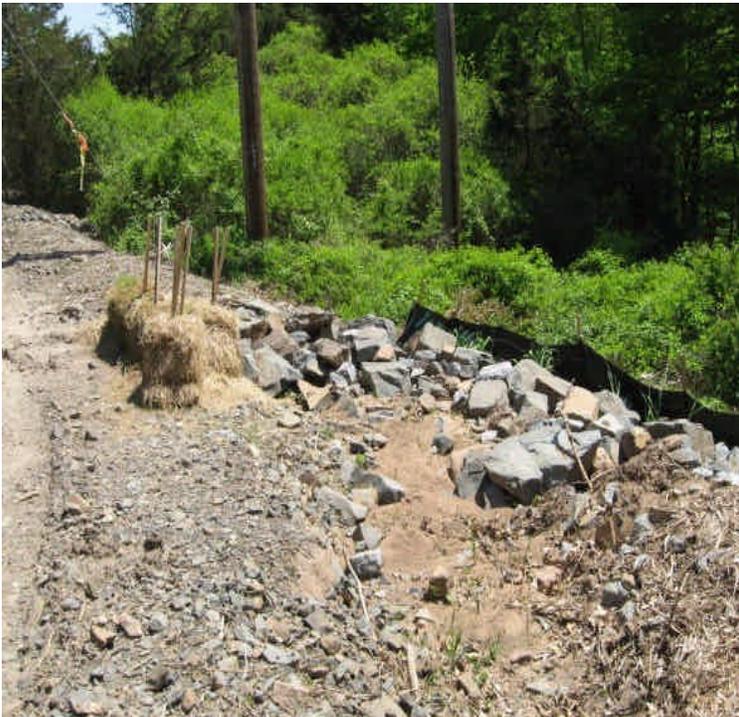
Accumulated sediment noted within a detention swale/trap off Black Walnut Dr.

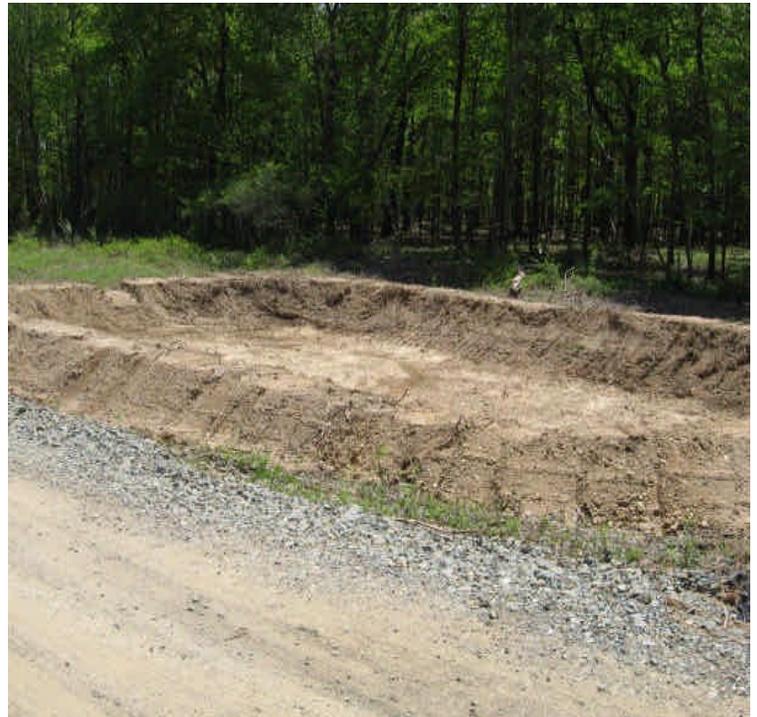
Detention basin remains in place off Black Walnut Dr., upgradient from Ball Brook.

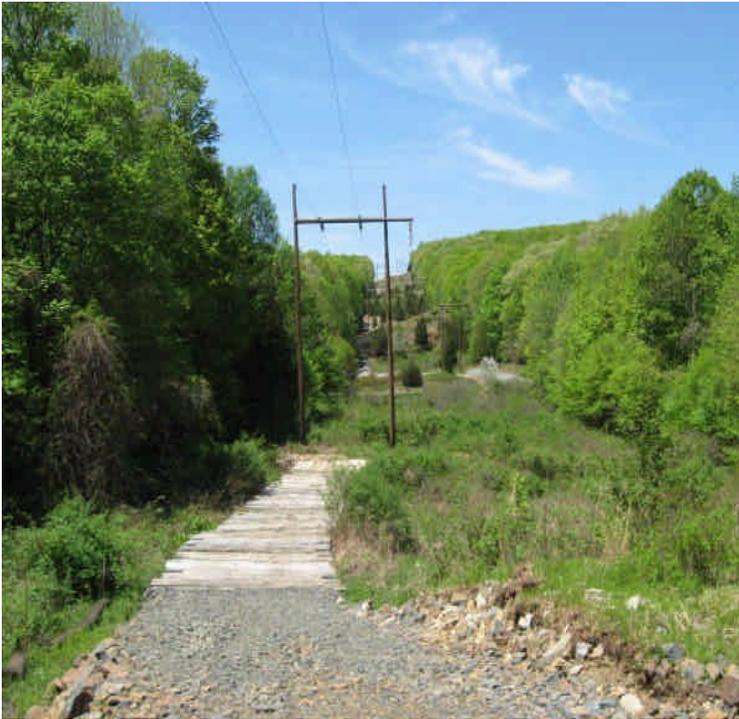
Wetland crossing off Foot Hills Rd. No turbid run-off was noted.

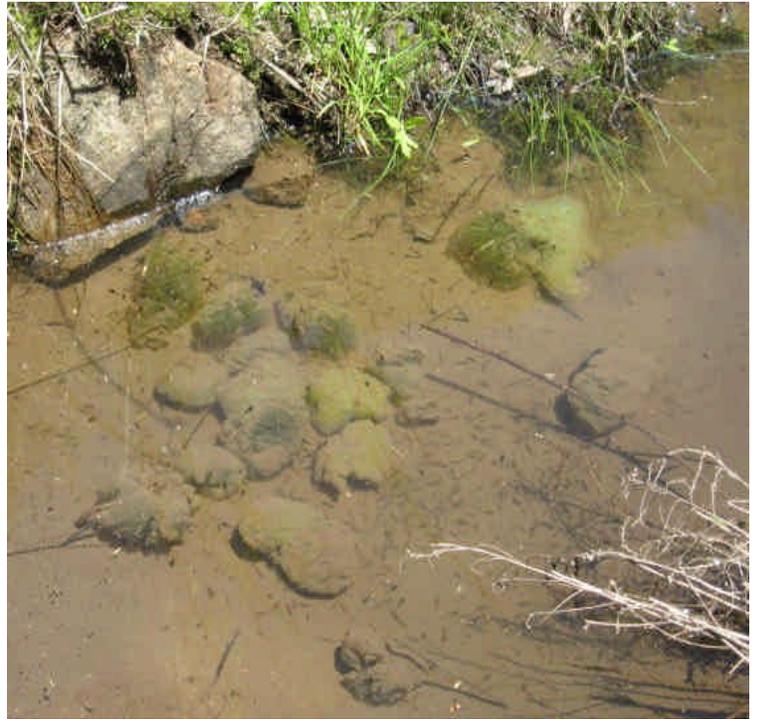
Amphibian egg masses and tadpoles were noted in the ponded water adjacent to a timber mat crossing off Johnson Ln. Slight sedimentation was noted. Continue to prevent turbidity and sedimentation here to the extent possible.

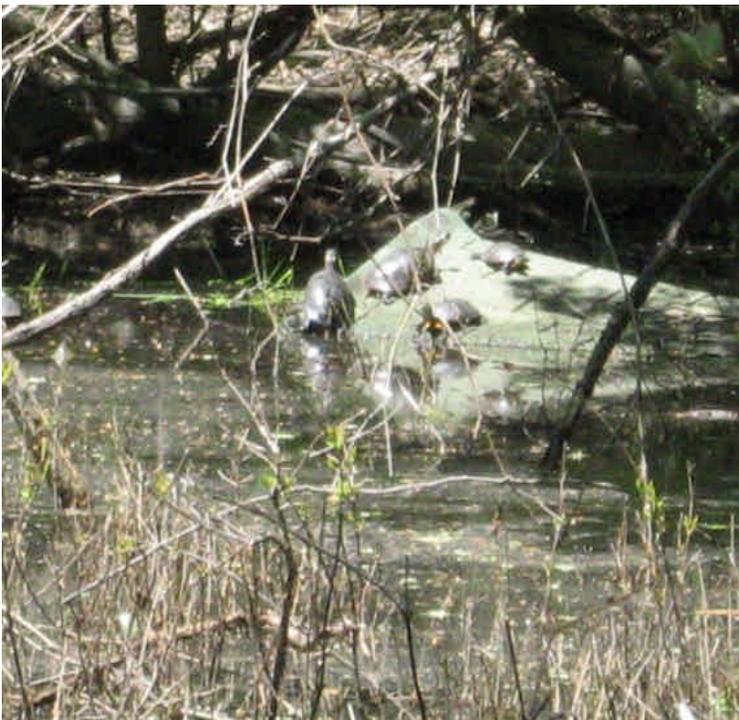
Numerous painted turtles basing within the pond off Haddam Quarter Rd. Although not a state listed species, be mindful during equipment movement in this area.

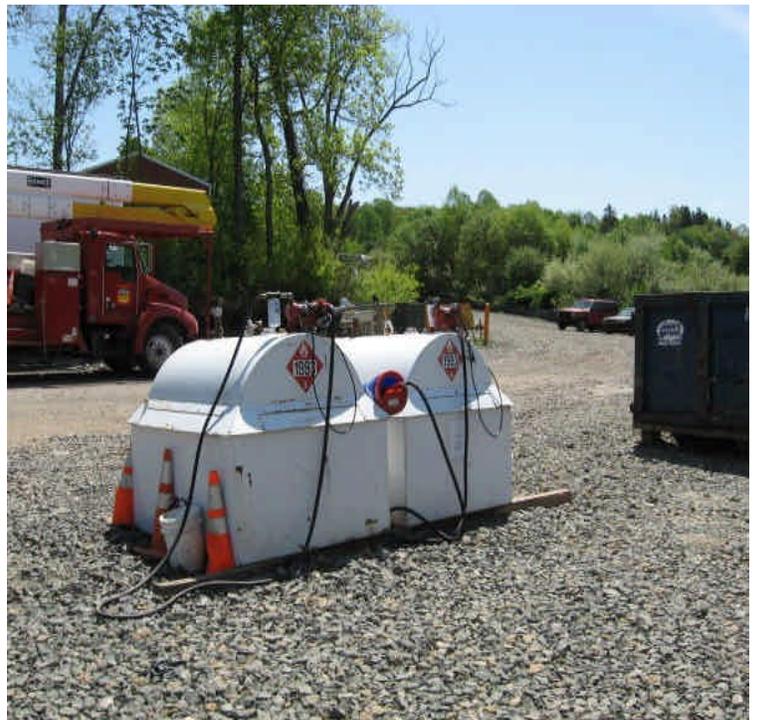
One nozzle was placed in the 5-gallon bucket, the other was in the holster within the contractor receiving yard.

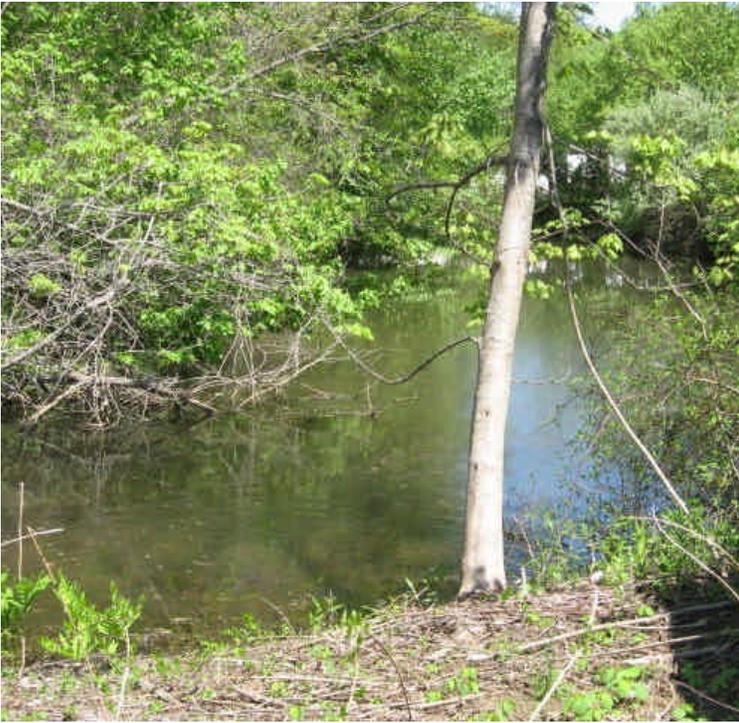
View of the pond adjacent to the contractor receiving yard. Most of the previous turbidity has settled.

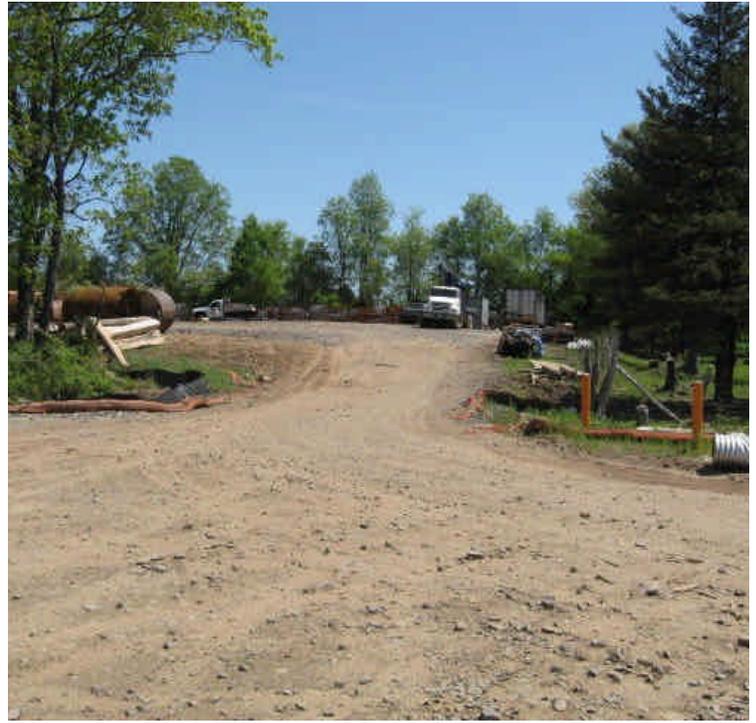
The entrance to the contractor receiving yard. Controls are largely in place around the perimeter of the yard but a few improvements could be made.

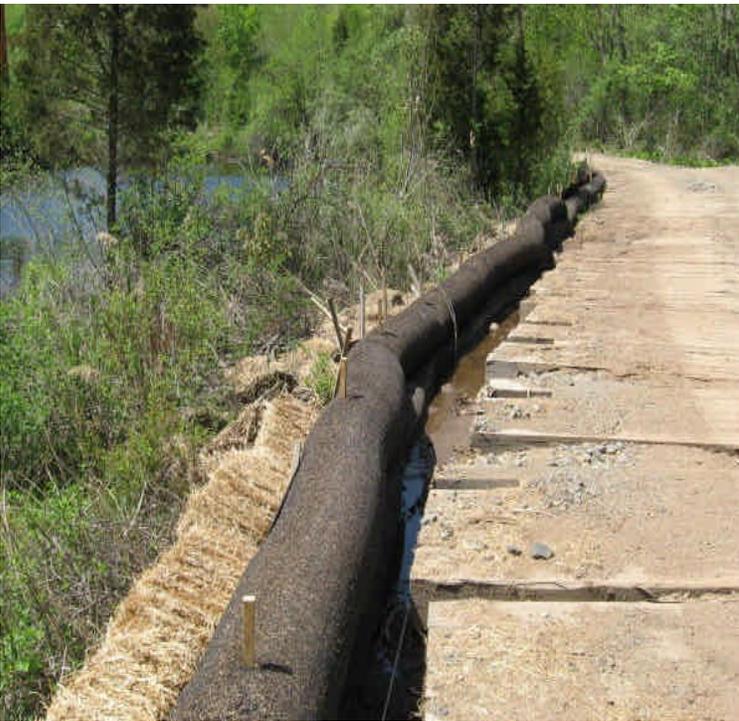
View of well installed haybales and fiber rolls at the timber mat crossing off Powder Hill Rd. Sediment is filtered from the run-off before it flows off-site in this area. Some turbid water is still being retained here but it is receding

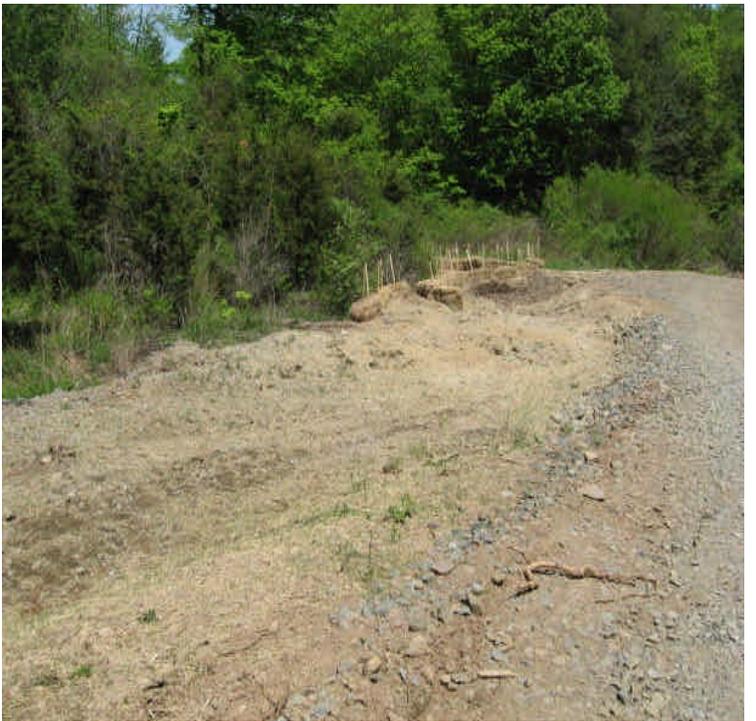
Hydroseed and haybales remain in work areas west of Powder Hill in an effort to restore the area.

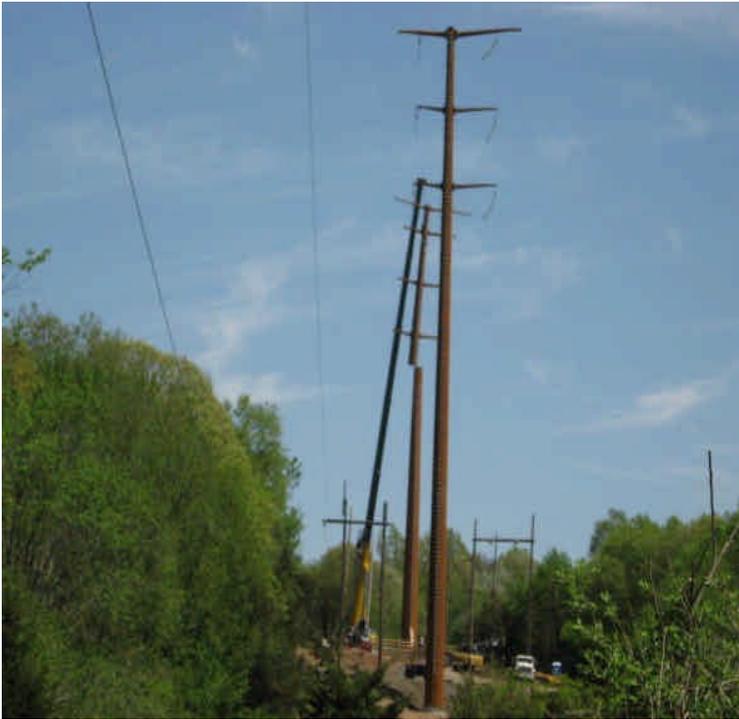
View of active pole installation east of Powder Hill Rd.

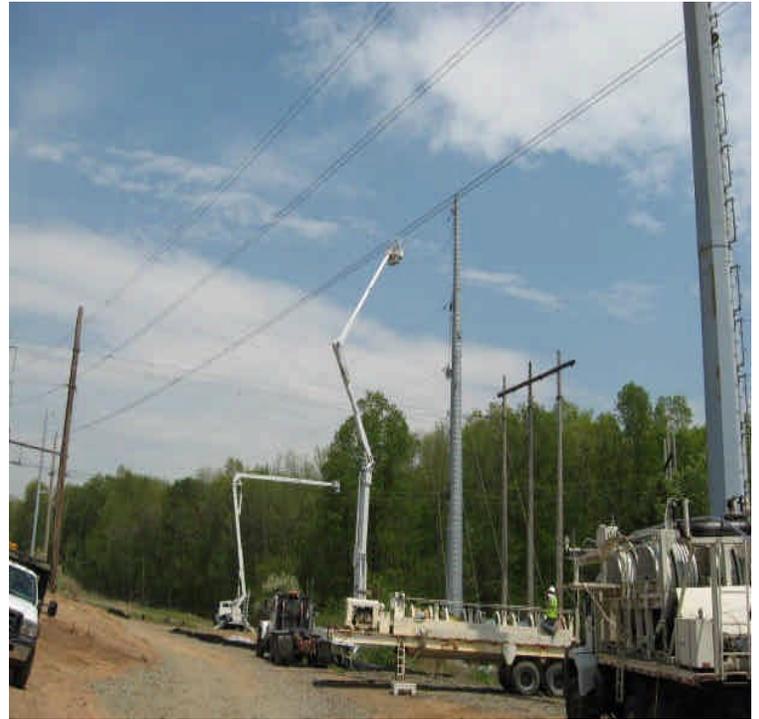
A line-pulling area north of Beseck SS has been graded and stone is in place to stabilize the area and reduce run-off. The area is now actively in use as line work continues.

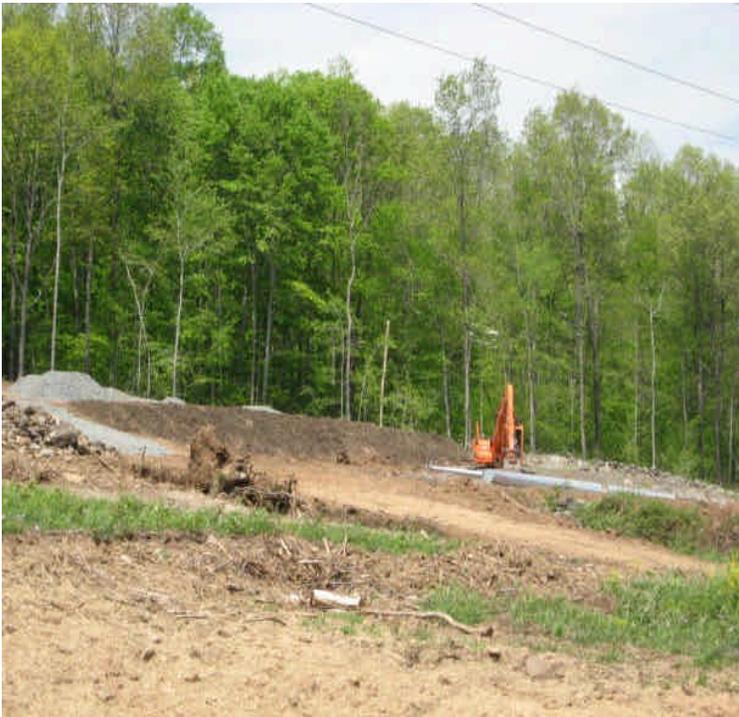
Installing a new pad site and access area north of Beseck SS.

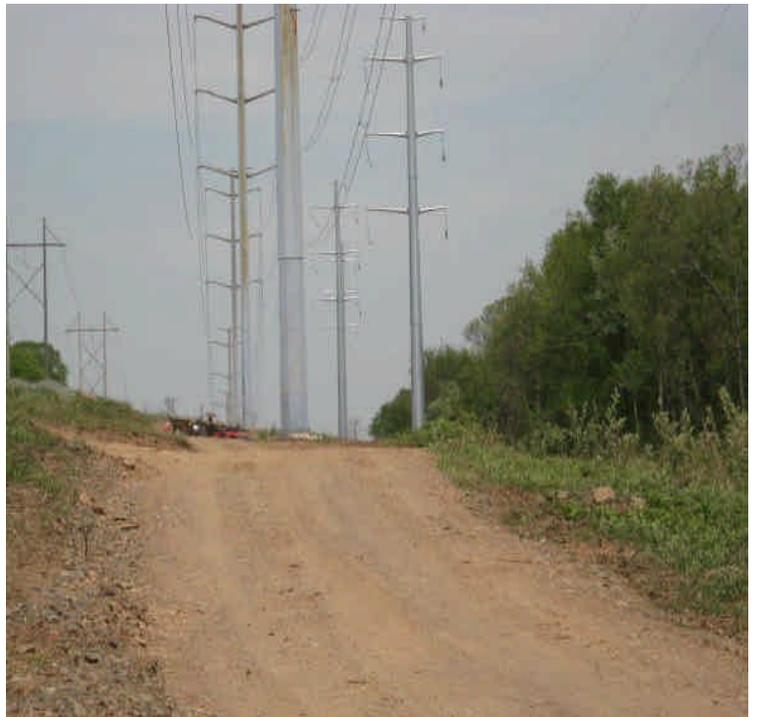
Ropes are in place in the pulleys north of Beseck SS. Line pulling is underway in this section.

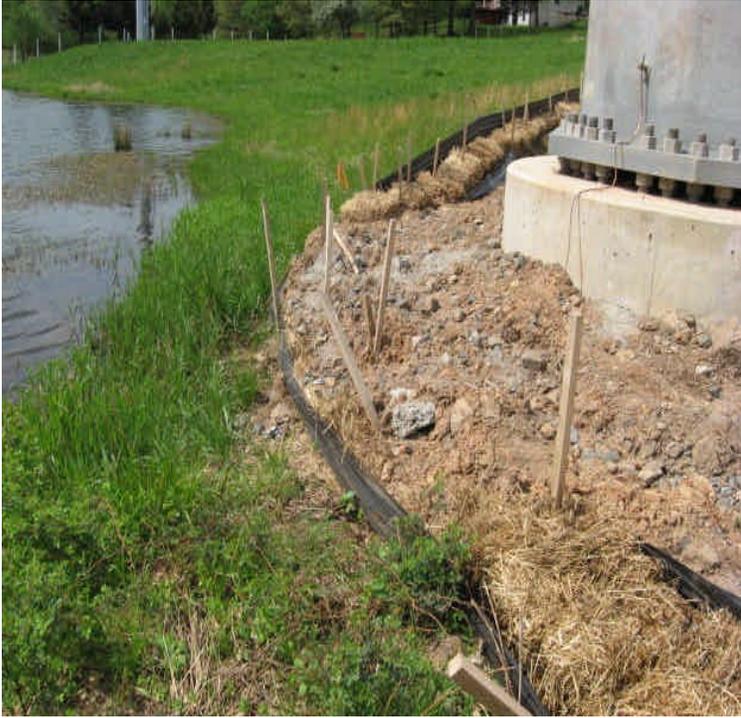
Controls remain in place along the pond north of Beseck SS to E. Meriden SS off Fleming Rd where pole installation is complete. However, sediment has filled controls to capacity and needs to be removed.

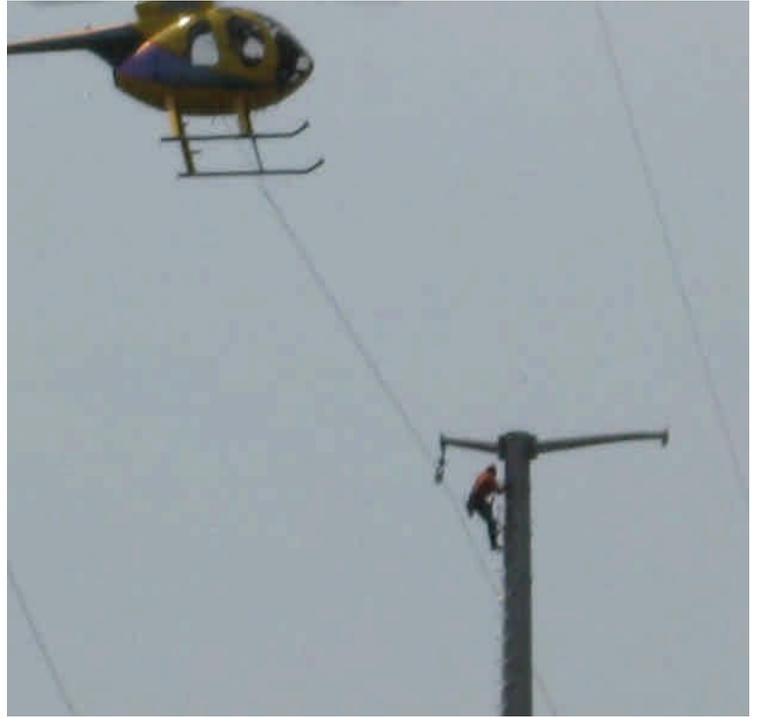
Line work just south of E. Meriden SS being conducted via helicopter:

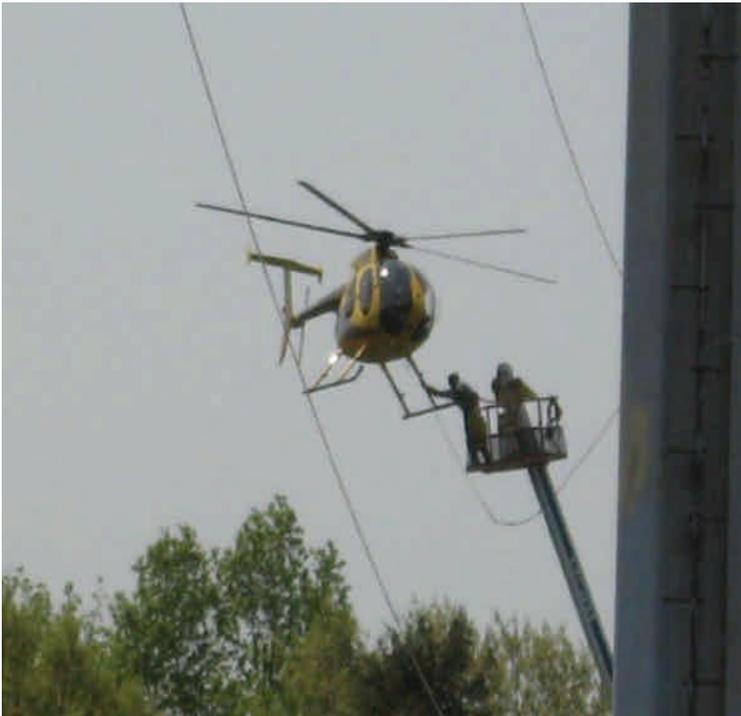
Crews were hooking rope onto the helicopter during line pulling south of E. Meriden SS.

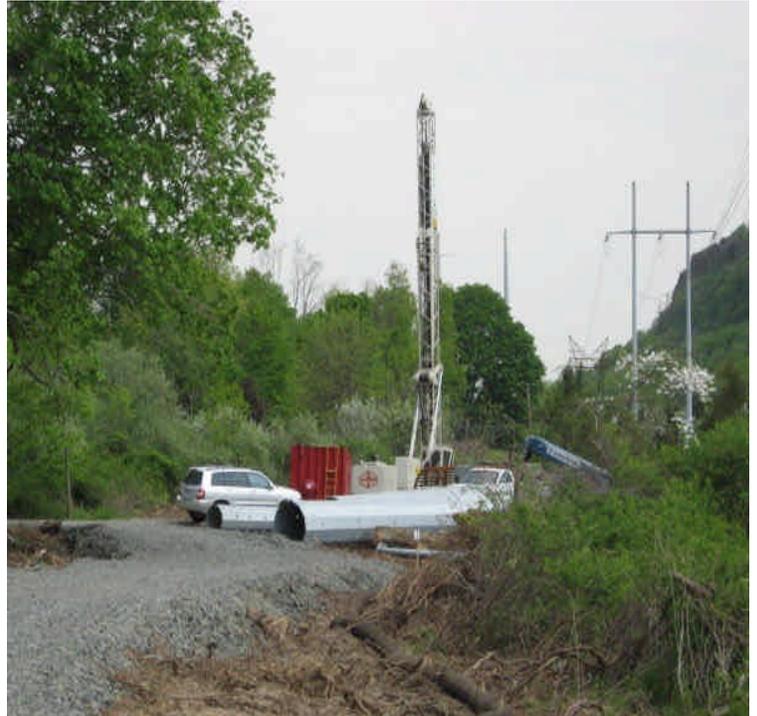
Drilling off East Main Street looking south toward Black Pond Jct.
