Docket No. 272 – Development and Management Plan Inspection

Segment 1a Inspection

Date: May 29, 2007

Location: Segment 1a – Scovill Rock Switching Station to Chestnut Junction, Oxbow Junction to Beseck Switching Station (excluding Royal Oak Bypass), and Black Pond Junction to Beseck Switching Station

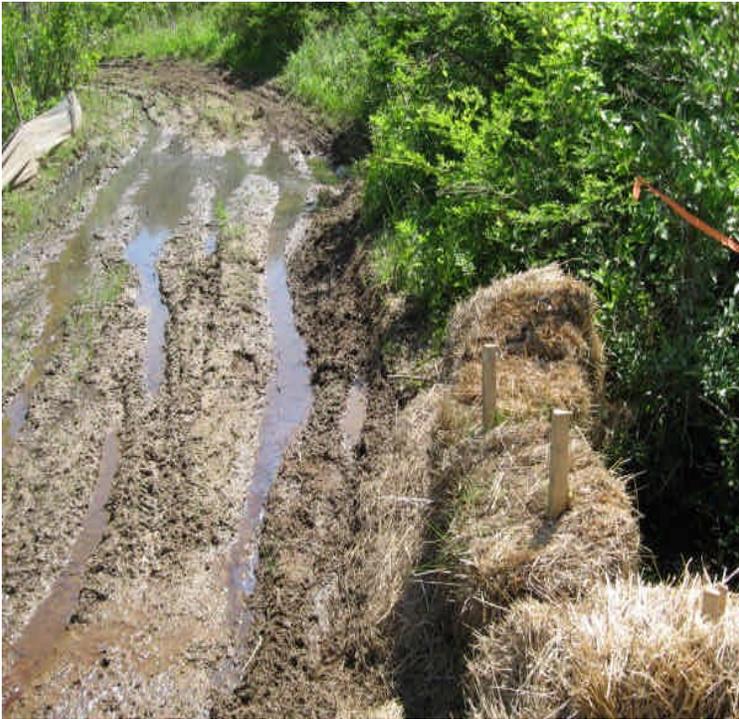
ROW access south of Scovill SS, adjacent to a pond. Controls are in place. ATV use is prevalent here.

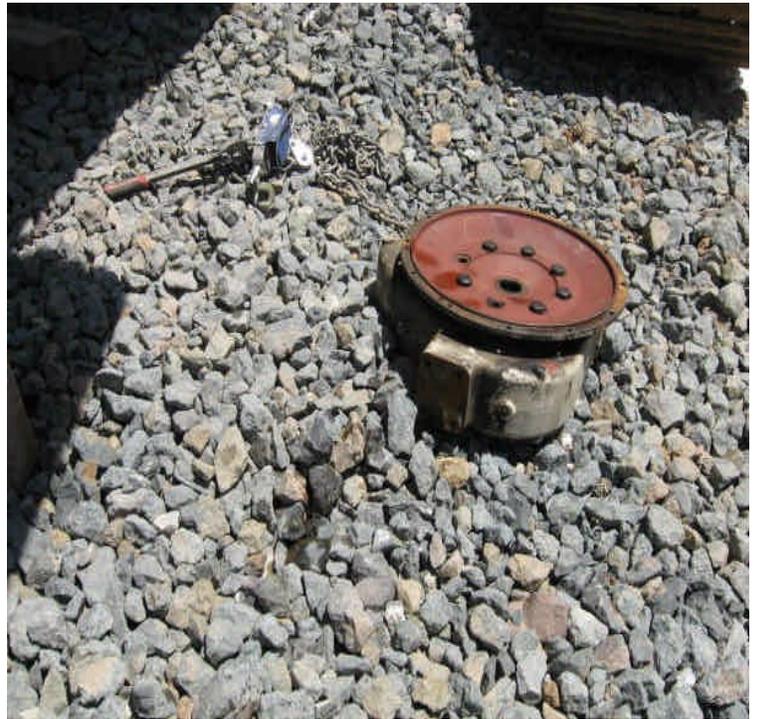
Some minor fluid leaking/dripping from bearing casing off Haddam Quarter Road.

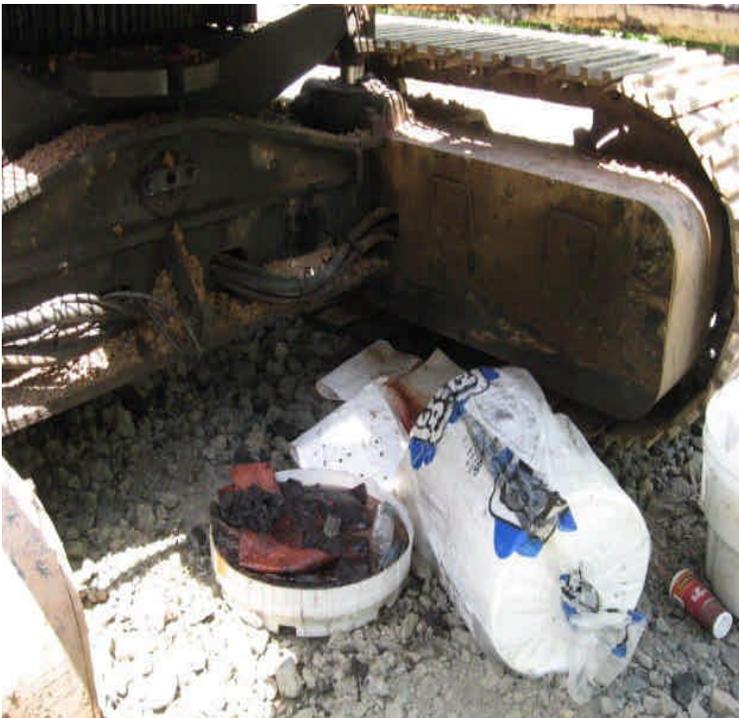
A piece of broken equipment was noted stored near wetlands. Efforts to control the leak were noted but more are needed. Also, relocate the machine as soon as possible.

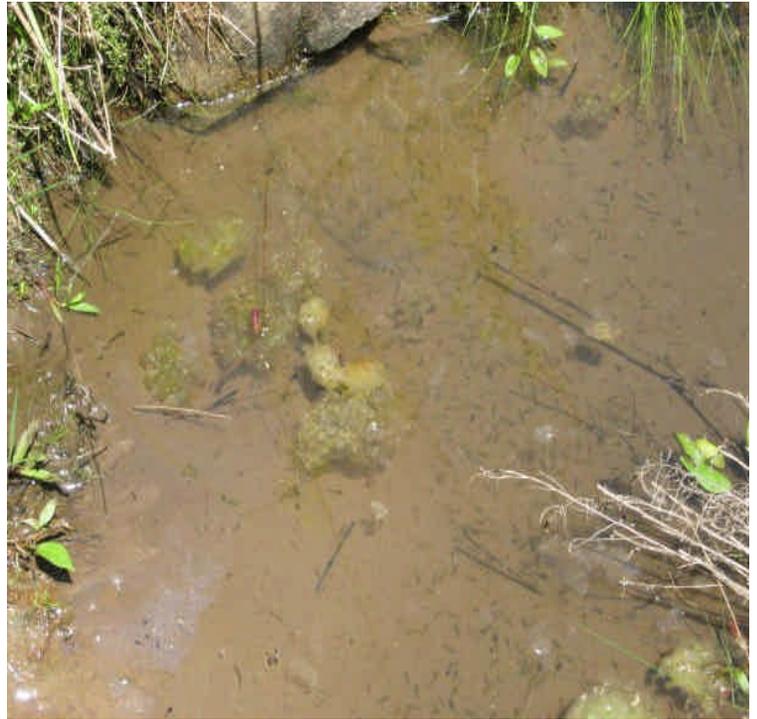
Amphibian egg masses, tadpoles, and larvae were noted in the pond water adjacent to a timber mat crossing off Johnson Ln. Continue to prevent turbidity and sedimentation here to the extent possible.

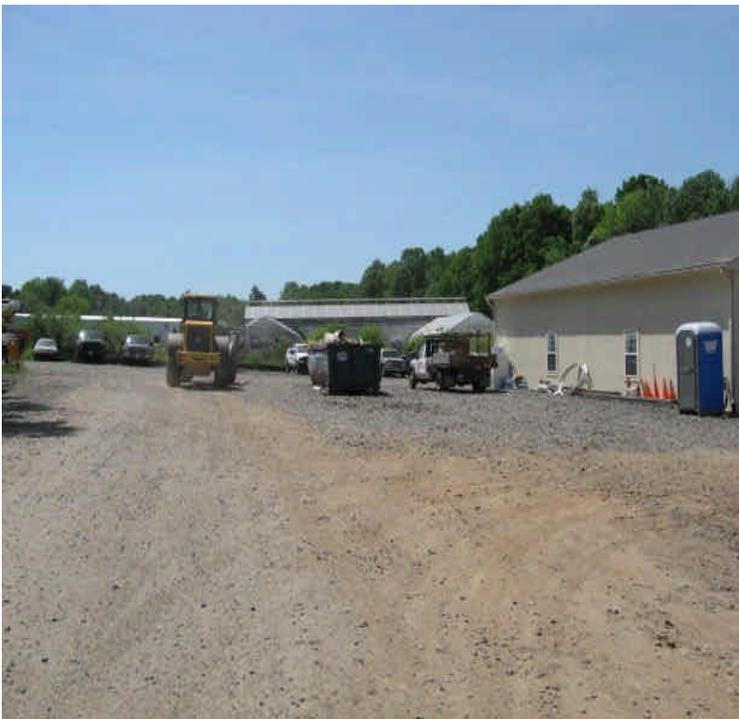
Fuel containers were removed from the contractor receiving yard.

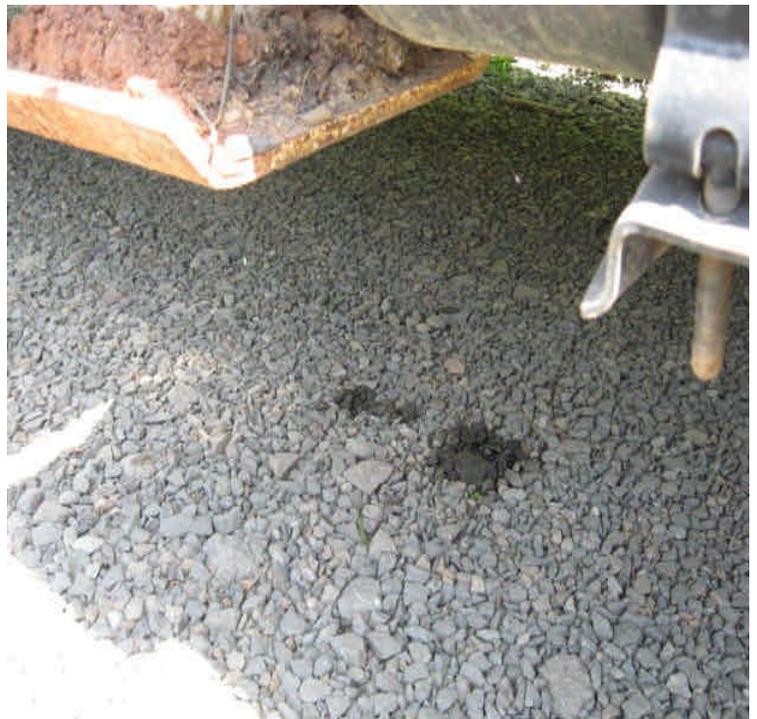
A leaking truck stored within the contractor receiving yard. Several drip spots were noted.

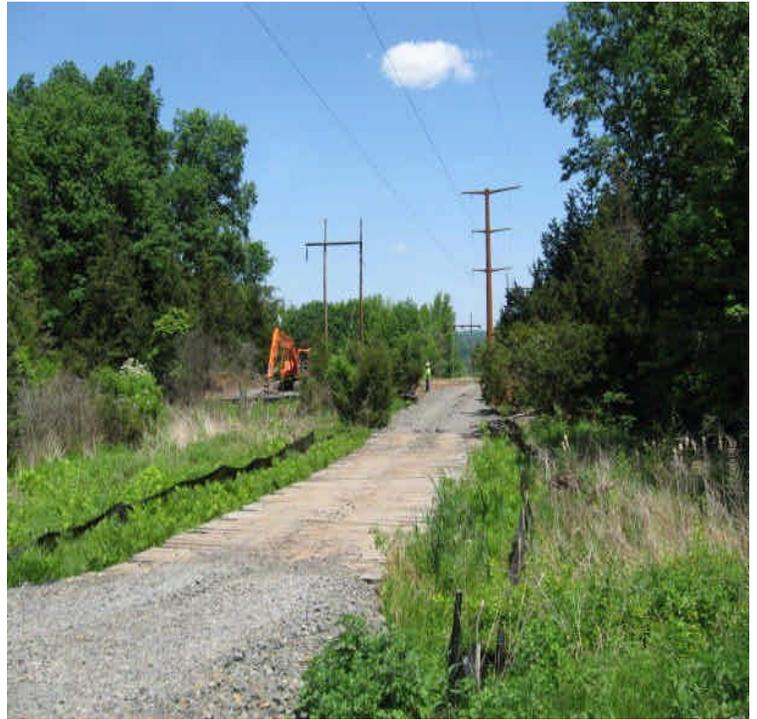
New pad site being installed off Elihu Drive. Controls are in place at the wetland crossing.

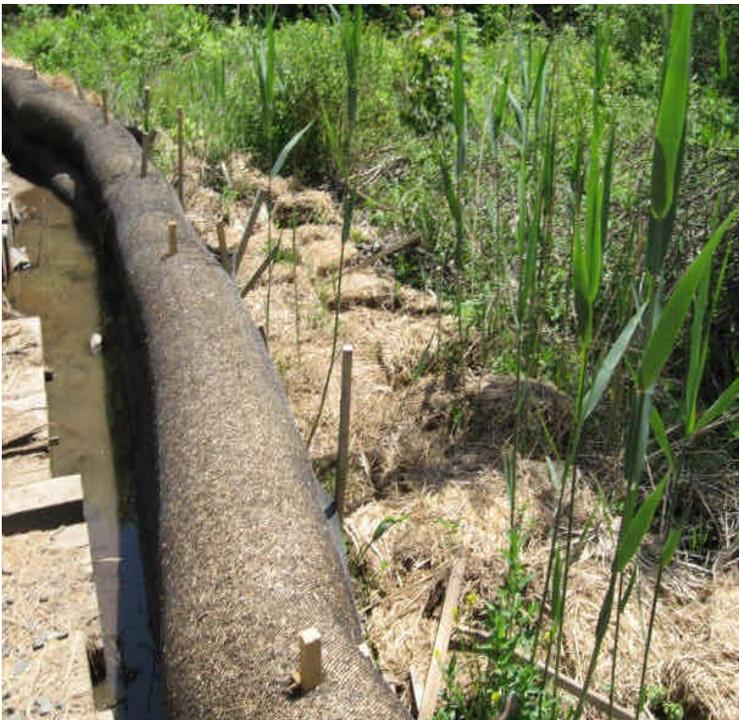
View of well installed haybales and fiber rolls at the timber mat crossing off Powder Hill Rd. Sediment is filtered from the run-off before it flows off-site in this area. Some turbid water is retained here.

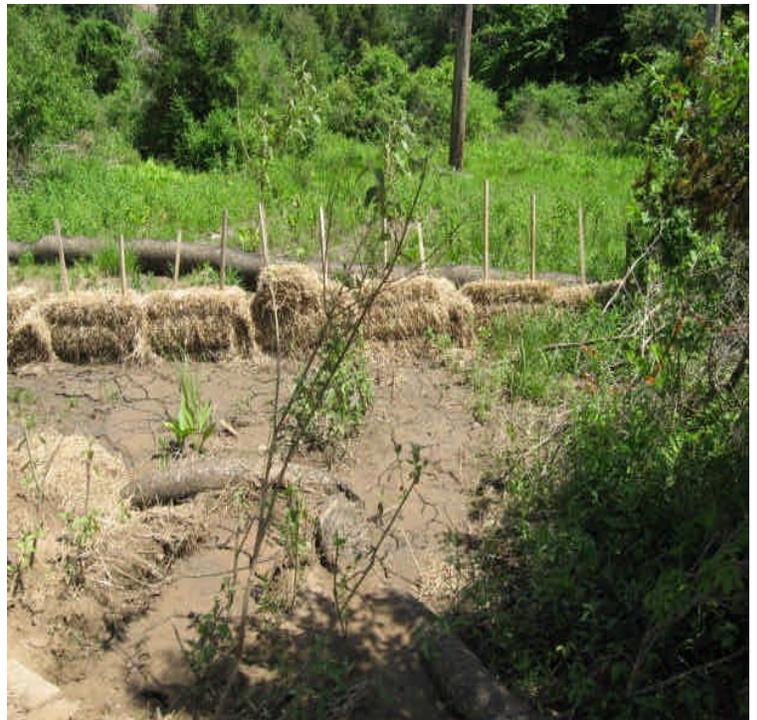
Sediment accumulation from previous heavy rains could be seen in wetlands west of Powder Hill Rd. now that standing water receded. Where accumulated sediment is more that 2" deep, it should be carefully removed from wetlands by hand.

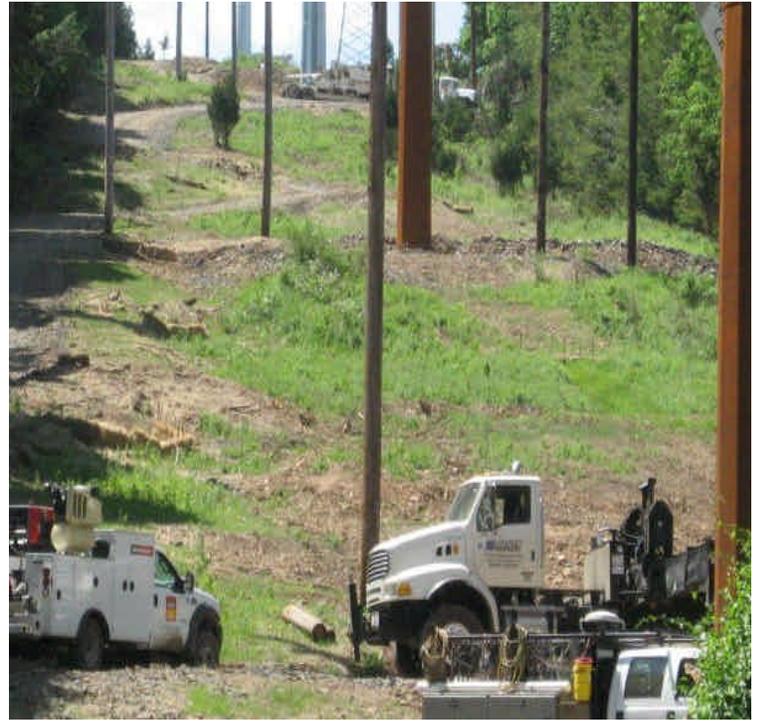
Looking west up Beseck Mt. Grass growth was noted from the recent hydroseed application.

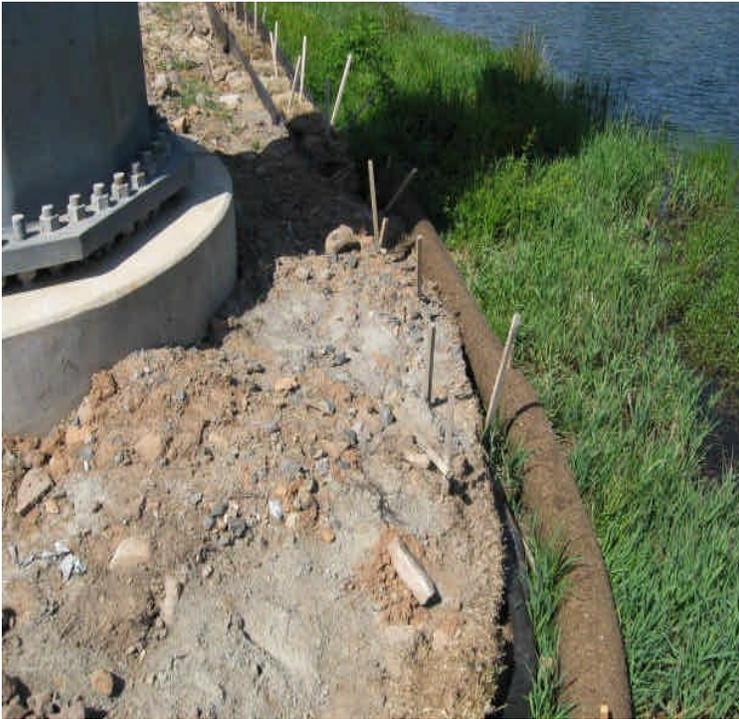
View along the pond north of Beseck SS to E Meriden SS off Fleming Rd where pole installation is complete where sediment has filled controls to capacity immediately adjacent to the pond. A filter sock has been added as another layer of control but sediment should still be removed.

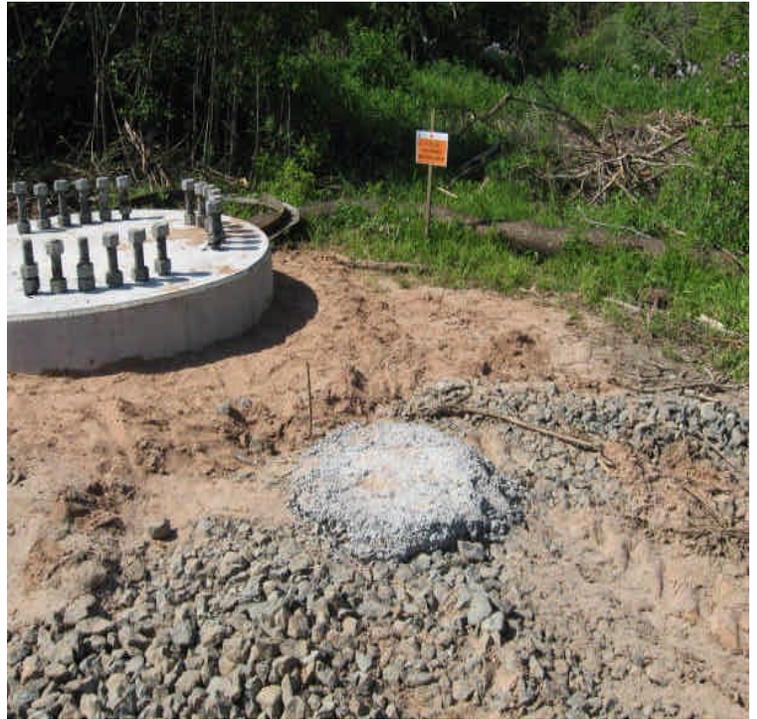
Concrete testing washout located within controls but adjacent to a wetland south of E. Main St. Remove material from the ROW and avoid uncontained washouts.

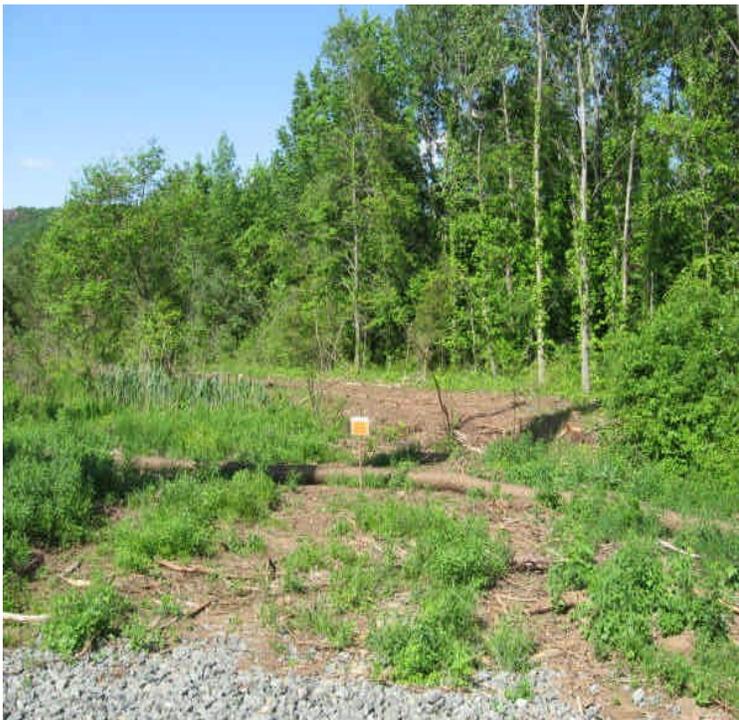
Controls along the new access road north of East Main Street.
