**Docket No. 272 – Development and Management Plan Inspection**

**Segment 2a Inspection**

**Date:** May 2, 2007

**Location:** Segment 2a – Beseck Switching Station to Cheshire/Hamden Town Line

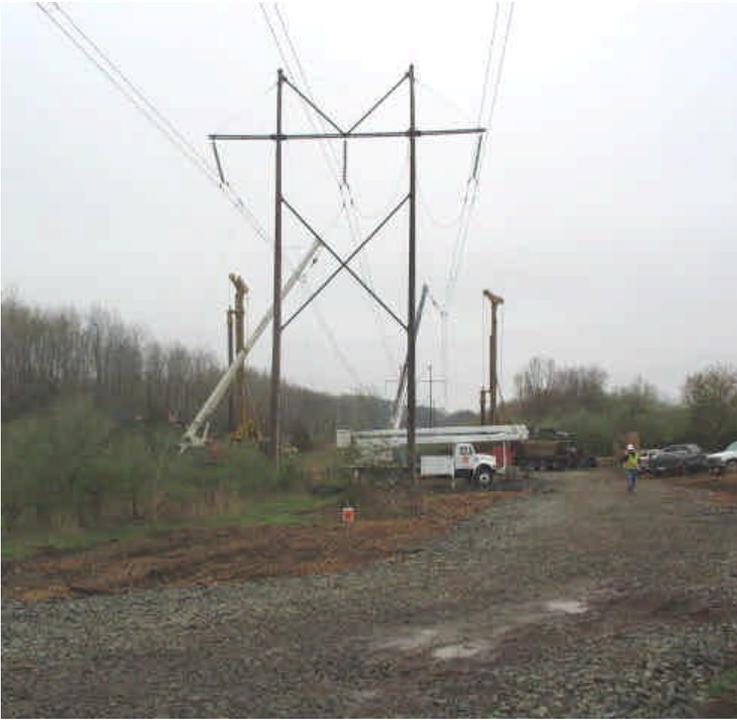
**New drilling/line work was occurring across from Beseck SS off Carpenter Lane.**

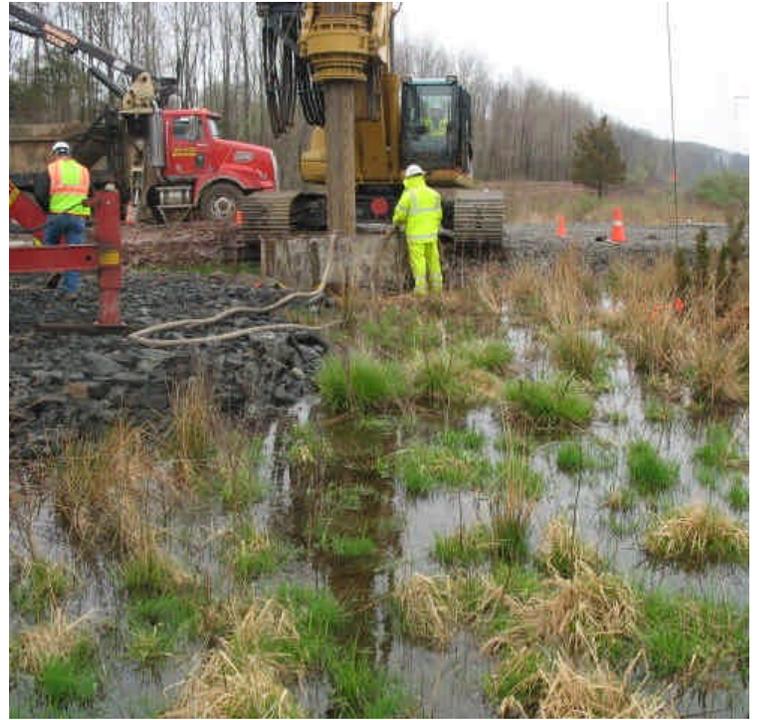
**Closer view of drilling within the wetlands south of Carpenter Lane. No turbid run-off was noted and slurry appears to be contained.**

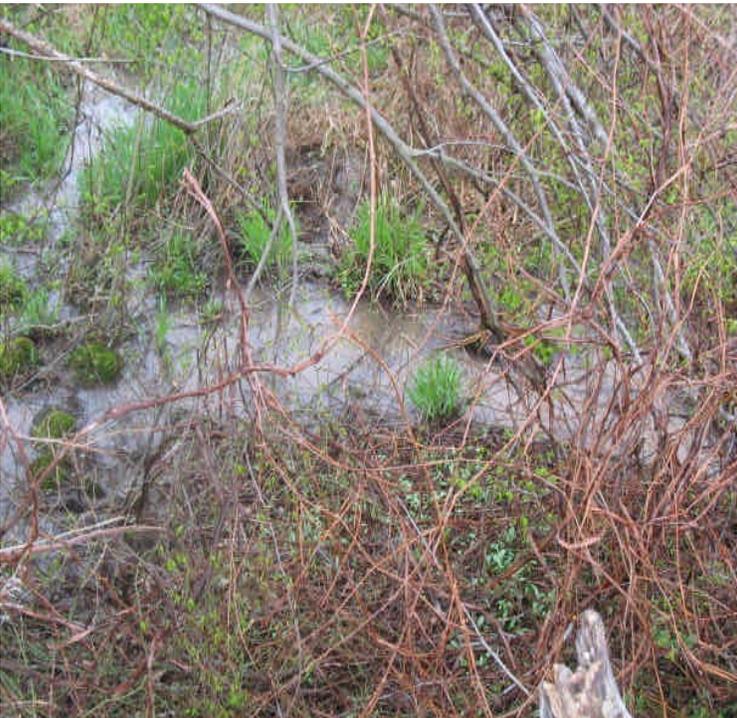
**Turbid run-off was noted off Williams Rd. Controls were needed to help filter or contain run-off.**

Areas of Inspection	Observation	Recommended Action	Corrected Action
	<p>Timber mats were removed from the Williams Rd access but turbid run-off was noted within the wetlands here. Controls were not observed between the wetland and the cleared area. 5/2/07</p>	<p>Controls are needed at the wetlands off Williams Rd. to prevent turbid run-off. 5/2/06</p>	<p>Needs evaluation and attention.</p>
<p>Powers Rd. &amp; Woodhouse Ave.</p>	<p>Erosion controls remain along the stone pad at the wetland edge off Woodhouse Ave. The stone is stressing the silt fence and a section of it was crushed. 4/3-5/2/07</p>	<p>Monitor and maintain controls. Add controls as needed. 4/3-5/2/07</p>	<p>Needs some attention.</p>
	<p>A small riprap diversion moves run-off around the timber mats, through a riprap channel flowing off-site and into silt fence barriers. 5/2/07</p>	<p>Monitor controls for effectiveness. Clean sediment from riprap as needed. 5/2/07</p>	<p>NA.</p>

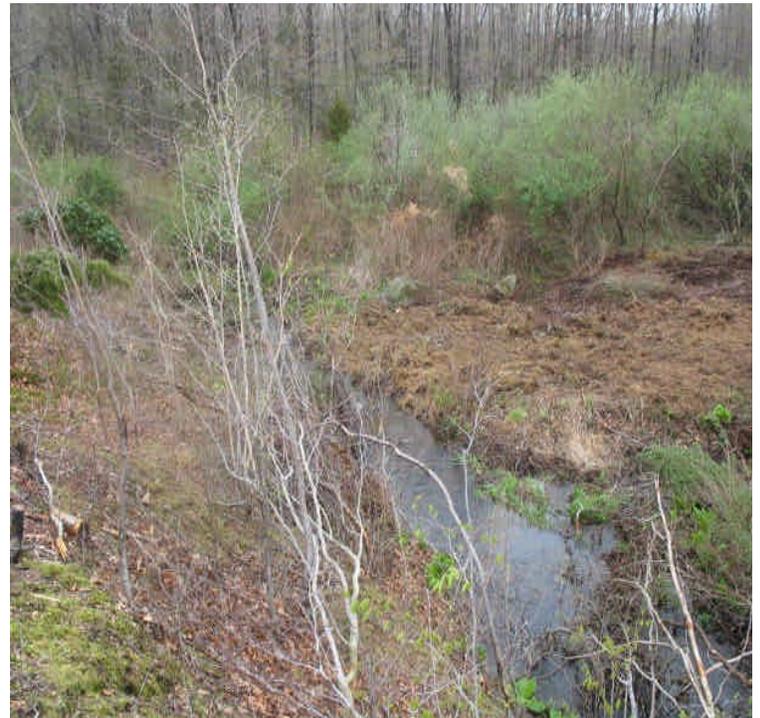
**Timber mats were removed from the stream crossing north of Stony Brook Road access adjacent to the wetlands. Mulch was also placed on disturbed soils.**

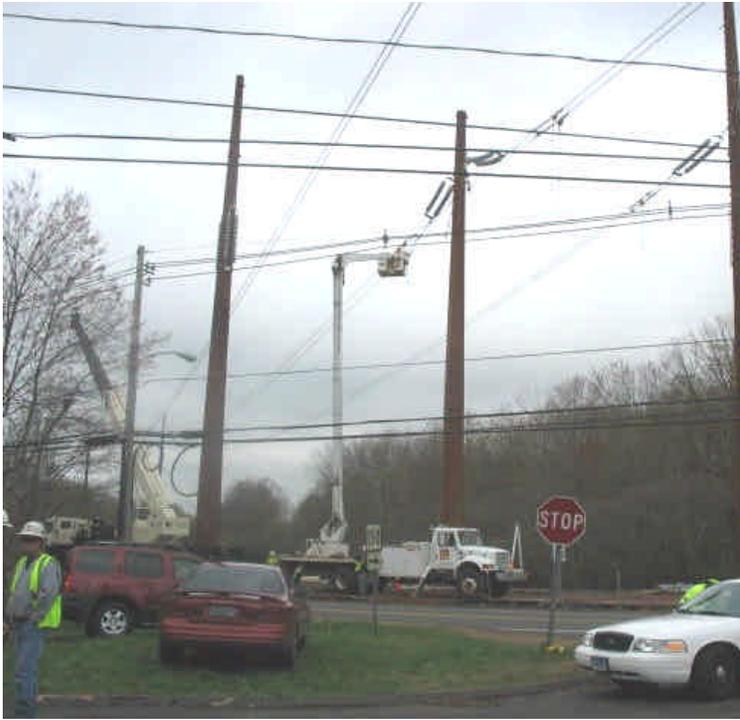
**Pole installation and line work off Woodhouse Ave.**

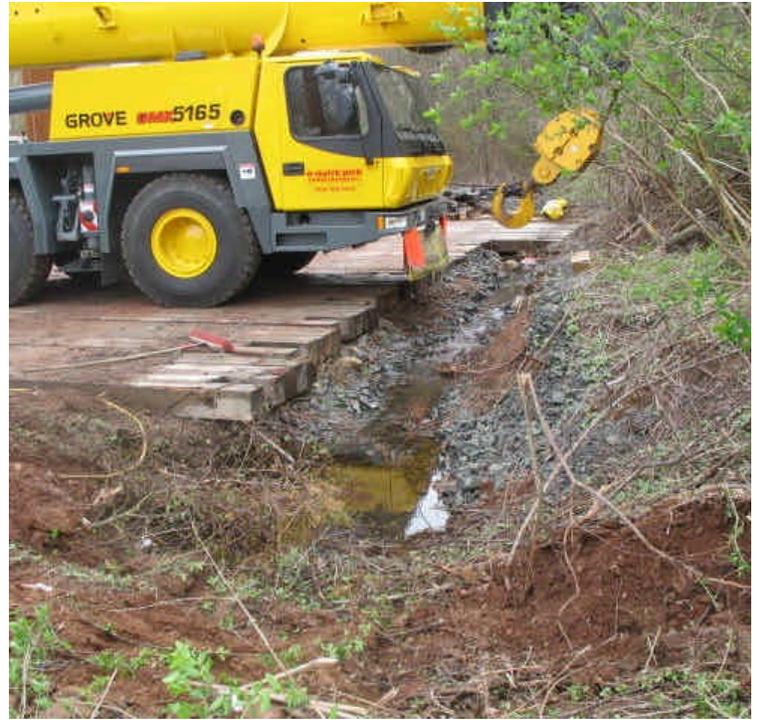
**View of timber mat pad constructed off Powers Rd with the adjacent rip rap swale. Continue to control and temporarily stabilize any areas of exposed soil.**

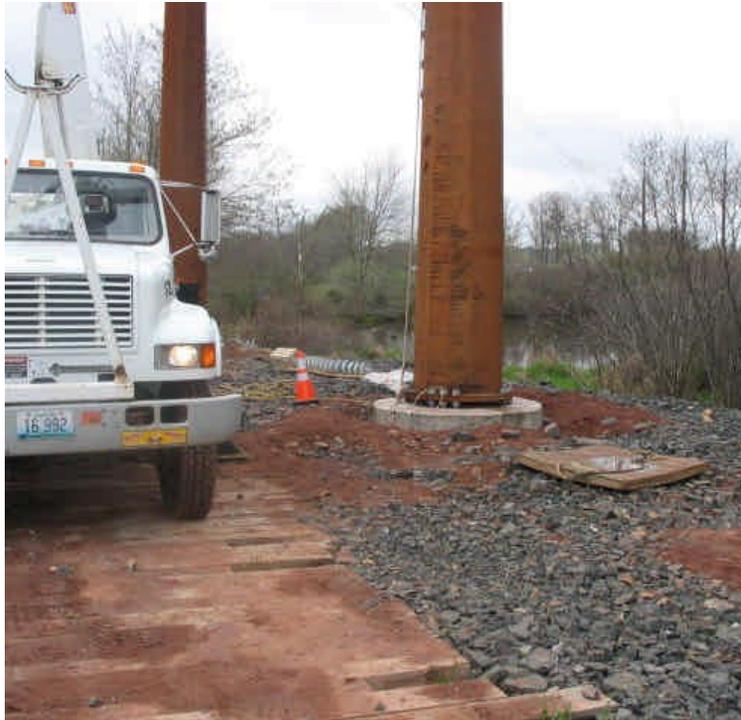
**Closer view of the recently installed structures off Powers Rd.**

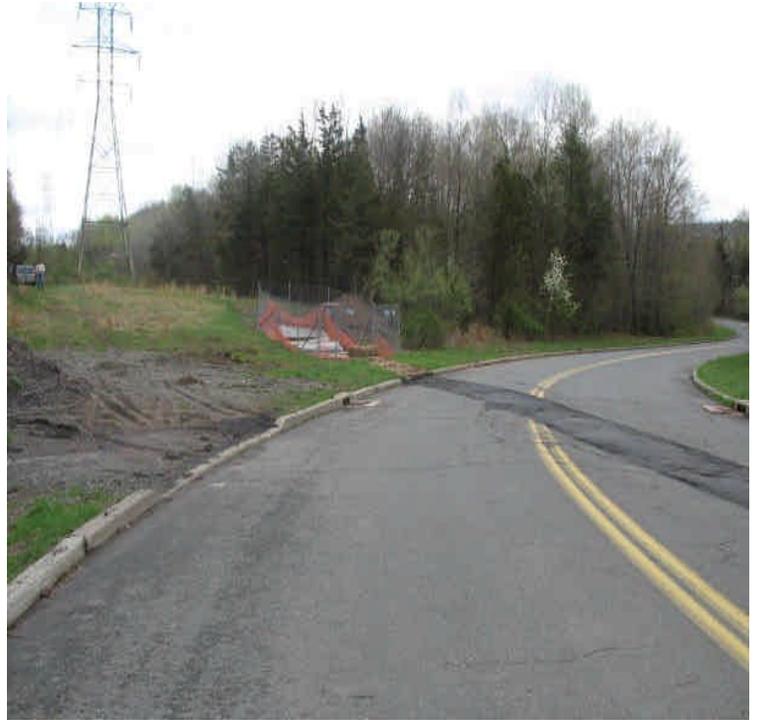
**An area of adjacent exposed soil and leftover fill is located in the overhead ROW off Old Farms Rd. Extra material should be removed or controlled and the disturbed area should be stabilized.**
