Docket No. 272 – Development and Management Plan Inspection

Segment 2a Inspection

Date: May 15, 2007

Location: Segment 2a – Beseck Switching Station to Cheshire/Hamden Town Line

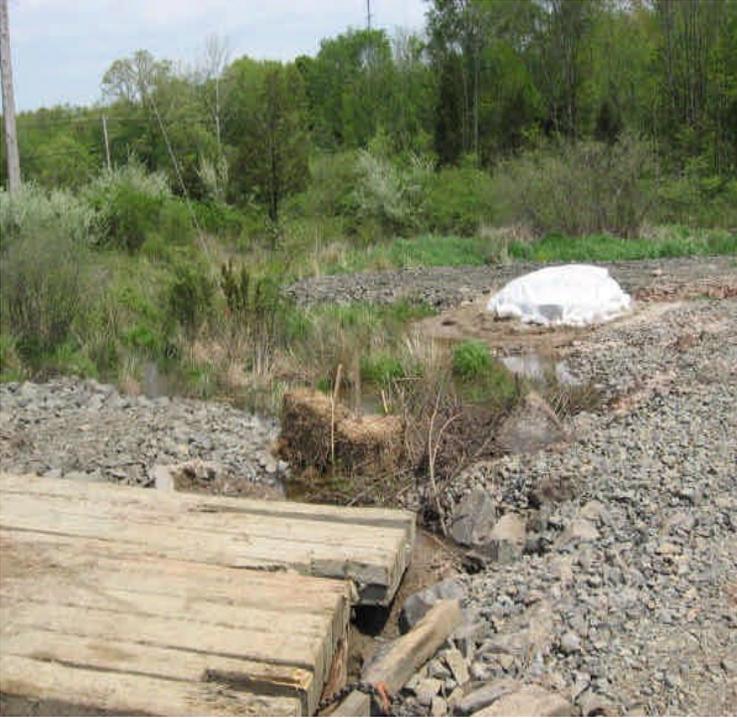
The foundation is in place within the wetland edge off Carpenter Lane. Place a filter sock between the exposed soil and the undisturbed portion of the wetland.

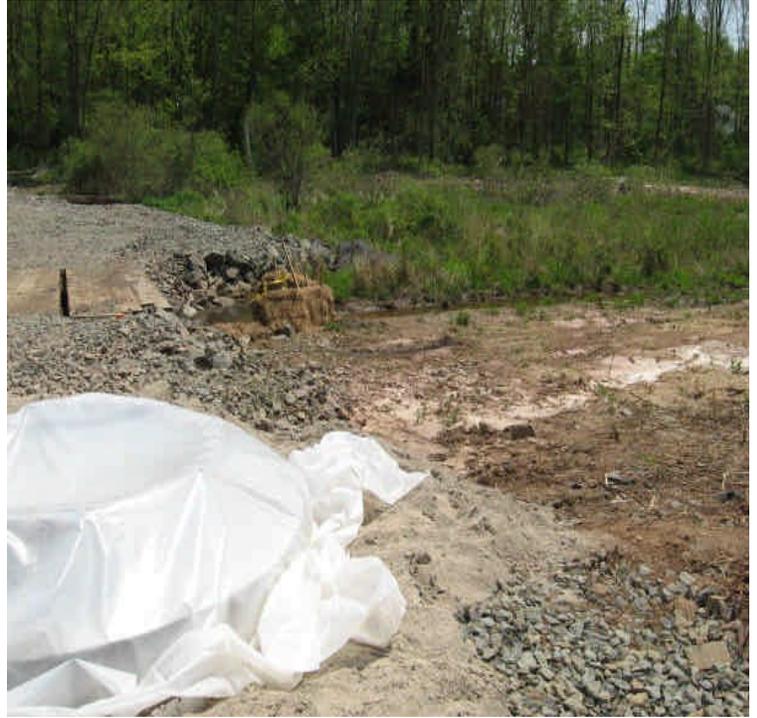
Slurry and sediment from a foundation had reached the edge of the and accumulated here against the haybales. Sediment over 2" deep should be carefully removed from the wetland by hand.

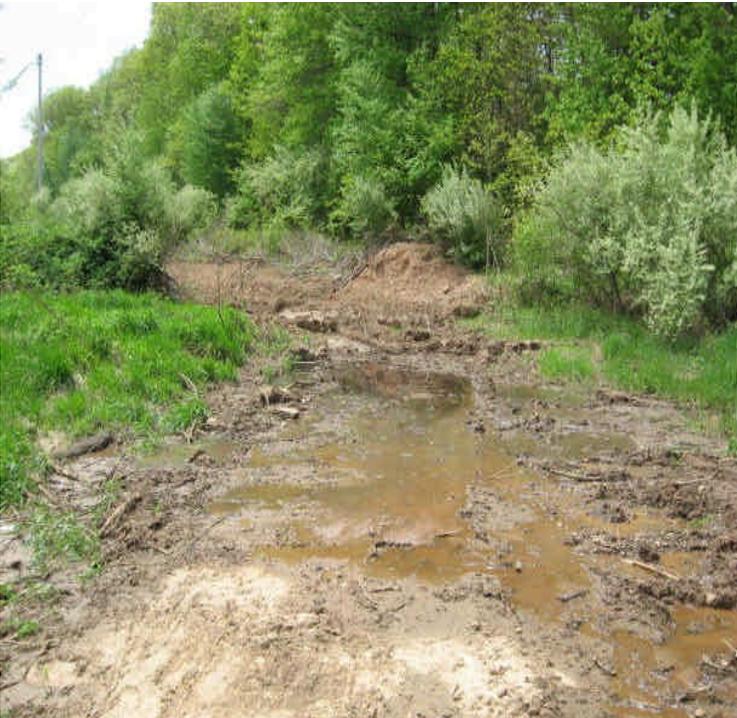
Wetland crossing off Williams Rd. Controls are needed to contain the disturbed soil and prevent run-off to the wetland.

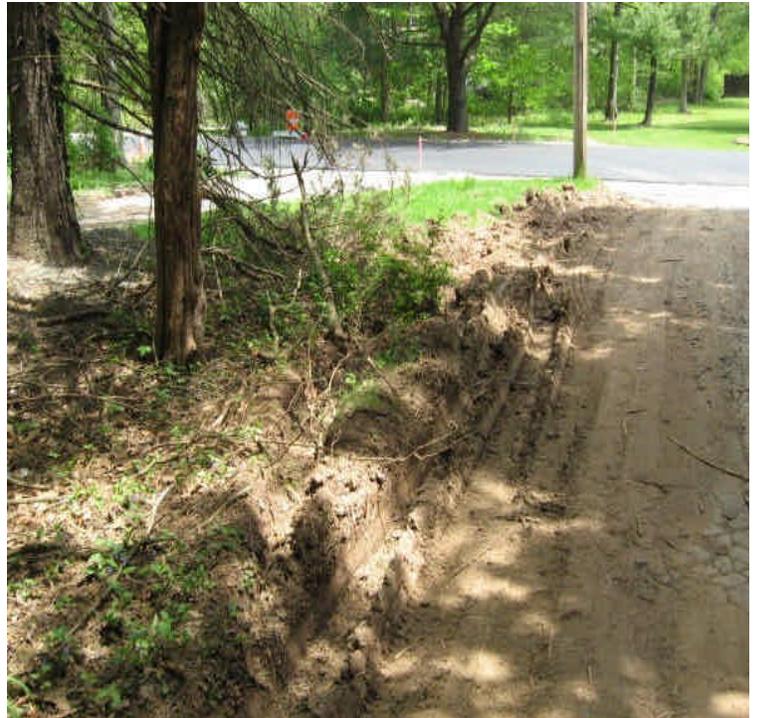
Williams Rd. entrance. Regrade the lawn area and seed/stabilize as needed. Watch for sediment tracking on the roadway.

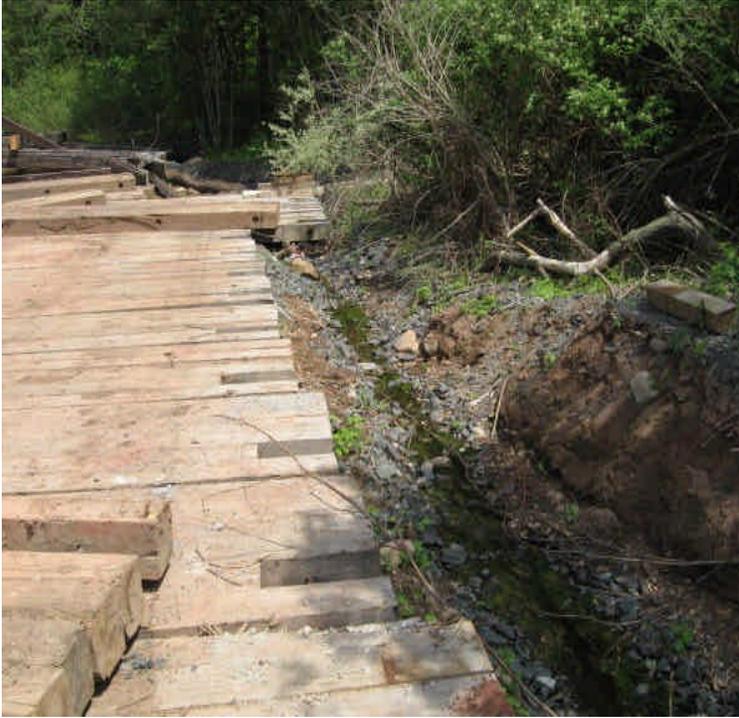
Controls and timber mats in place off Powers Road. Stabilize any exposed soil when feasible.

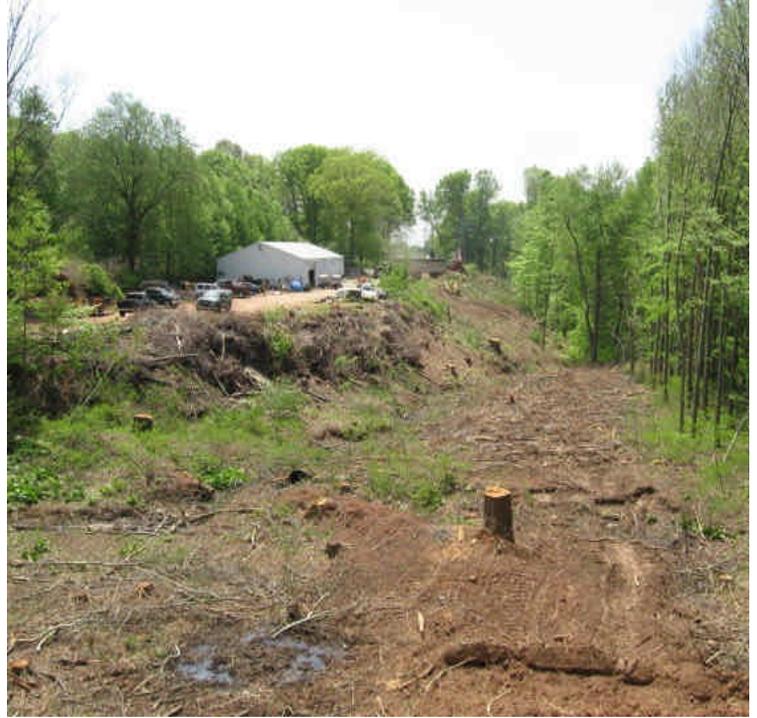
Looking toward Harrison Rd.; new clearing on a steep slope adjacent wetlands and previously unidentified Eastern box turtle habitat. Add controls wherever soil is exposed.

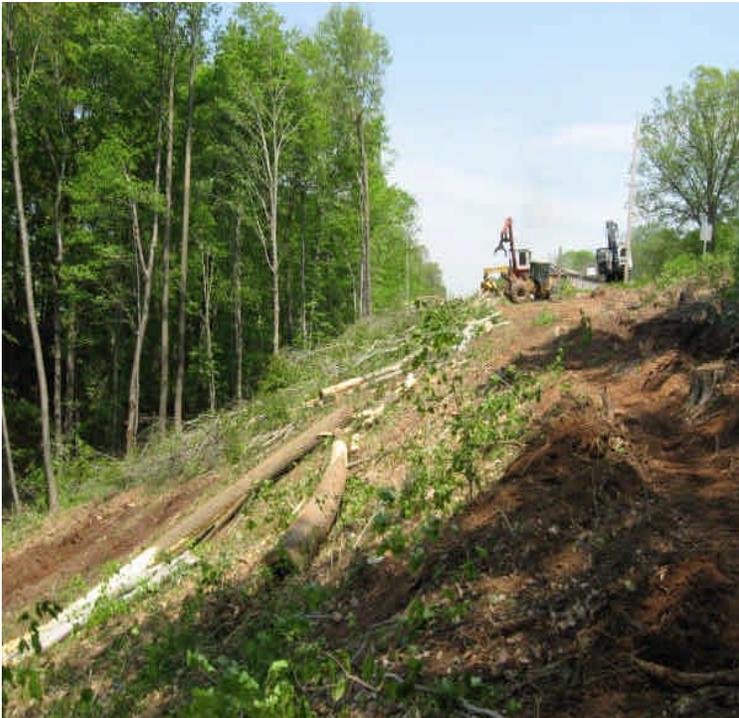
New clearing off Harrison Rd. along a steep slope upgradient from a wetland.

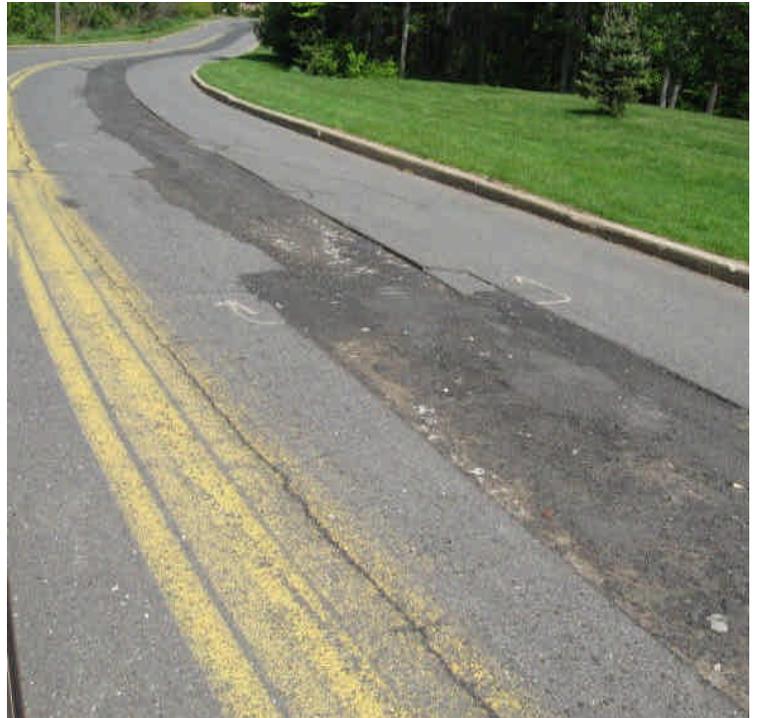
The asphalt patch along the trench along Old Farms Road is deteriorating and asphalt continues to crumble and accumulate along the roadway. Crews should finalize this surface as soon as feasible.
