**Docket No. 272 – Development and Management Plan Inspection**

**Segment 2a Inspection**

**Date:** May 30, 2007

**Location:** Segment 2a – Beseck Switching Station to Cheshire/Hamden Town Line

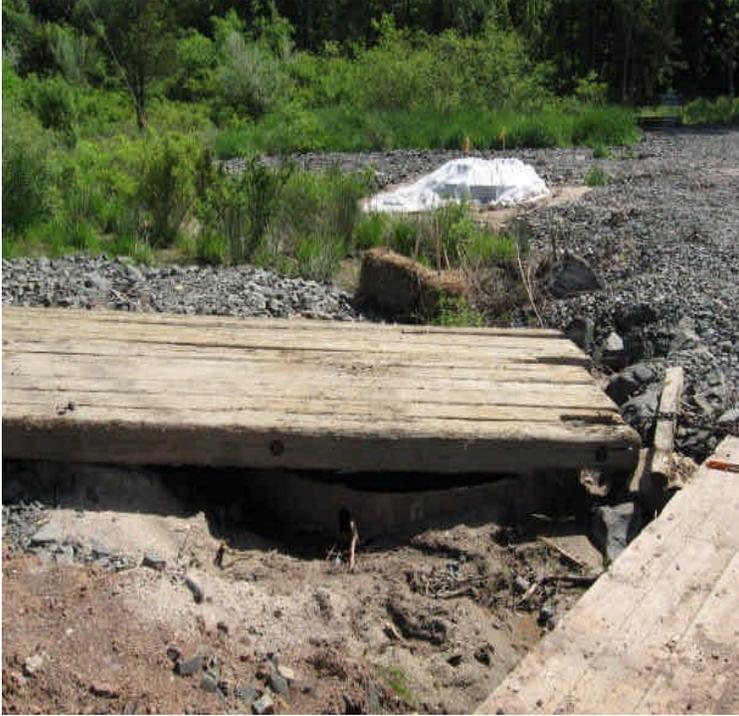
**The foundation is in place within the wetland edge off Carpenter Lane. Place a filter sock between the exposed soil and the undisturbed portion of the wetland.**

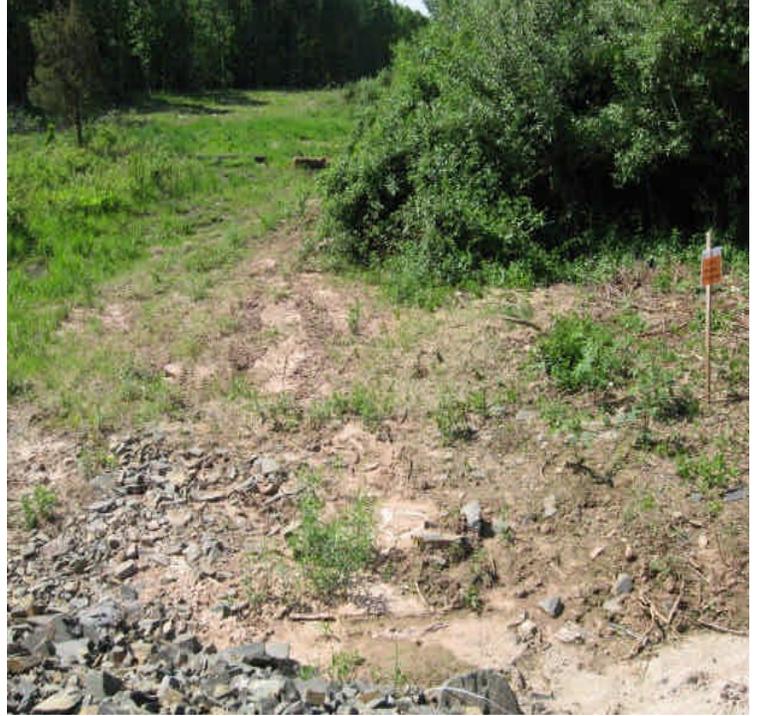
**Slurry and sediment from a foundation had reached the edge of the wetland and accumulated here against the haybales. Sediment over 2" deep should be carefully removed from the wetland by hand.**

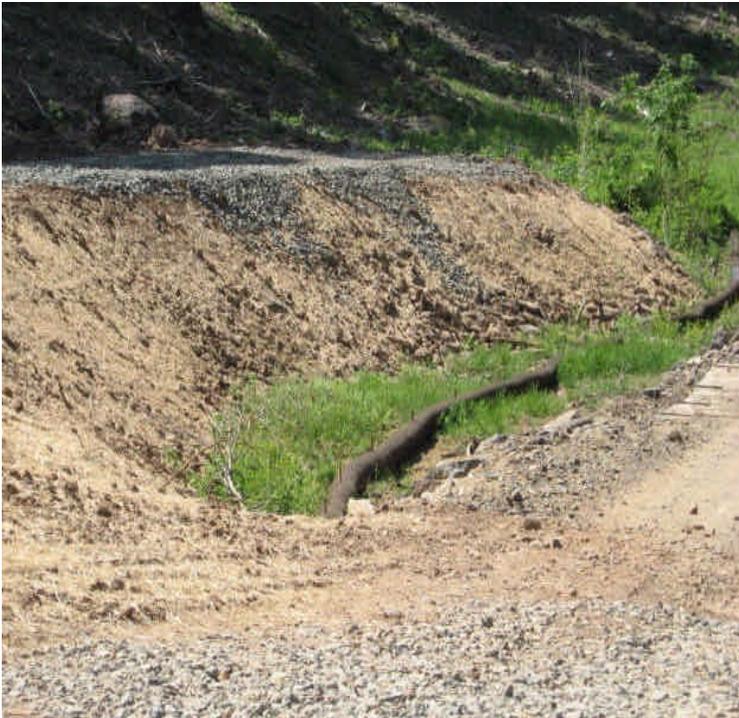
**pad site installed upgradient from a wetland crossing off High Hill Rd. Controls (filter socks) were added at the base of slope.**

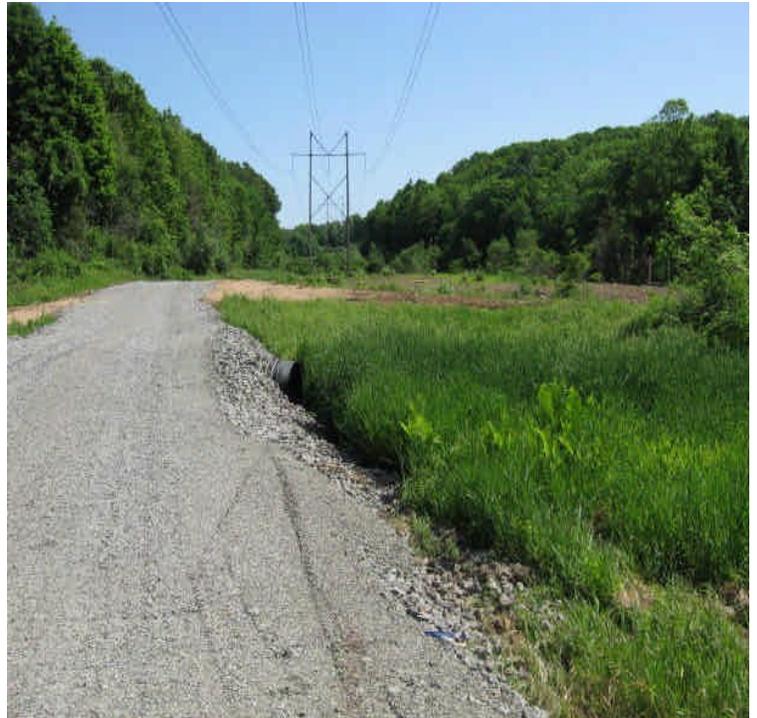
**New access road installed with culvert off Liney Hall Lane. Monitor and install controls along the road if run-off is noted.**

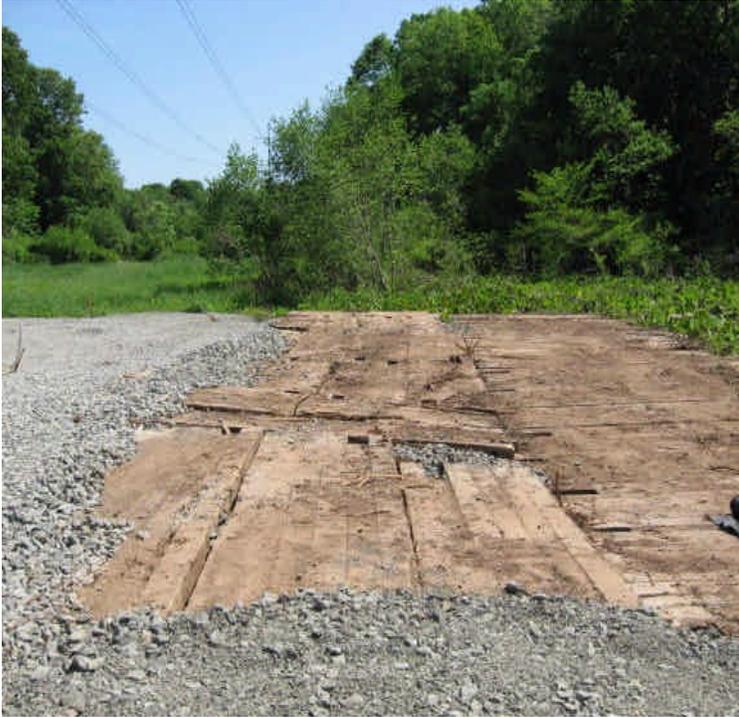
**Timber mat staging area off Liney Hall Lane. Controls were added at the edge of the work area.**

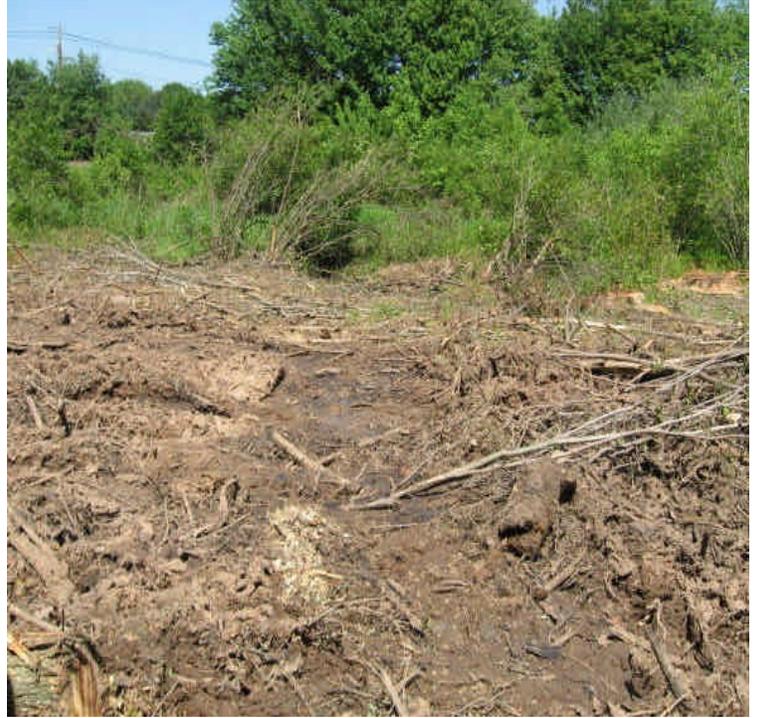
**Controls are needed at wetlands off Powers Road where clearing and access are occurring.**

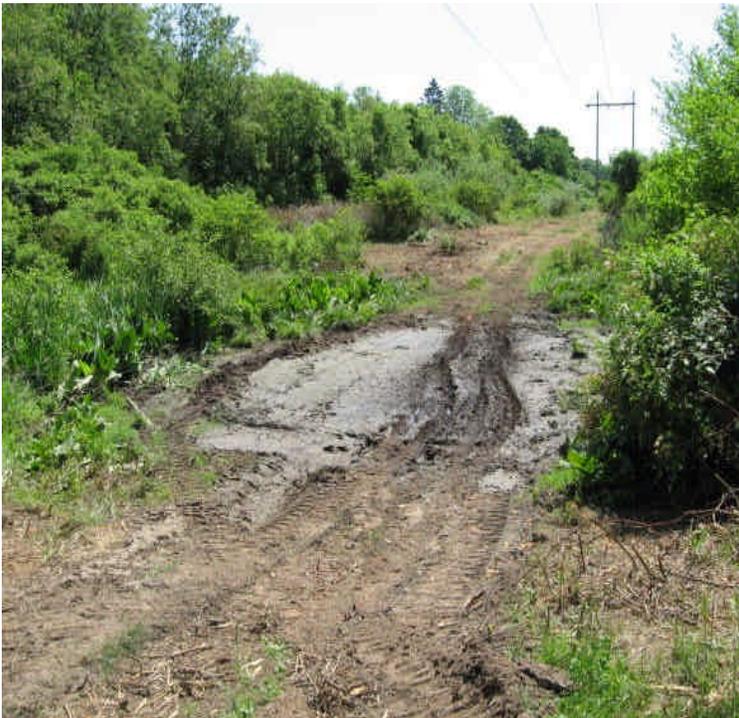
**Dry pond off Pond Hill Road. Mowing complete in this area but tracking remains. Install appropriate crossing measures if further access is needed.**

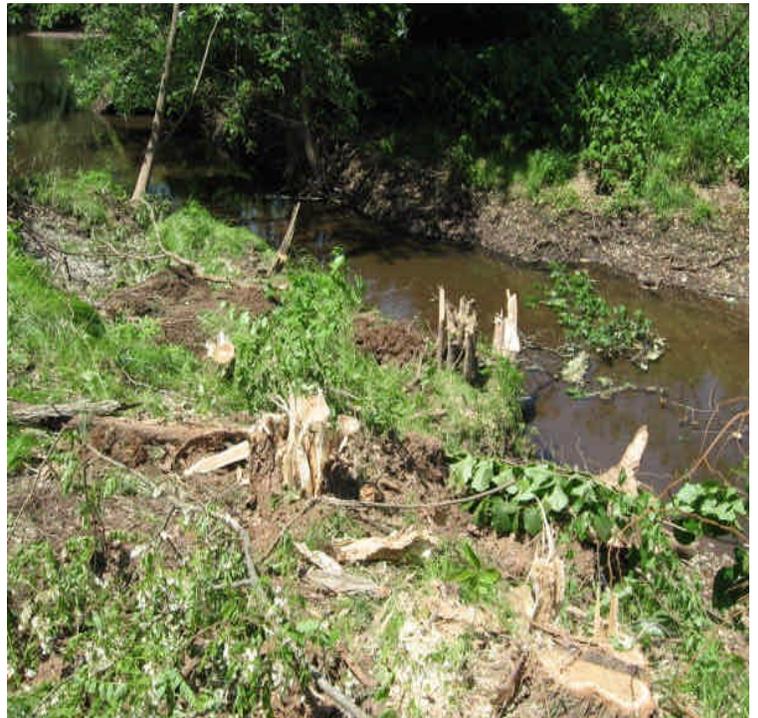
**New clearing was noted along the banks of the Quinnipiac River. Continue to leave roots/stumps in place to stabilize soil and reduce disturbance. Add controls as needed.**
