Docket No. 272 – Development and Management Plan Inspection

Segment 2a Inspection

Date: June 5, 2007

Location: Segment 2a – Beseck Switching Station to Cheshire/Hamden Town Line

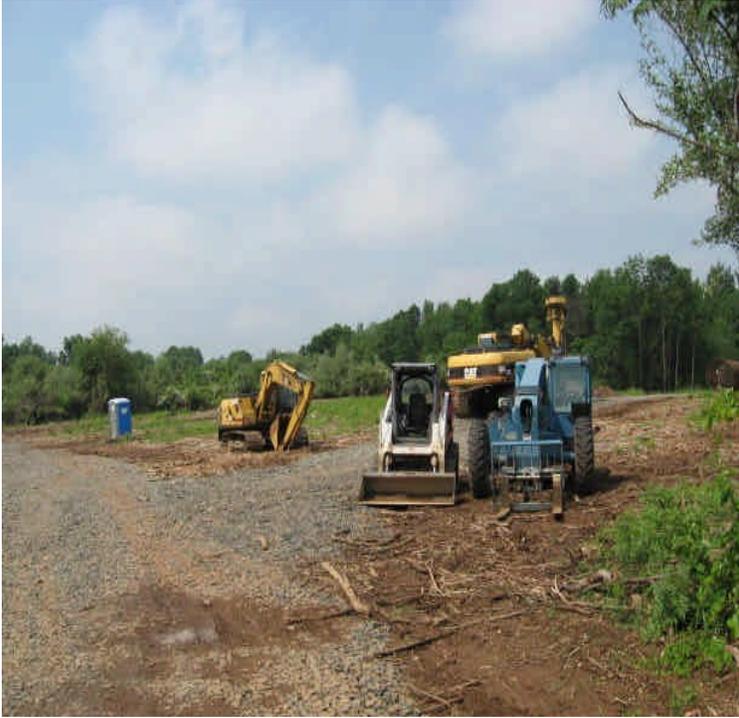
Equipment parked off Carpenter Lane. Continue to make sure vehicles are not stored within 100 feet of wetlands whenever feasible.

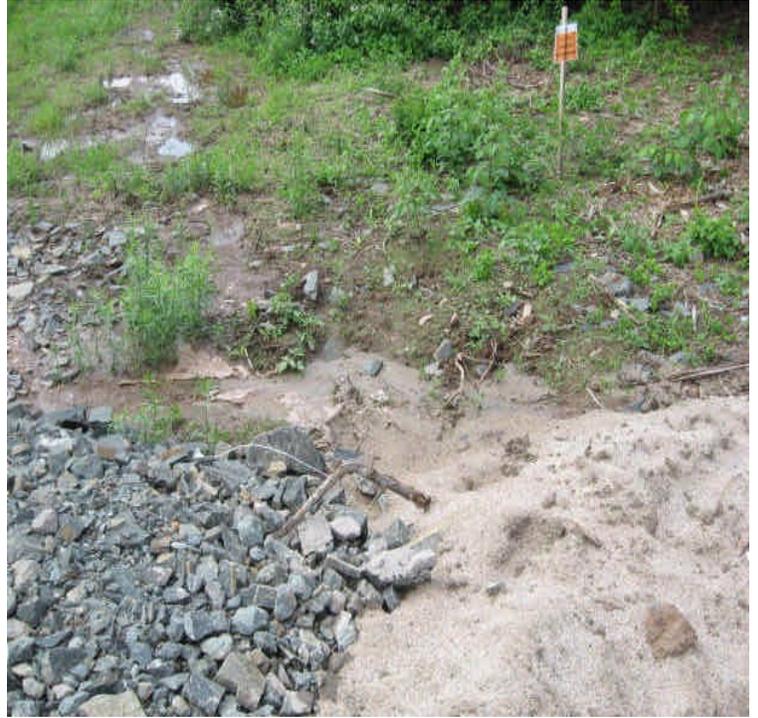
<p>Dewatering</p>	<p>Dewatering was required at the foundations installed south of Carpenter Ln. and will be required when pouring the final foundation. Some slurry did migrate to the line of controls at the wetland. 5/8-6/5/07</p>	<p>Monitor dewatering closely and remove slurry accumulation from wetlands. Maintain adequate controls when dewatering. See erosion control section. 5/8-6/5/07</p>	<p>Needs evaluation and attention.</p>
<p>Blasting</p>	<p>No blasting is proposed. 6/5/07</p>	<p>None</p>	<p>NA</p>
<p>Spills, soils and material storage</p>	<p>Spill control materials are being brought to sites when work is performed. Small drip stains have been noted in several work areas along the ROW. 6/5/07</p>	<p>Always use spill control materials when working on equipment and during refueling. Replace as needed. Check equipment daily for leaks and repair as soon as possible. 6/5/07</p>	<p>Needs evaluation.</p>

Slurry and sediment from a foundation had reached the edge of the and accumulated here against the haybales. Sediment over 2" deep should be carefully removed from the wetland by hand.

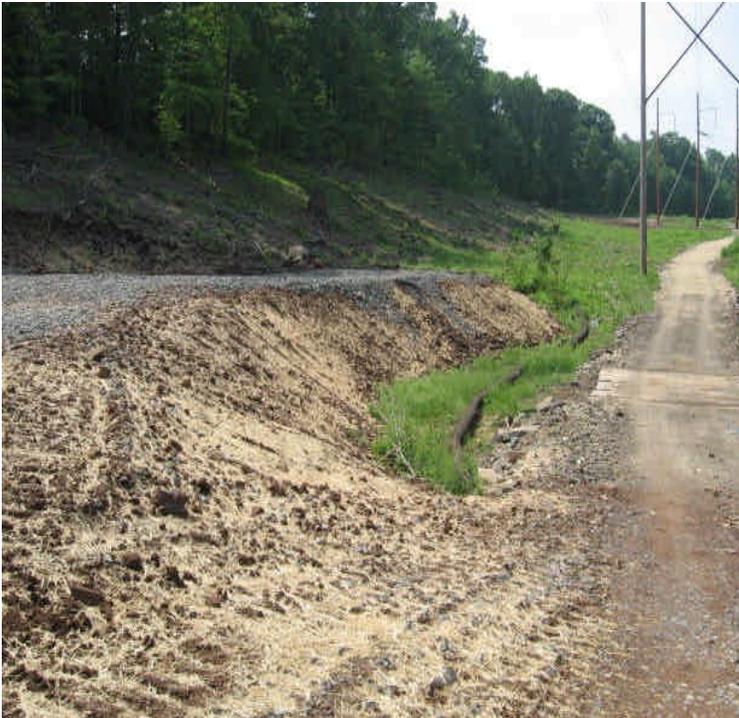
Pad site upgradient from a wetland crossing off High Hill Rd. has controls (filter socks) in place. Slopes were mulched with straw.

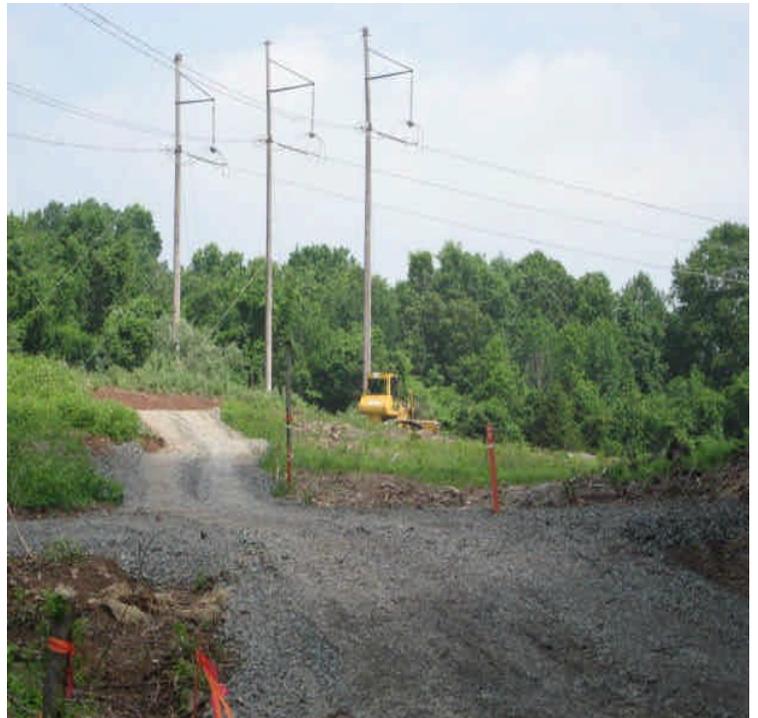
New pad grading/installation was observed off Durham Rd.

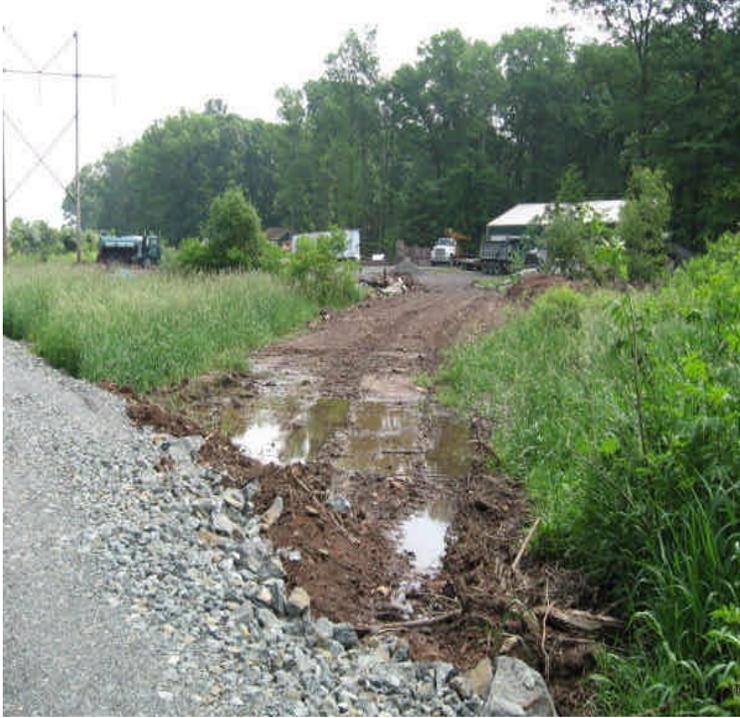
Exposed soil at Williams Rd. crossing did not appear to be fully contained adjacent to a wetland area (noted since	The old access road area should be stabilized and regraded to original contours as necessary. Promote establishment of	Needs attention.

View of old access road and new stone access road off Williams St. Stabilize the exposed soil along the old access and restore original contours as necessary.

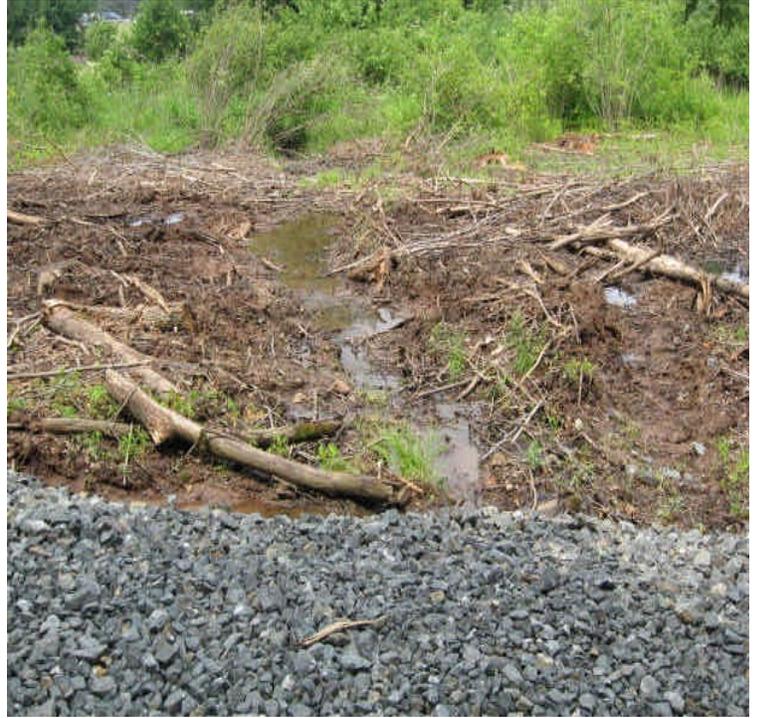
Powers Rd. & Woodhouse Ave.	<p>A new stone access road was installed in wetlands off Powers Rd., replacing the corduroy road. A culvert may be needed. No controls were added. 6/5/07</p>	<p>Monitor area closely and determine if conditions require a culvert. See erosion control section. 6/5/07</p>	<p>Needs evaluation</p>
Woodhouse Ave.; Harrison Rd.	<p>Clearing within wetlands completed by hand and trees were winched out to reduce impacts to wetlands. 6/5/07</p>	<p>Continue reducing impacts to wetlands to the extent feasible. 6/5/07</p>	<p>NA</p>
Pond Hill Rd. & Docker Dr. (I 91 – Rte. 5)	<p>Clearing and access had occurred through two wetlands and a small pond. Stream near Rte 5 was clear. 6/5/07</p>	<p>See erosion control and access road sections. 6/5/07</p>	<p>Needs to be monitored.</p>
Pent Rd. & Oliver Creek Rd.	<p>Clearing almost complete along the Quinnipiac River and in the floodplain. No controls installed but stumps and</p>	<p>See erosion controls section. Retain as much vegetation as feasible and reduce soil disturbance. Add controls and stabilize</p>	<p>Stumps were retained. Needs to be monitored</p>

Controls are needed at wetlands off Powers Road where clearing and access road installation have occurred.

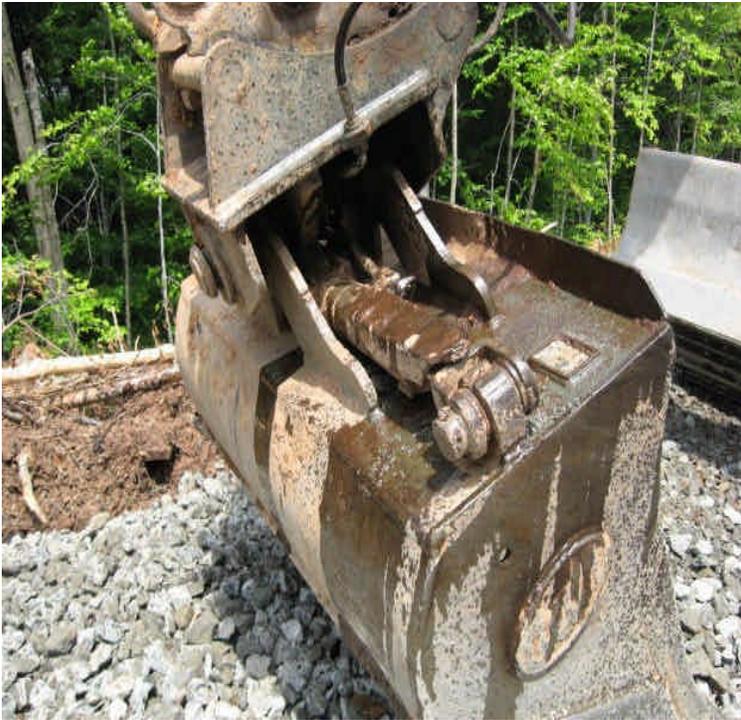
Areas of Inspection	Observation	Recommended Action	Corrected Action
Harrison Rd.	Small spill occurred when a pressurized fitting failed. The equipment was shut down and repaired immediately. Controls were used to clean equipment. 6/5/07	Continue to ensure that all of the spill is contained and affected areas are cleaned up. Keep leaking equipment out of sensitive areas until repaired. 6/5/07	Equipment leak was observed, and contained, repaired, and cleaned immediately.
Merritt Parkway	Small drip noted under tree mulcher. The drip was contained during inspection. 6/5/07	Continue to check equipment daily for leaks. Repair or contain equipment as soon as a problem is noticed. 6/5/07	Equipment was dripping controls were used.
Old Farms Rd. (Equipment Storage Area)	The storage yard for the underground work off Old Farms Rd. is no longer active. 6/5/07	If storage yard will no longer be used, remove silt fence and small asphalt stockpile. 5/2-6/5/07	Area should be restored

Leaking equipment off Harrison Rd. Controls were used to clean Equipment. Ensure that fluid is contained and repairs are made.

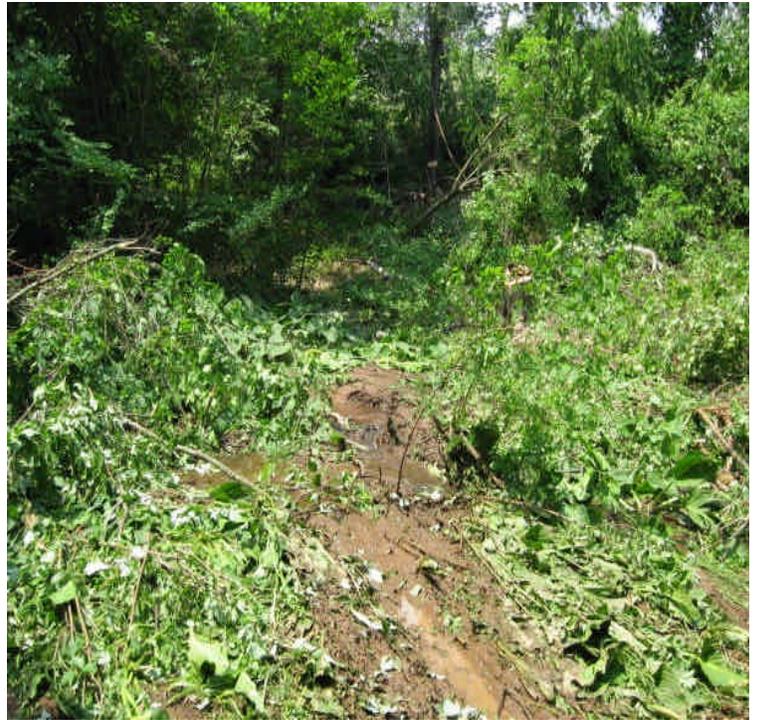
<p>S. Turnpike + Merritt Parkway Area</p>	<p>New clearing is underway within wetlands. Deep</p>	<p>Regrade rutted areas and stabilize as soon as</p>	<p>Needs attention/evaluation.</p>

New clearing noted through wetlands off Merritt Parkway. Retain vegetation wherever feasible and install controls adjacent to areas of disturbed soil.
