Docket No. 272 – Development and Management Plan Inspection

Segment 3 Underground Line

Date: May 2, 2007

Location: East Devon Substation to the Housatonic River Crossing

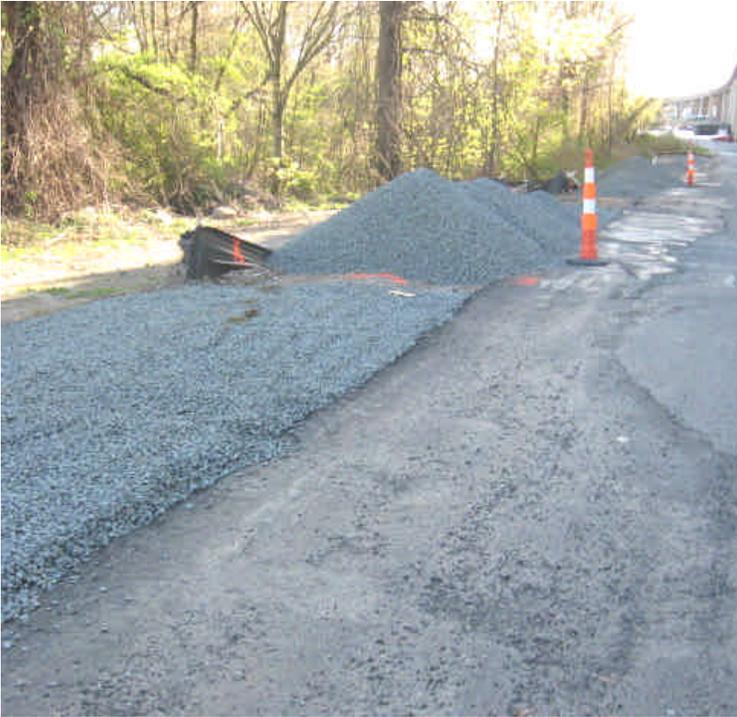
Photograph of trenching location near sta. #1018. Stone is being applied to stabilize exposed soils. Watch placement of stone on/against erosion controls.

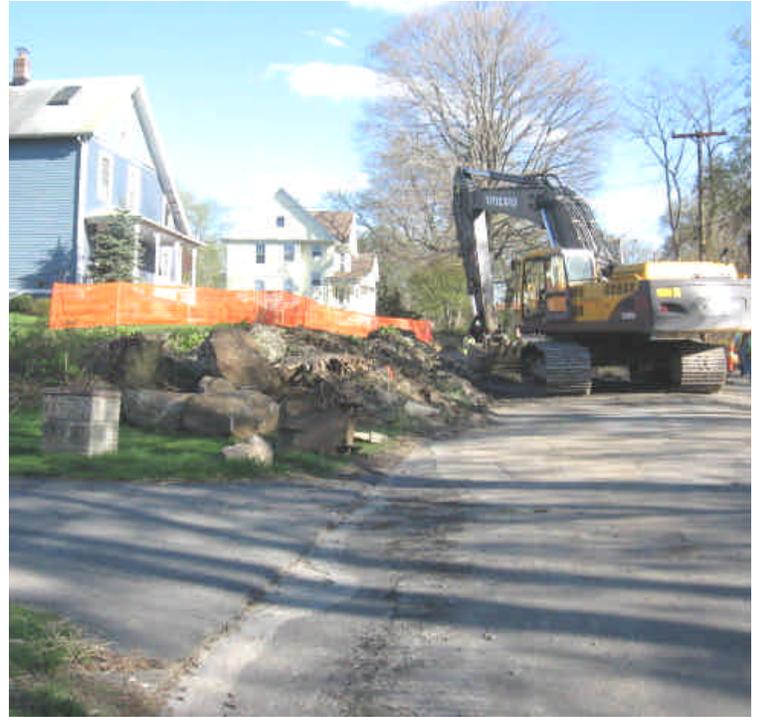
Vault #3 installation activities required the removal of a tree and shrubs.

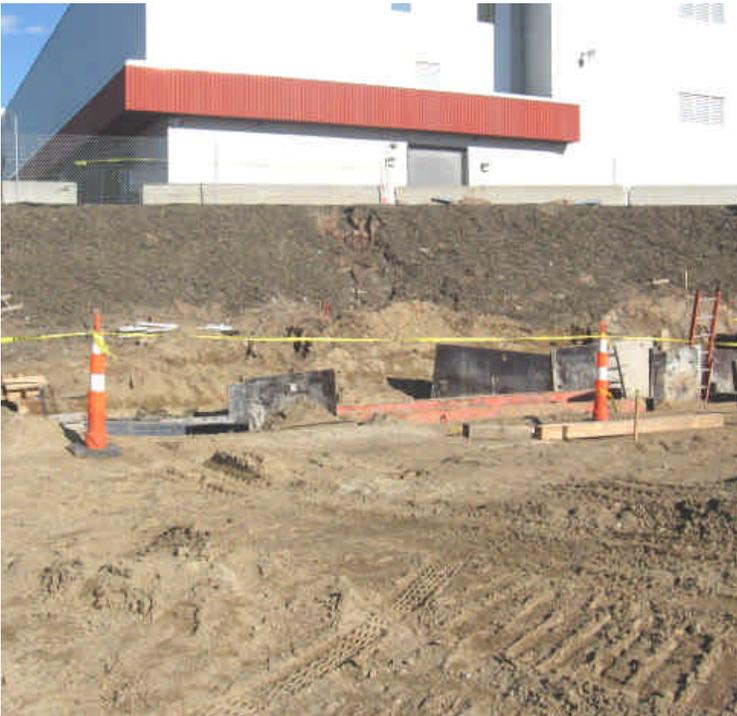
Photo of the slope located adjacent to vault #5. It had previously been stabilized with bark mulch but a portion had slumped and washed out.

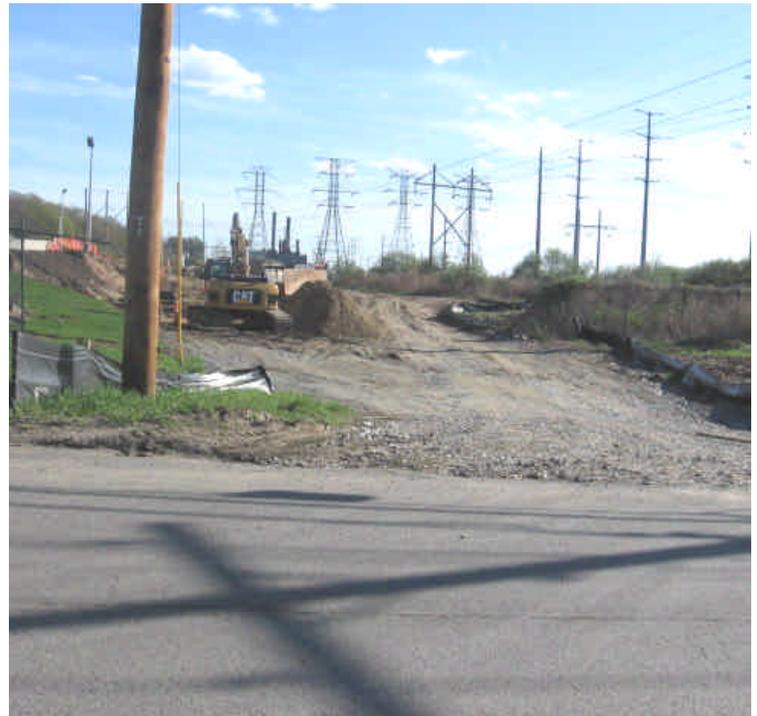
Photo of the construction entrance off of Bic Dr near sta #1081. No sediment tracking was observed on the roadway.

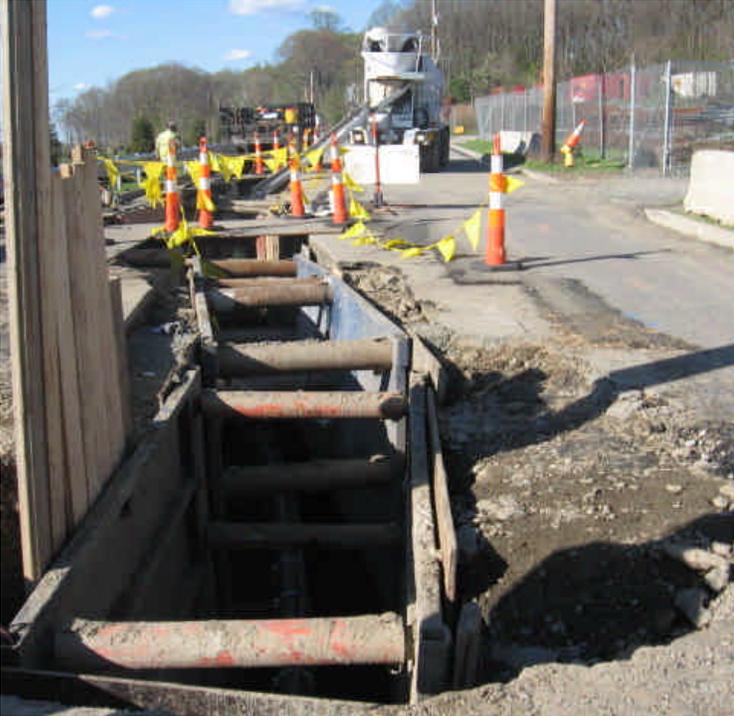
Trenching activities and backfilling were observed at sta. #1096-1097.

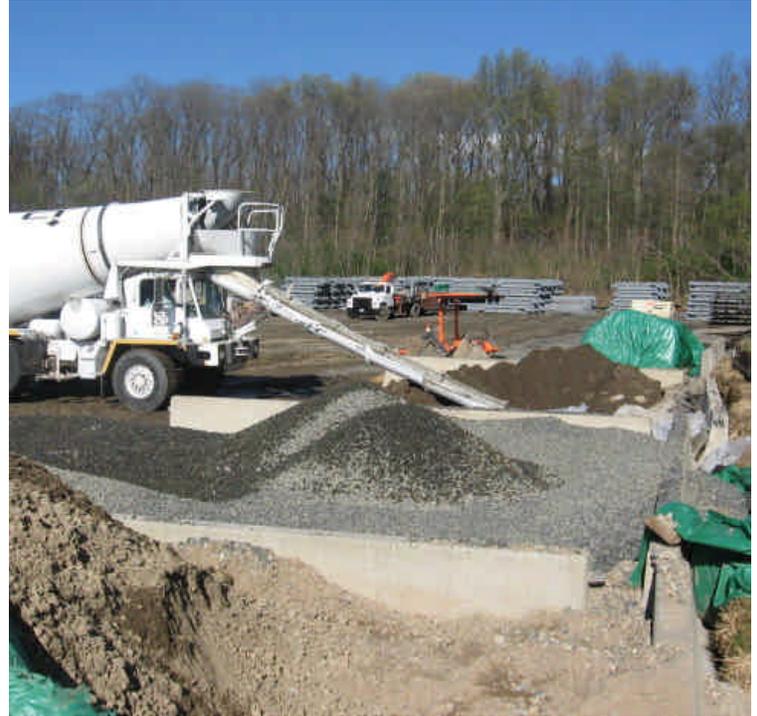
A concrete truck was washing out in disposal soil in the Milford lay-down yard. If concrete washout is to continue in yard, it should be properly contained in a basin or similar.

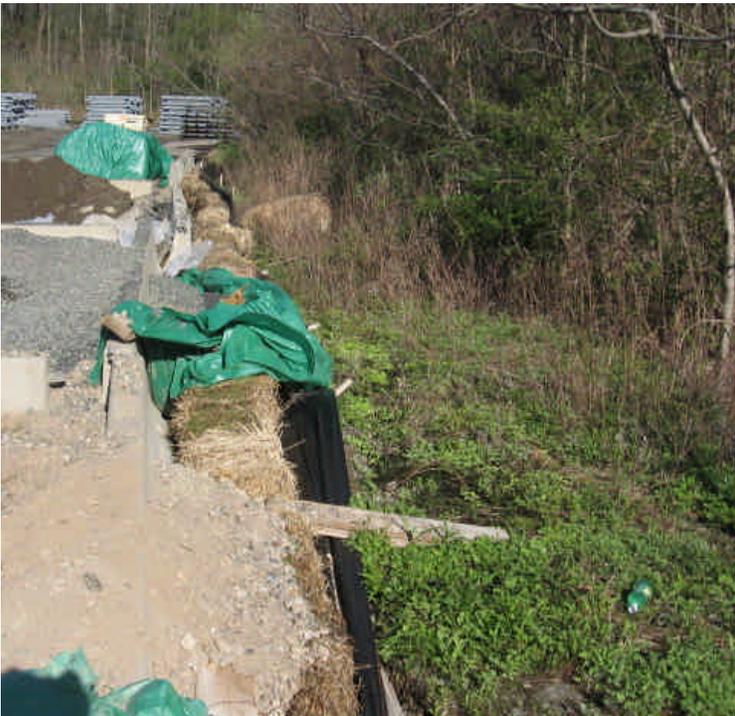
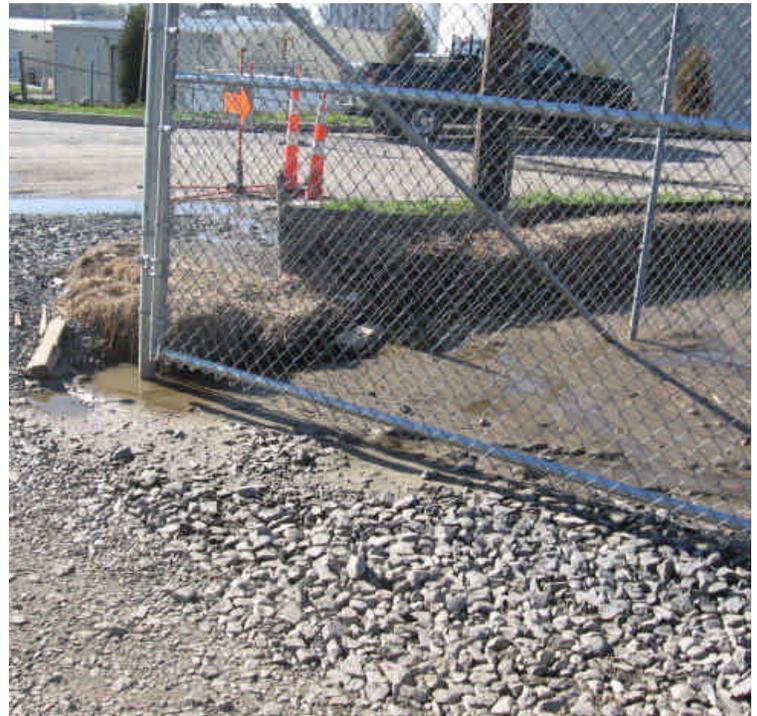
Both photos are of the Milford lay-down yard. Left: Materials are spilling beyond the containment area in the yard. The materials do not extend beyond the erosion controls but are currently compromising them. Pull materials back within the yard to alleviate stress on the controls. Right: Sediment has accumulated against the fence and haybale barrier adjacent to the entrance to the yard. Stabilize any exposed soils where feasible, and pull back sediment and reinforce controls as necessary.
