Docket No. 272 – Development and Management Plan Inspection

Segment 3 Underground Line

Date: May 17, 2007

Location: East Devon Substation to the Housatonic River Crossing

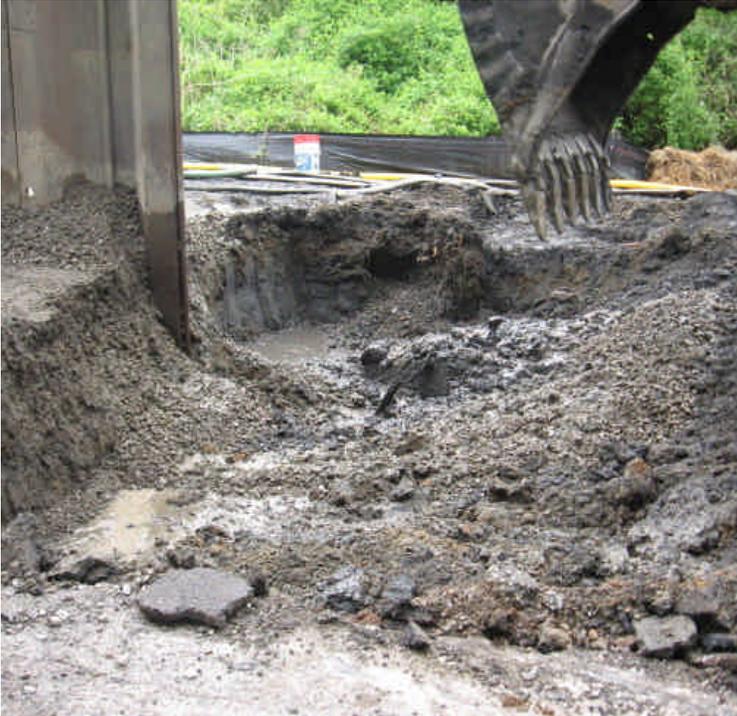
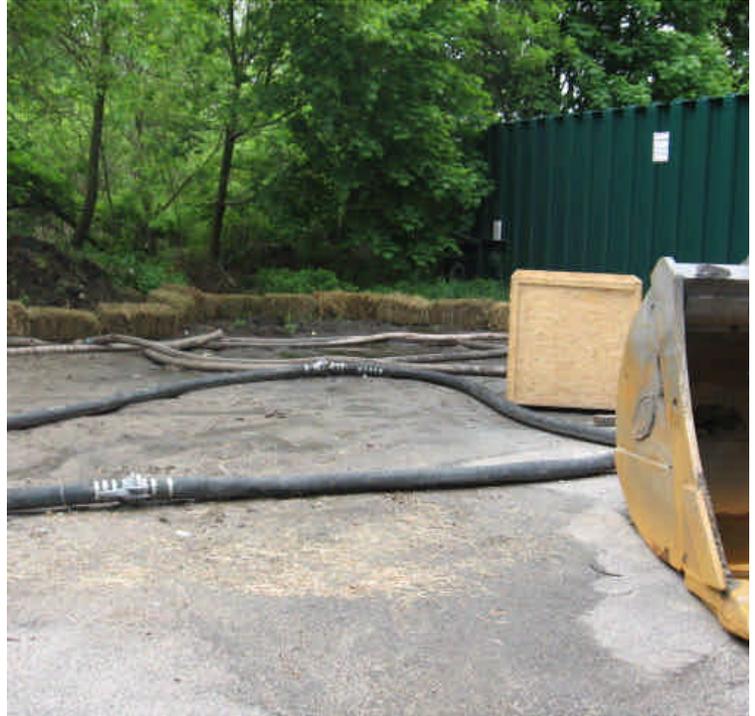
Both photos are of vault #1 excavation activities. Left: View of excavation pit for vault installation, the work area was being dewatered. Right: Erosion controls have been installed adjacent to construction activities. Sediment was noted near the dewatering tanks.

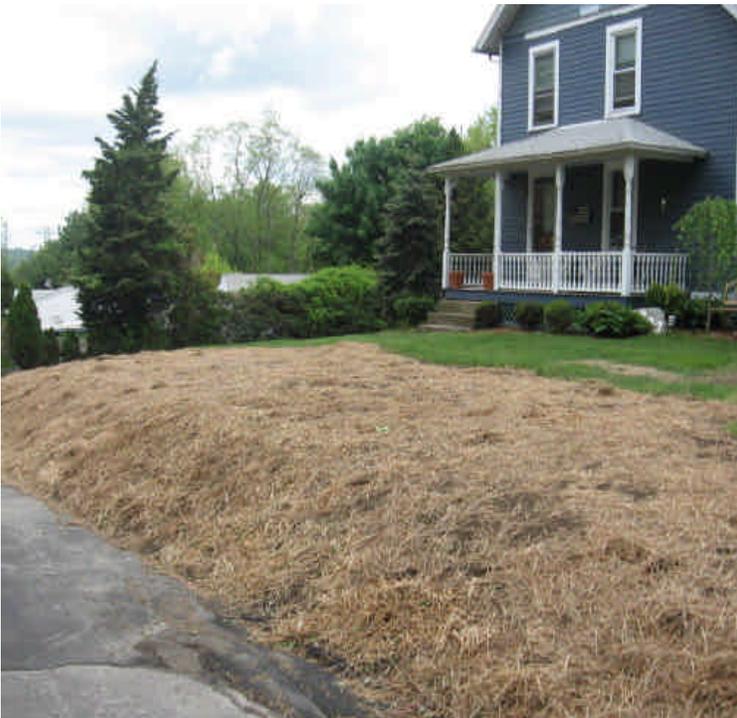
Photo of temporary stabilization measures (mulch) at vault #3. Continue to monitor for adequate lawn restoration.

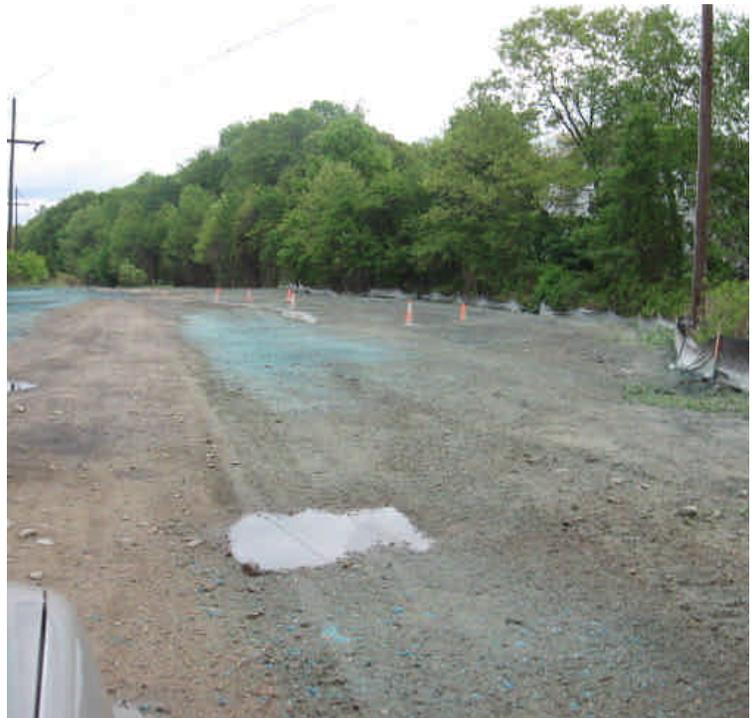
Hydroseed (and mulch) has been applied to the cross-country portion of the ROW where soils were disturbed as a result of Segment 3 work.

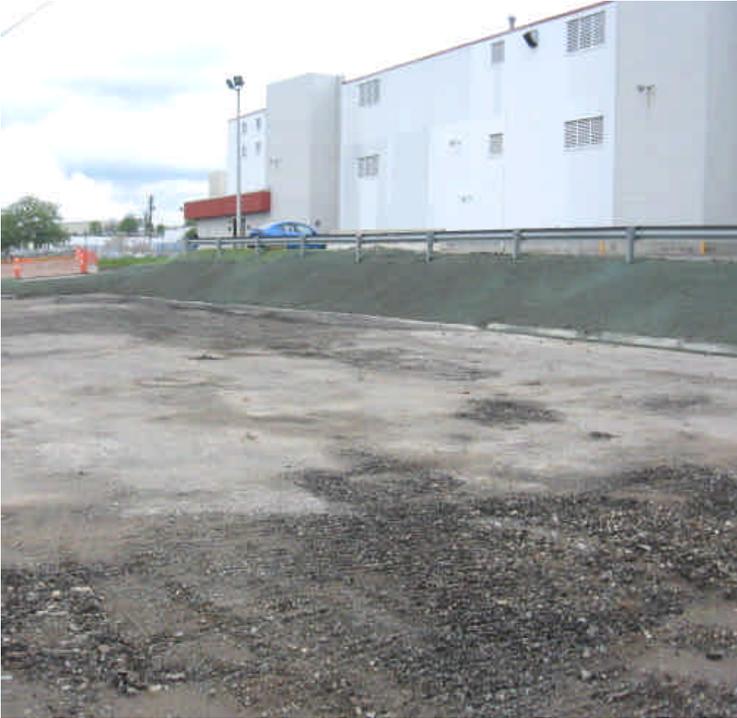
Hydroseed (and mulch) has been applied to the exposed, hard pack slope at sta. #1075 to 1076. Continue to monitor for vegetative cover.

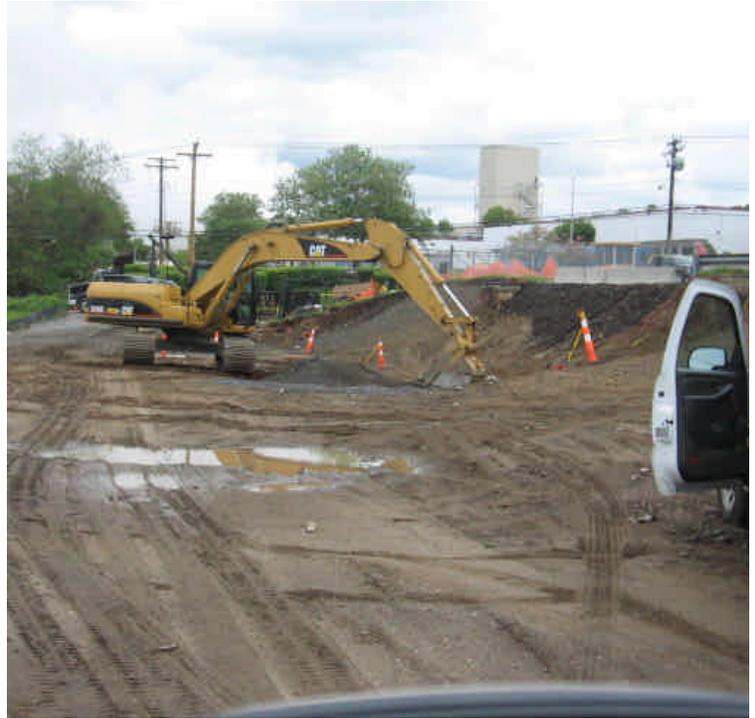
Excavation/trenching activities continue near sta. #1079.

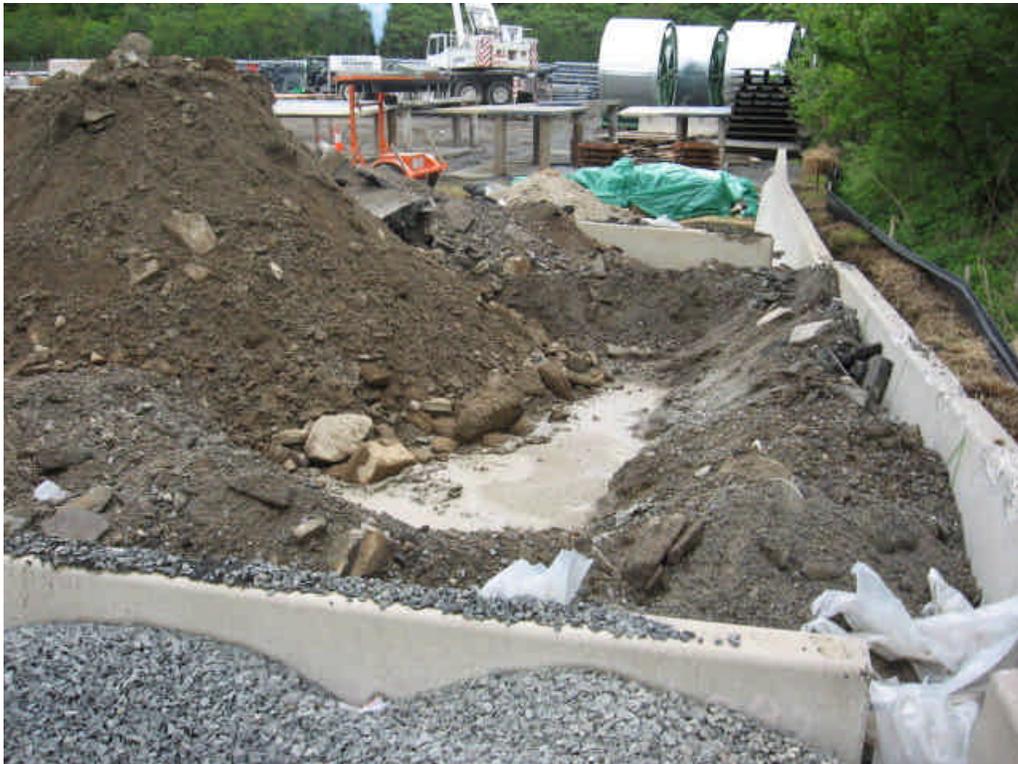
Concrete washout was observed within the soil in the material storage bins. If the need for washing-out concrete within the yard continues, proper containment should be provided. Washout should be properly disposed of. Attention is also needed where materials are overtopping the storage bins here.
