Docket No. 272 – Development and Management Plan Inspection

Segment 4a Underground Line

Date: May 2, 2007

Location: Singer Substation to Fairfield/Westport Town Line

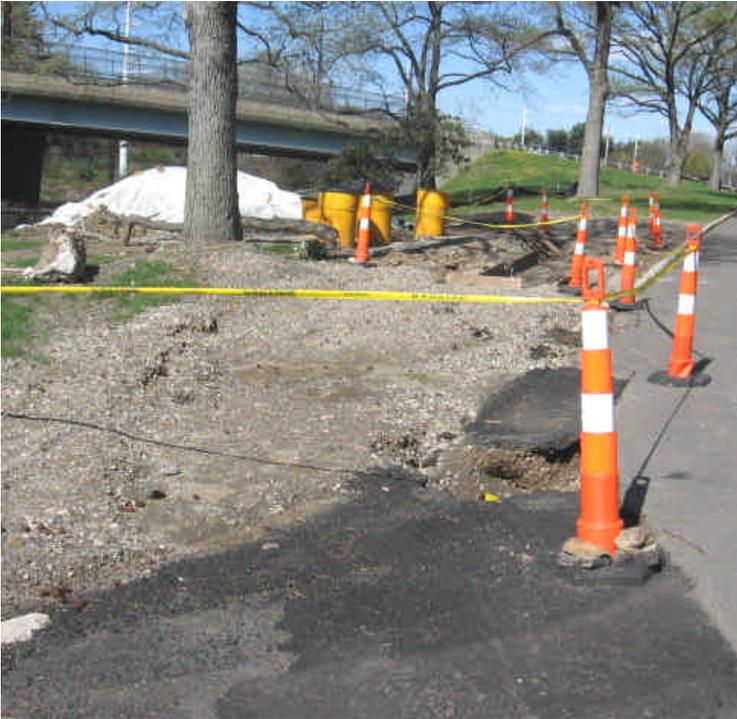
Disturbed soils from construction activities along Pequot Ave. remain largely stable.

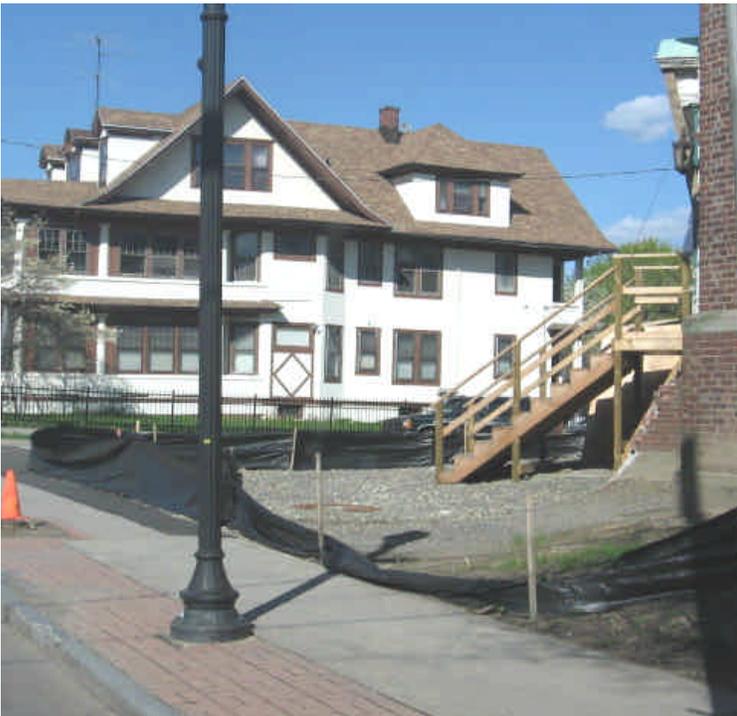
Slurry from saw cutting activities has the potential to enter catch basins. Problems with slurry were not observed this week. 5/02/07	Prevent slurry from entering catch basins and sensitive areas, by quickly attending to it as it is generated during cutting. 5/02/07	NA
	Fairfield	Work at vault #41 is largely complete. A portion of the silt fence installed around the remaining exposed soils is again in disrepair. 5/02/07	Repair/maintain controls and continue to stabilize soil as feasible. 5/02/07
A soil stockpile along Pequot Ave. remains covered with plastic and has adjacent silt fence. 5/02/07		Continue to monitor and maintain controls. 5/02/07	NA

Photo of the vault #41 location. Although, silt fence is in disrepair and needs maintenance, exposed soil remains stable.

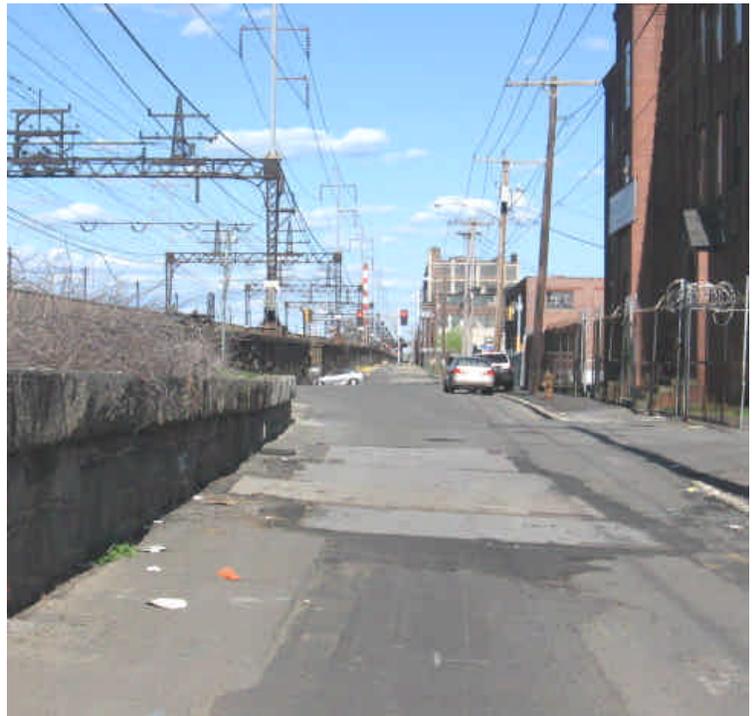
View of trenchwork located within Railroad Ave. at sta. #722.

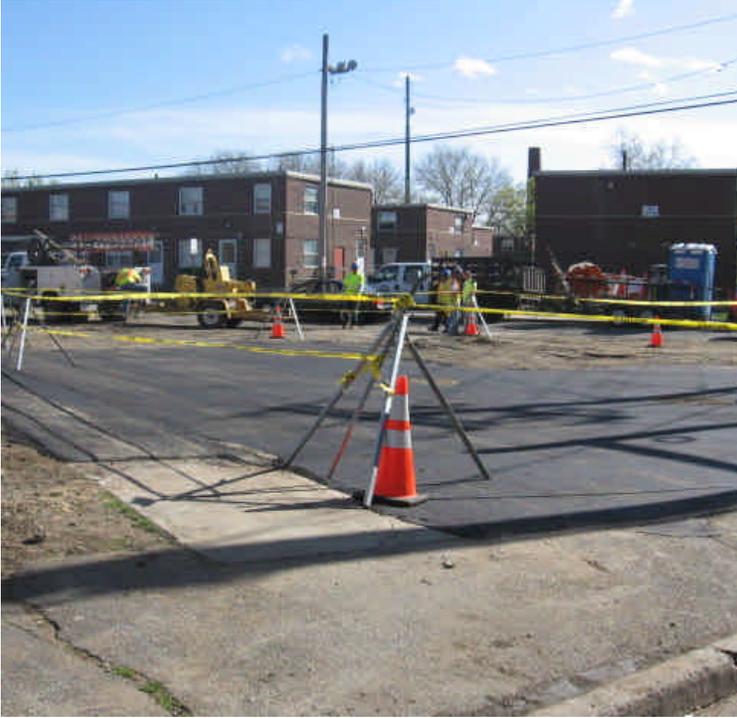
Construction activities were nearing completion at Vault #47. Portions of the disturbed soil areas had been repaved.	None. 5/02/07	NA

Construction activities at vault #47 are nearing completion. Some previously disturbed areas have been re-paved.

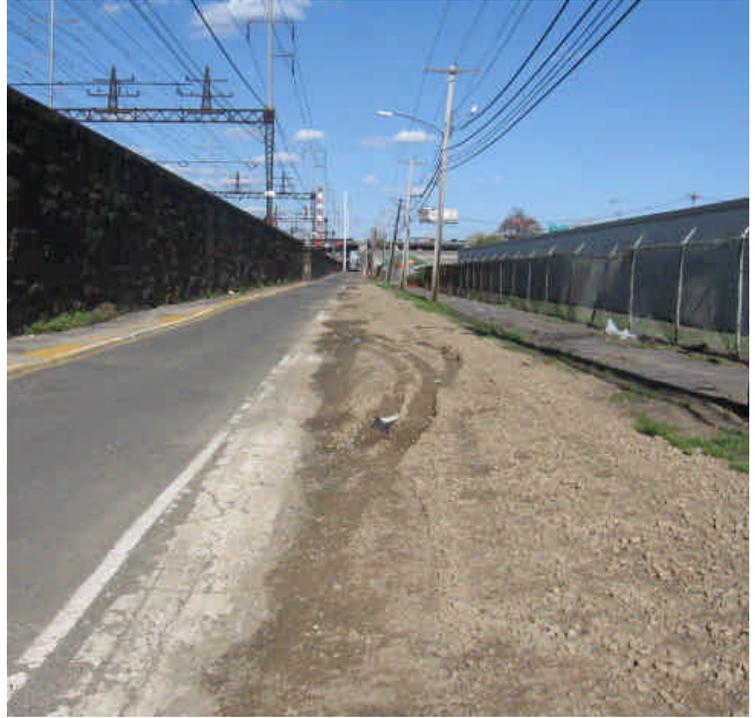
Stone has been applied to the shoulder of Railroad Ave. where necessary, in an effort to reduce vehicle ruts.

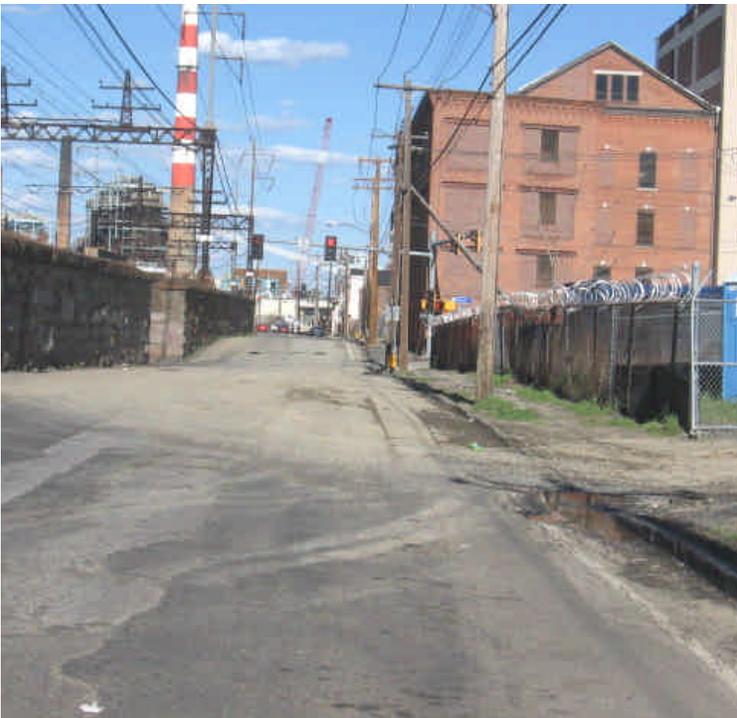
Photo of Railroad Ave. at its intersection with Myrtle Ave. Sediment tracking is regularly noted at this location but is due to a storage yard for a project not covered under this D&M plan.

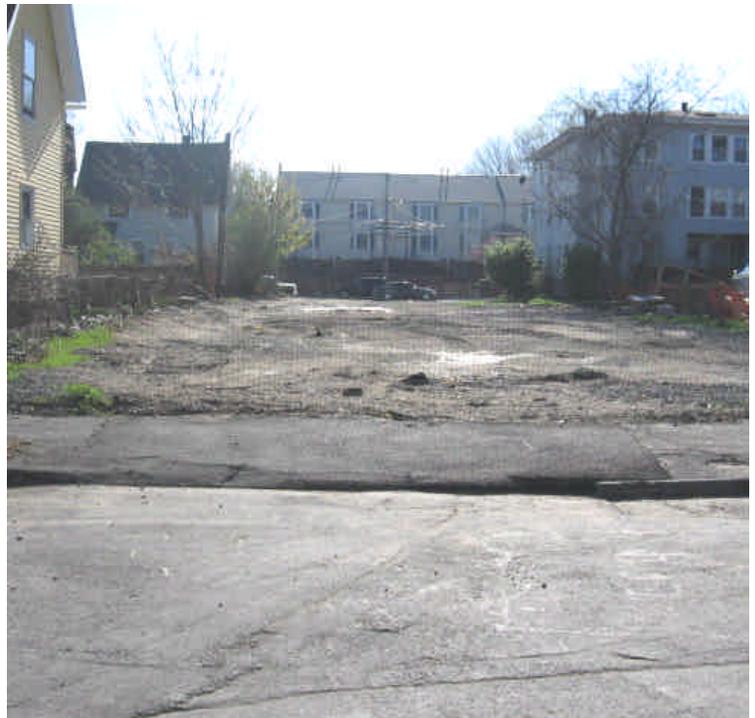
Two trees were removed near sta. #462 in accordance with the D&M Plan the week of 3/27/07.	Vegetation should be restored as necessary upon completion of work in this area. 5/02/07	NA at this time.
	The trench formerly located between Broad and Main St. has been backfilled with a hard pack material on 4/13. The area appears to be stable but remains as a bare, exposed surface. 5/02/07	Permanently stabilize the area with final restoration measures when feasible. 4/13-5/02/07	Needs attention when feasible.
Dewatering	Dewatering activities were observed at sta. #458 to # 463 during this week's inspection. 5/02/07	Discharge water appeared to be appropriately contained and/or filtered. 5/02/07	NA
Blasting	No blasting has been proposed. 5/02/07	None 5/02/07	NA
Spills and Material Storage	Spill cleanup materials/kits were observed in the storage	Ensure that spill kits are also present with each vehicle during active	NA

Soil within the trenching area between Broad and Main St. remains stable, although final stabilization measures are needed when feasible.
