Docket No. 272 – Development and Management Plan Inspection

Segment 4a Underground Line

Date: May 17, 2007

Location: Singer Substation to Fairfield/Westport Town Line

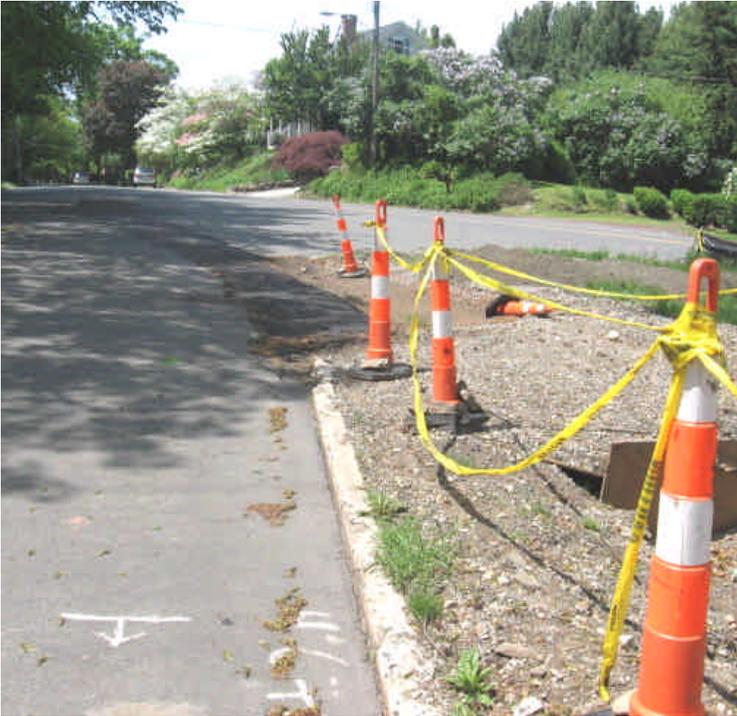
The portion of the road that was undermined by run-off has been repaired

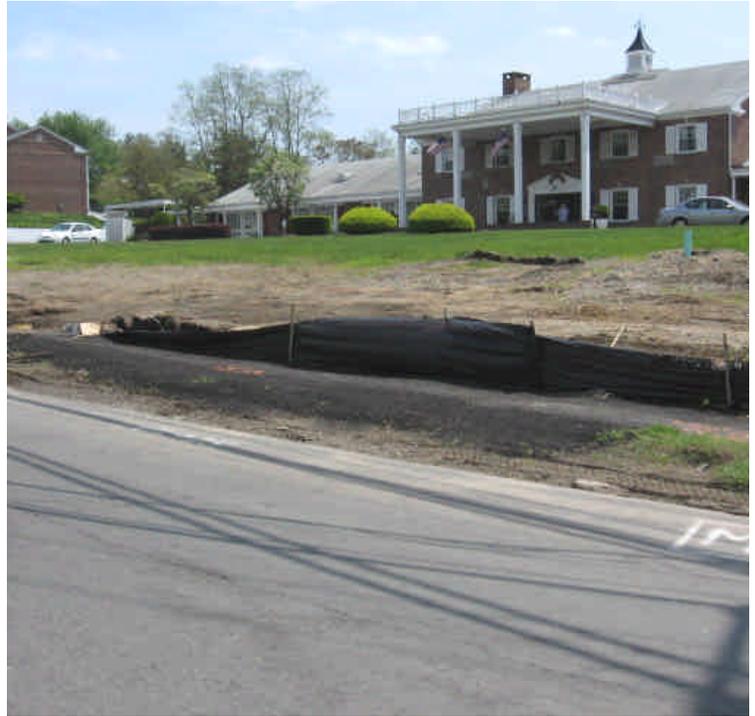
<p>Fairfield</p>	<p>Access to construction activities near vault #37 has been gained via an opening in the erosion controls at station #612, leaving exposed soil uncontained at the close of each work period. 5/17/07</p> <p>A private yard next to vault #28 has been stabilized with seed and hay mulch. 5/17/07</p>	<p>Erosion controls should be re-established in this location at the close of each work period to prevent potential sediment migration during heavy rain events. (Haybales could also be placed across the access.) 5/17/07</p> <p>Continue to monitor to ensure adequate establishment of vegetation and lawn cover. 5/17/07</p>	<p>Needs attention.</p> <p>Area was seeded and mulched.</p>

Activities continue at the vault #37 location. Access to the construction area has been obtained through an entrance in the erosion controls. Recommend re-establishing controls or placing haybales at the close of each day to prevent sediment migration during heavy rain events.

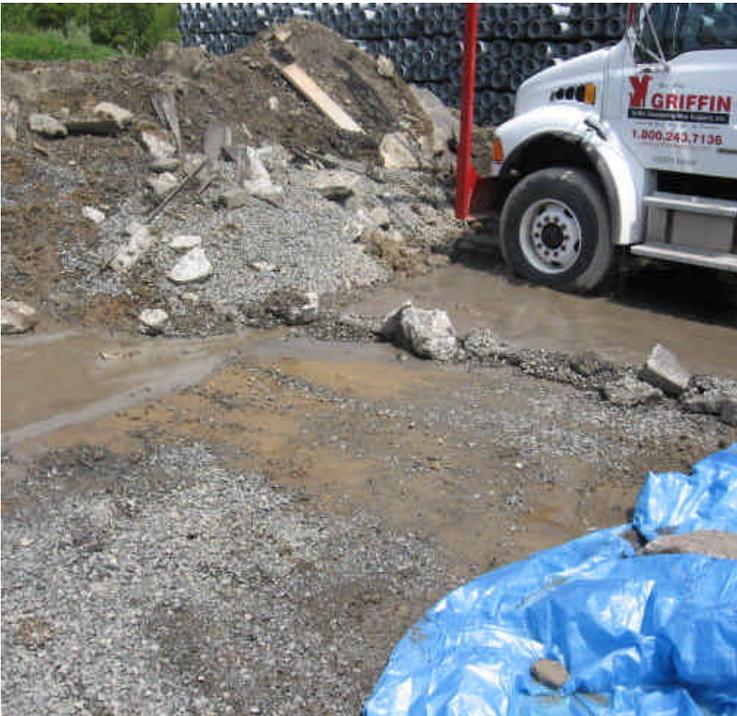
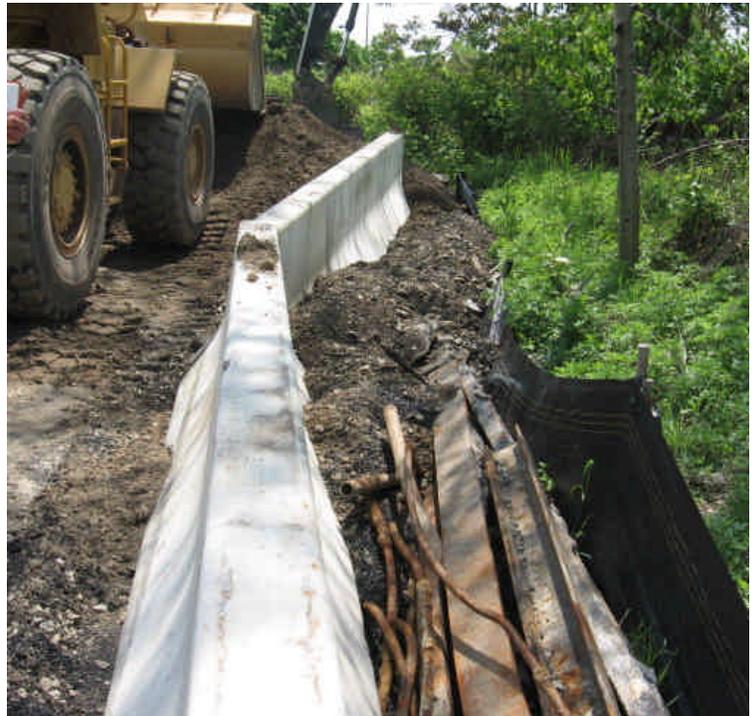
Both photos were taken within the King's Highway lay-down yard. Left: Accumulated slurry remains adjacent to the disposal soil pile. Right: Material is still overwhelming the silt fence perimeter control within the yard. Pull the soil back and restore the controls. However, resource areas are not located adjacent to this area.
