Docket No. 272 – Development and Management Plan Inspection

Segment 4a Underground Line

Date: May 31, 2007

Location: Singer Substation to Fairfield/Westport Town Line

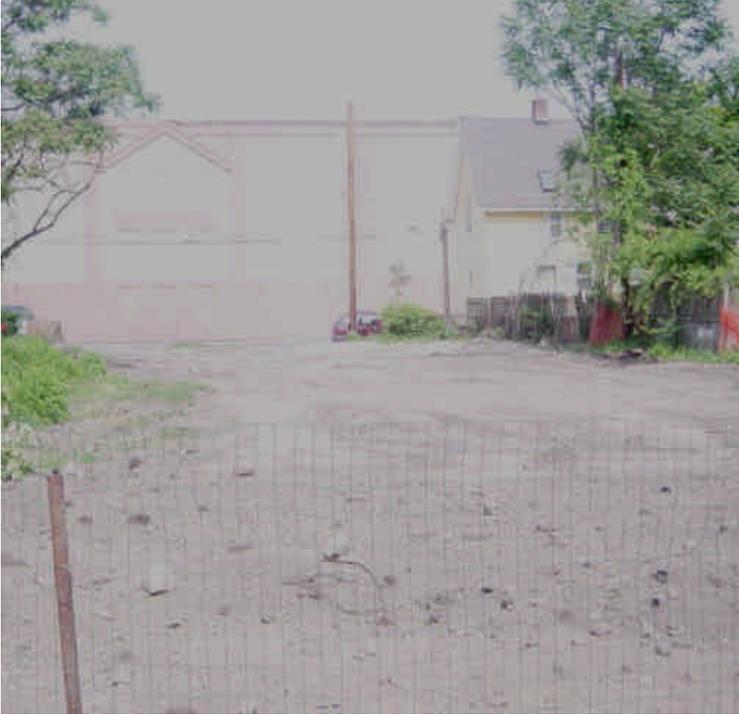
Topsoil continues to be added to the trenching location between Broad and Main Street in an effort to restore the area.

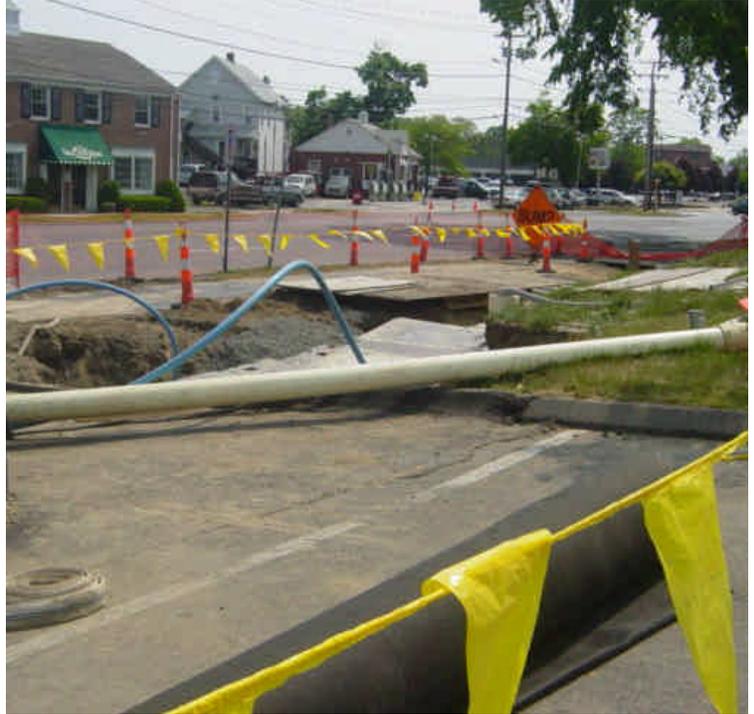
View of trenching activities at sta. #594.

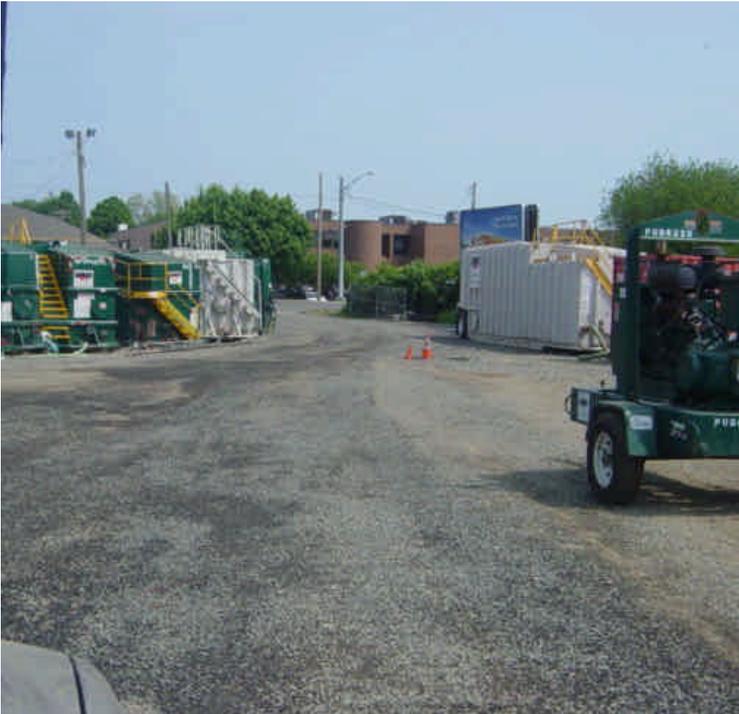
The King's Highway lay-down yard was recently watered down to proactively prevent airborne dust.

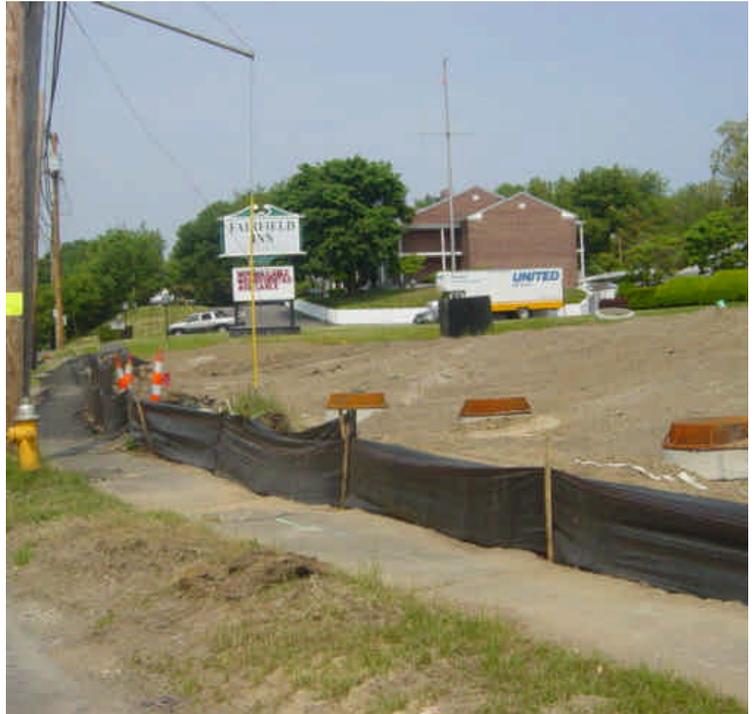
Erosion controls have been re-established at sta. #610. Stabilization of exposed soil is recommended when feasible.
