Docket No. 272 – Development and Management Plan Inspection

Segment 4a Underground Line

Date: June 21, 2007

Location: Singer Substation to Fairfield/Westport Town Line

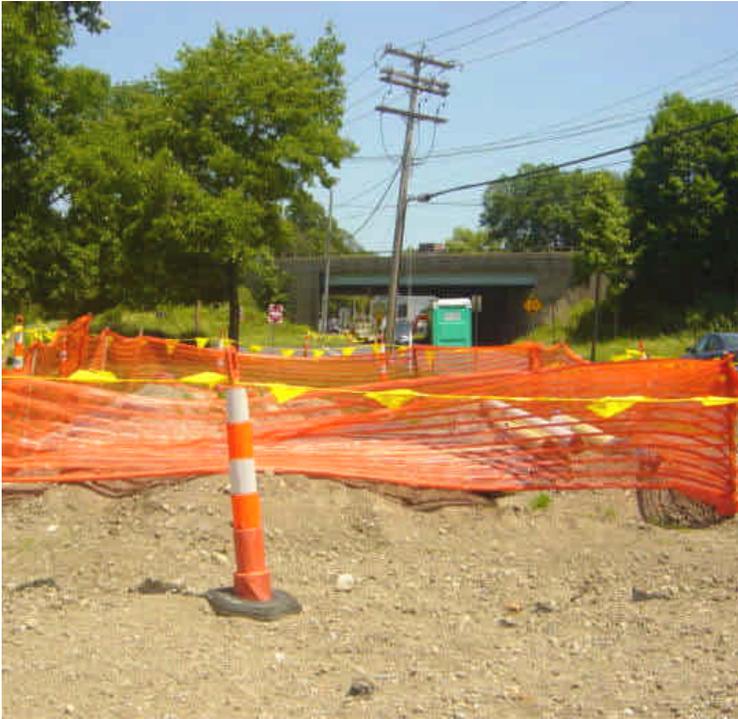
View of open trenchwork near sta. #461 to #462.

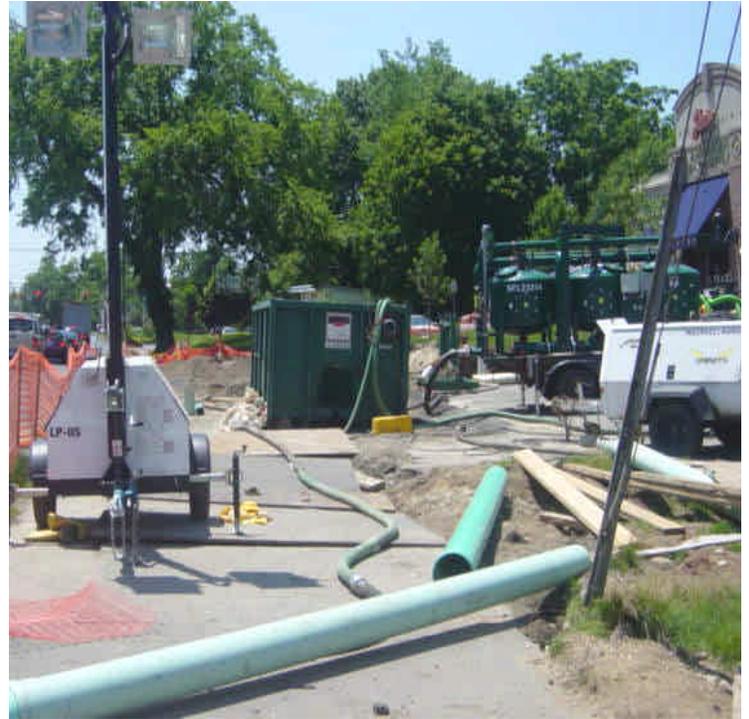
Dewatering	Dewatering activities were observed at near sta. #596 (near Vault #36), and near #789 during this week's inspection. A frac tank was in place at #596 and a vac truck was used at #789. 6/21/07	When dewatering is necessary, continue to appropriately contain and/or filter discharge water. 6/21/07	Frac tanks and vac trucks were in place.
Blasting	No blasting has been proposed. 6/21/07	None 6/21/07	NA
Spills and Material Storage	<p>Spill cleanup materials/kits were observed in the storage yards. 6/21/07</p> <p>Fluid filled equipment in the King's Highway yard continue to be proactively stored on liners or similar</p>	<p>Ensure that spill kits are also present with each vehicle during active construction 6/21/07</p> <p>Continue to monitor. Good proactive controls are being used even though leaks were not</p>	<p>NA</p> <p>NA</p>

View of dewatering activities near vault #36.

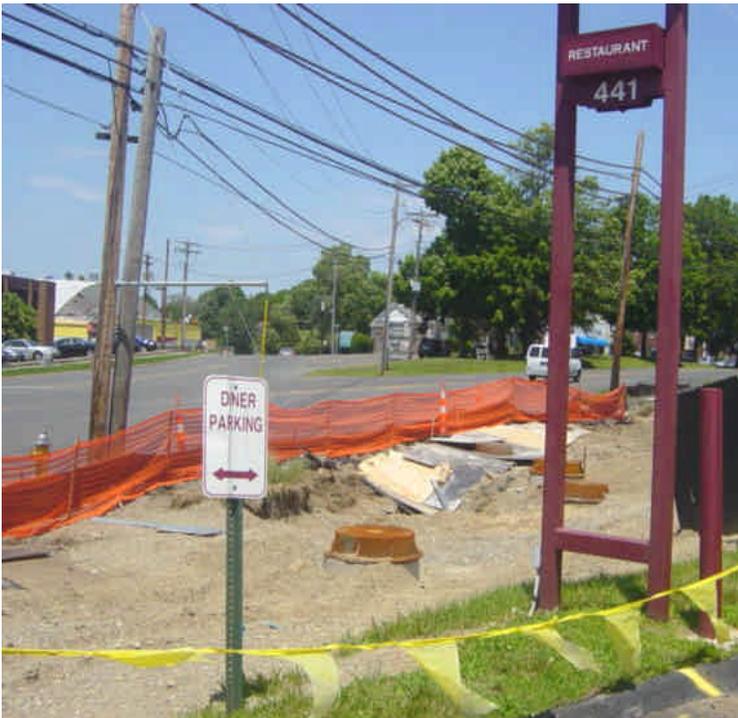
Silt fence has been restored near vault #37. It is anticipated that the area will be seeded and mulched once the man hole rims are set.

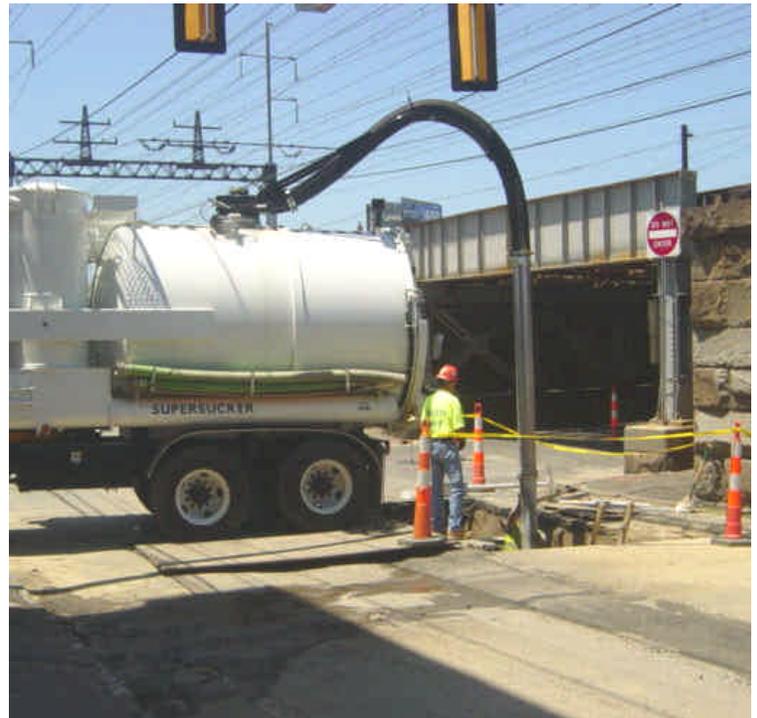
Dewatering and trenching activities were occurring along Railroad Avenue near sta. #789. A vac truck was used to remove the water.
