Docket No. 272 – Development and Management Plan Inspection

Segment 4b Underground Line

Date: May 10, 2007

Location: Fairfield/Westport Town Line to Westport Avenue in Norwalk

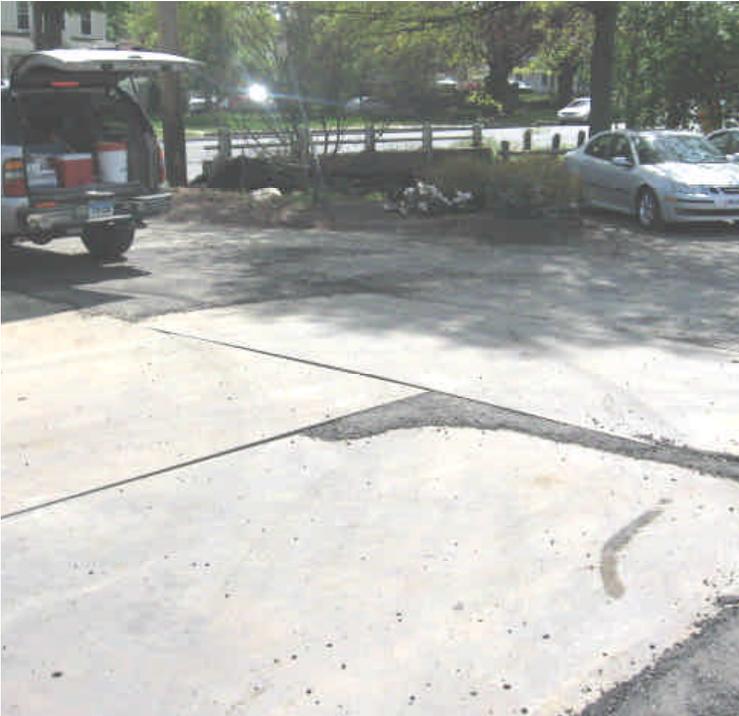
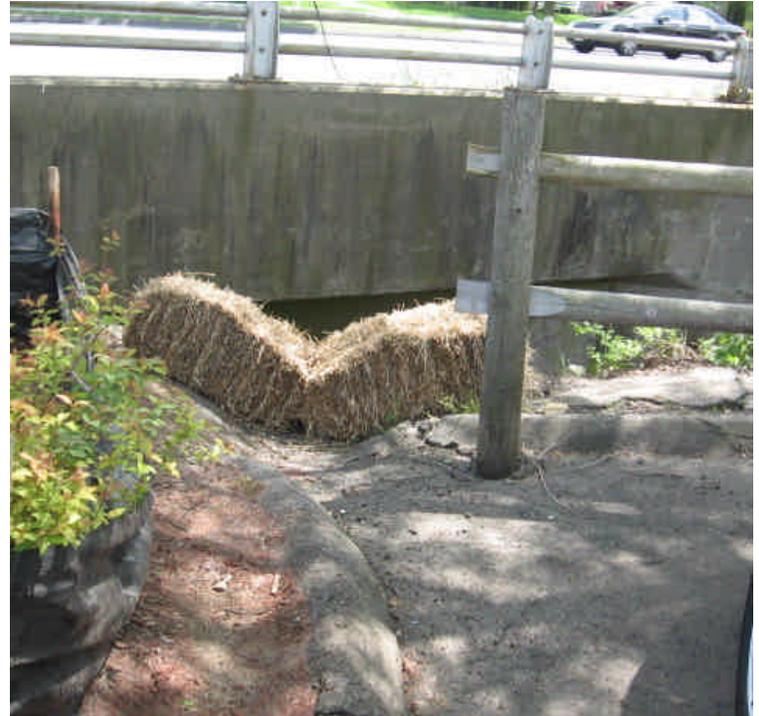
Both photos are of vault #13, located adjacent to Stoney Brook (shown on Right). Erosion controls were adequately installed between construction activities and the Brook, taking into account existing drainage patterns.

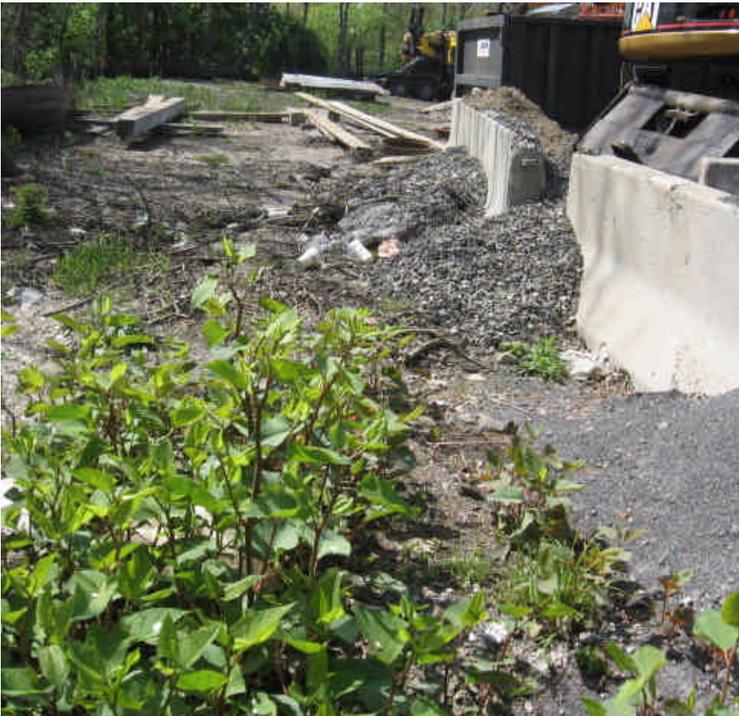
A contractor lay-down yard is located off of Imperial Ave. in Westport. Stockpiles of materials remain contained to the yard at this time but were overflowing beyond the storage bins. 5/10/07	See erosion control section. Continue to monitor piles for stability and containment. 5/10/07	NA
	A contractor lay-down yard is located within Sherwood Island State Park. Multiple controls were used to stabilize the yard from the beginning. 5/10/07	See Erosion Control section for more details. Continue to monitor the one stormwater discharge point. 5/10/07	NA
Soils	No significant issues with tracking or soil storage were observed at this time. 5/10/07	Continue to restore exposed soils when feasible and mitigate for dust as necessary. See erosion control section.	NA

Both photos were taken in the Imperial Ave. lay-down yard. Left: Materials are overwhelming their containment areas but remain within the yard. Right: Sediment accumulation/drainage patterns were noted within the yard. Continue to prevent the migration of the sediment towards the nearby resource area.

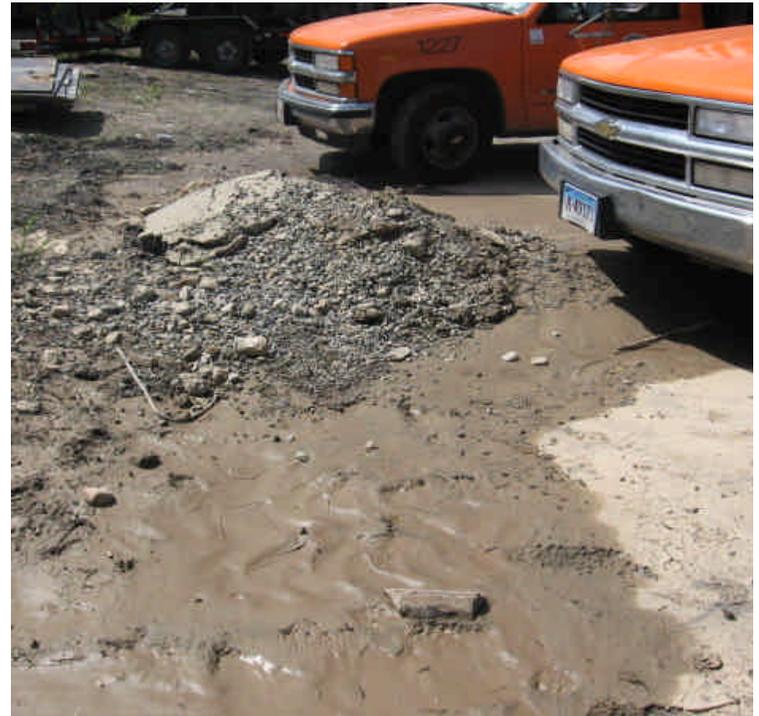
<p>Sediment accumulation/drainage patterns were observed in the yard from a small soil pile in a direction towards the adjacent resource area.</p>	<p>Soil pile could be proactively removed or relocated to a contained location to prevent migration towards the adjacent resource area.</p>	<p>No issues noted but proactive attention could be provided.</p>

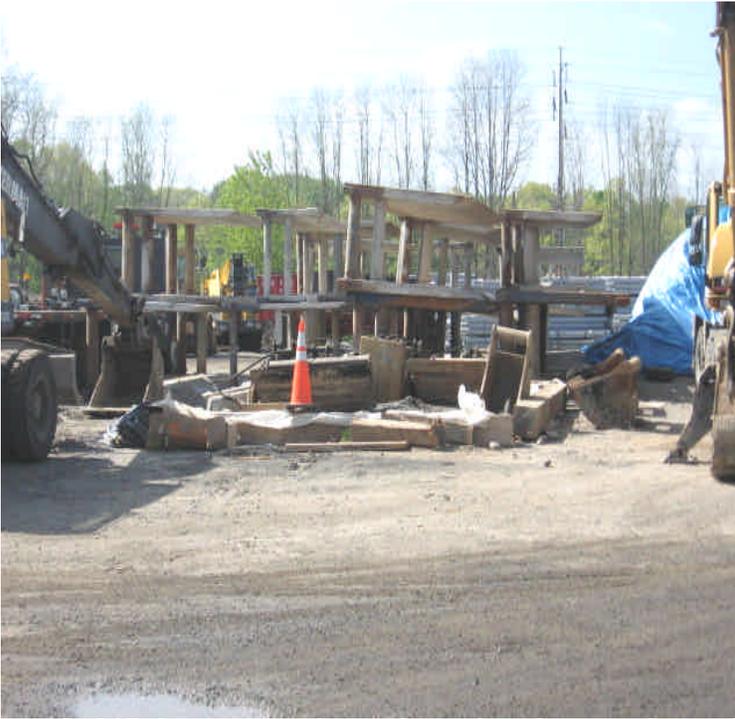
King's Highway Lay-down Yard

Fluid filled equipment is being adequately and proactively stored in a lined containment area.

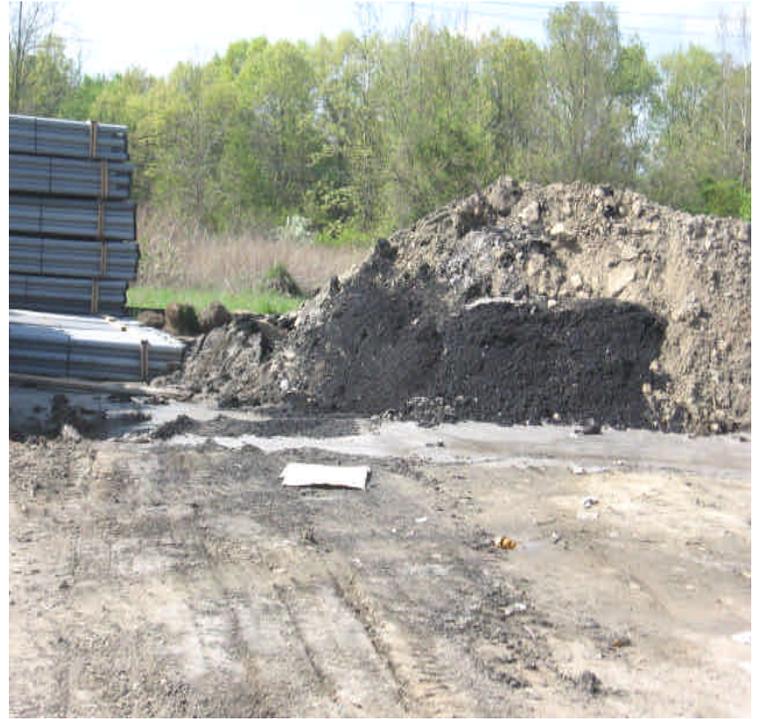
<p>Concrete washout or slurry was deposited in an uncontained location. 5/10/07</p>	<p>Properly dispose of the observed material and provide containment for future washouts. 5/10/07</p>	<p>Needs attention</p>
Sherwood Island lay-down yard	<p>Silt fence has been overwhelmed by soil/materials in one location along the perimeter of the yard. 5/10/07</p>	<p>Pull the material back into the yard and repair the compromised erosion controls. 5/10/07</p>	<p>Needs attention</p>
	<p>The only stormwater discharge point has been controlled well with haybale and silt fence barriers. 5/10/07</p>	<p>Continue to monitor the controls and reinforce or adjust as necessary. 5/10/07</p>	<p>NA</p>
Imperial Ave lay-down yard	<p>Sediment tracking at the yard's entrance was negligible during this week's inspection. 5/10/07</p>	<p>Continue to maintain stone construction access pad if necessary and/or sweep sediment from roadway on a regular basis. 5/10/07</p>	<p>No issues noted but needs regular attention.</p>

Slurry or concrete washout was deposited in an uncontained location within the yard. Concrete washout should occur in a proper containment area.

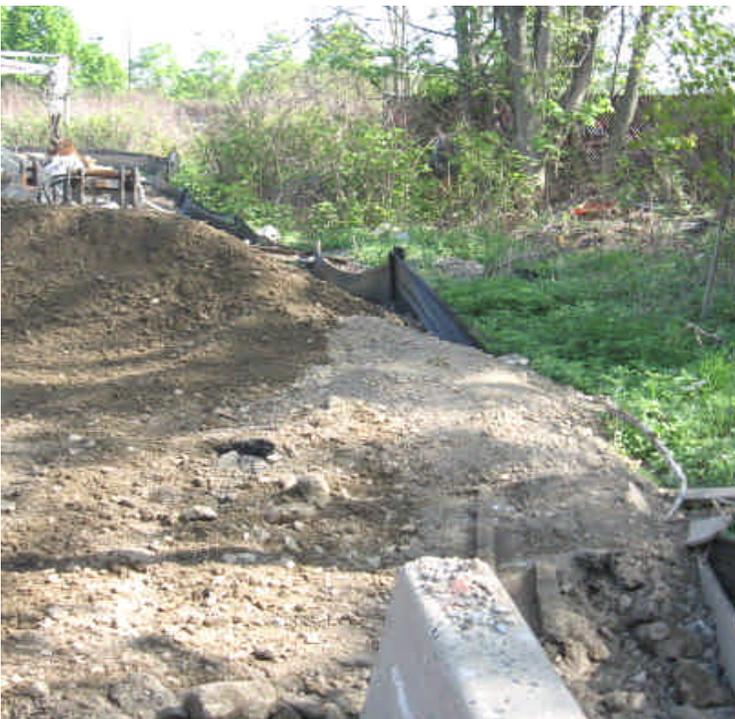
Material is overwhelming the perimeter controls in one location. Pull the soil back and restore the controls.

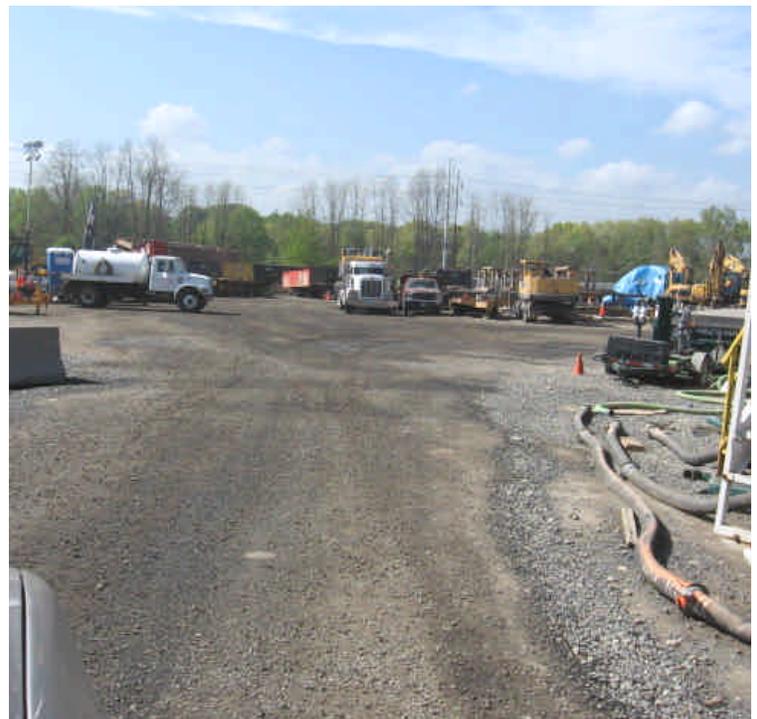
Calcium chloride has been applied to the yard in an effort to prevent dust migration proactively.
