Docket No. 272 – Development and Management Plan Inspection

Scovill Rock Switching Station Inspection

Date: November 21, 2006

Location: Scovill Rock Switching Station

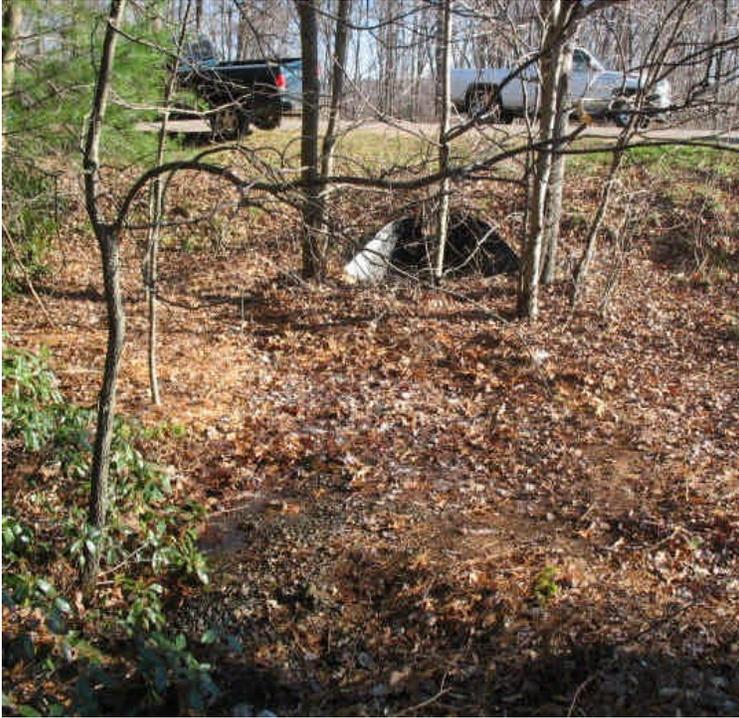
Areas of Inspection	Observation	Recommended Action	Corrected Action
Erosion and sediment controls (continued)	An existing culvert located off site under the access driveway had some stormwater flow but no sedimentation issues. 11/21/06	Closely monitor any work done on the access driveway above the culvert. 11/21/06	NA
Inland Wetland and Watercourse encroachment and mitigation	Wetlands located to the south and northeast remain unaffected by site work. 11/21/06 The haybale lines at the storm drain outlet are degraded and can be removed as all soil disturbance on site is complete and no water has been documented leaving the pipe since the start of construction. 11/21/06	Continue to monitor the storm drain pipe outlet during rain events. 11/21/06 Remove haybales when feasible. 11/21/06	NA NA
State species of concern, threatened and endangered species.	According to the D&M plan, state-listed species are not located in this work area.	None	NA

Water was noted flowing through the culvert under the access drive due to the recent rains. Sediment issues were not observed.

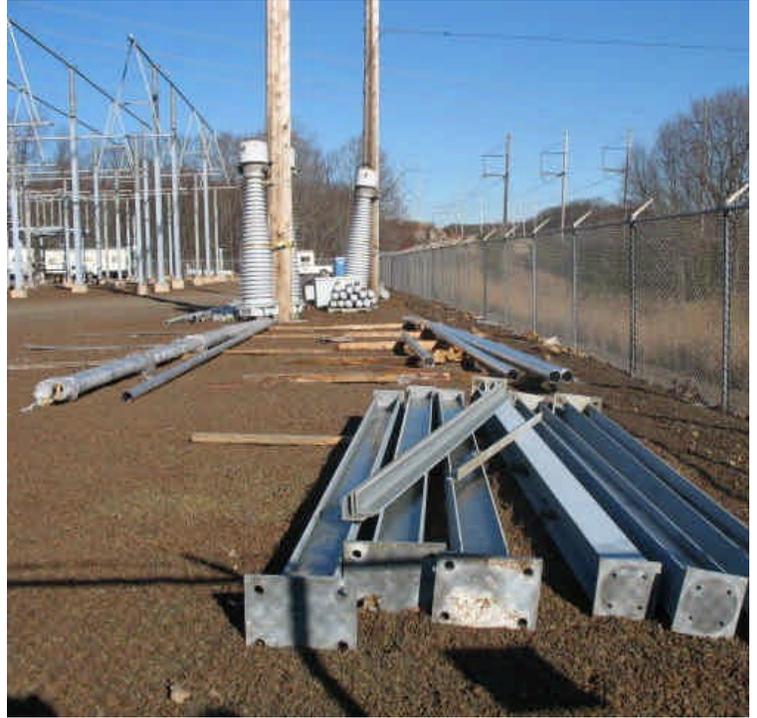
Silt fence was removed from the perimeter of the yard and the site is stable. Soil-disturbing work on site is complete at this time.

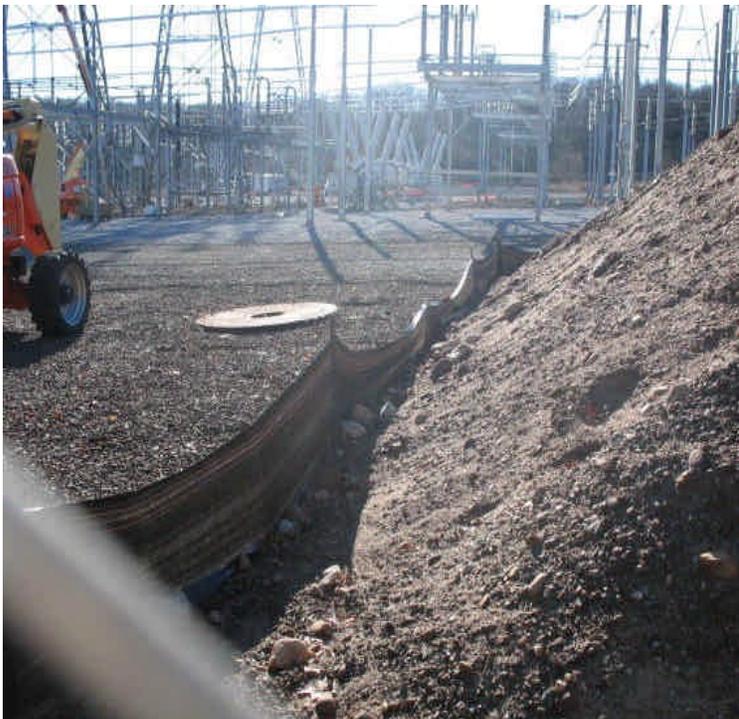
Only one stockpile remains within the yard. The stockpile is surrounded by silt fence and a flat stone surface. It will be removed from the site as soon as possible. 11/7-11/21/06	Once soil analysis is complete, remove soil and dispose of properly. Soils are contained within the yard. 11/21/06	Silt fence remains around the remaining soil stockpile.

The remaining soil stockpile is surrounded by silt fence.

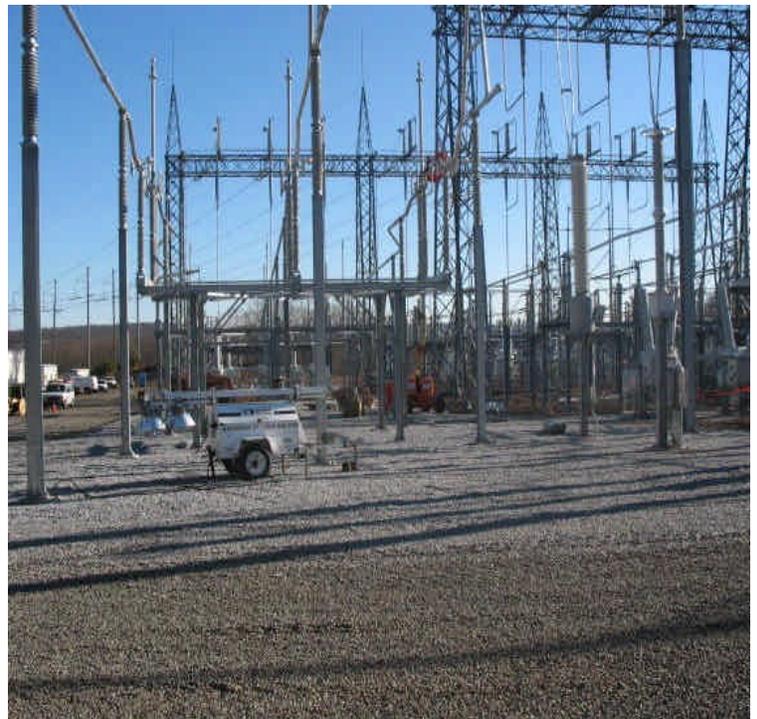
Work continues on structures.
