Docket No. 272 – Development and Management Plan Inspection

Segment 4a Underground Line

Date: November 20, 2006

Location: Singer Substation to Fairfield/Westport Town Line

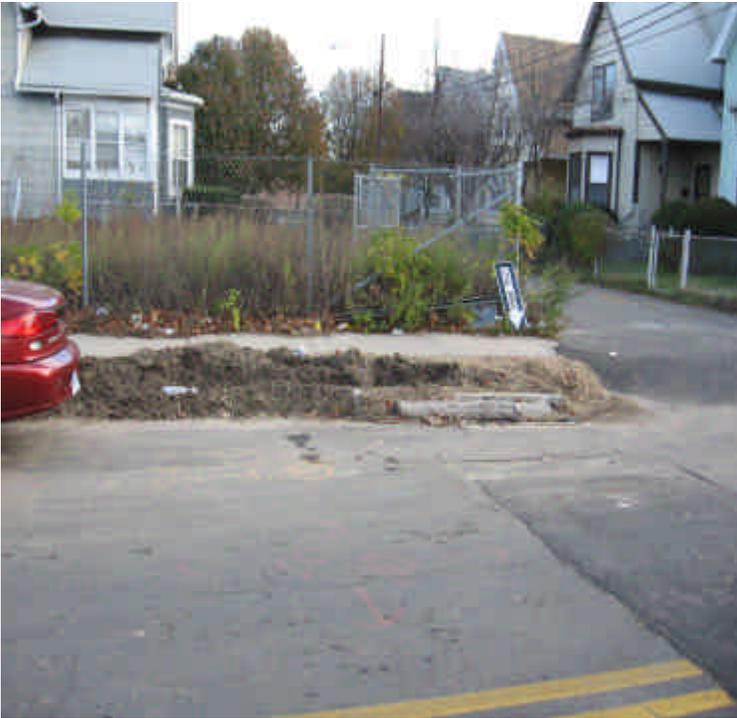
State species of concern, threatened and endangered species.	<p>According to the D&M plan, state-listed species are not located in this work area. 11/20/06</p>	<p>None 11/20/06</p>	<p>NA</p>
Vegetative clearing (including trees to save or danger trees noted) or stabilization	<p>A tire rut was noted in the shoulder of Broad St. Most other recently disturbed areas have been seeded or mulched along the shoulders of the roadway. 11/20/06</p> <p>Four ornamental plum trees were removed from the Vault #7536 location. 11/01-11/20/06</p>	<p>Continue to place mulch or other temporary stabilization on exposed surfaces. 10/27- 11/20/06</p> <p>Stabilize/restore area when appropriate. 11/20/06</p>	<p>NA</p> <p>Needs attention when work is complete.</p>
Dewatering	<p>Water from trench work is filtered by frac tanks and released appropriately to the sanitary</p>	<p>Continue to monitor 11/20/06</p>	<p>The pipe inlet had some controls in place.</p>

**Photo of tire rut from a vehicle on the shoulder of Broad St.
Repair when feasible.**

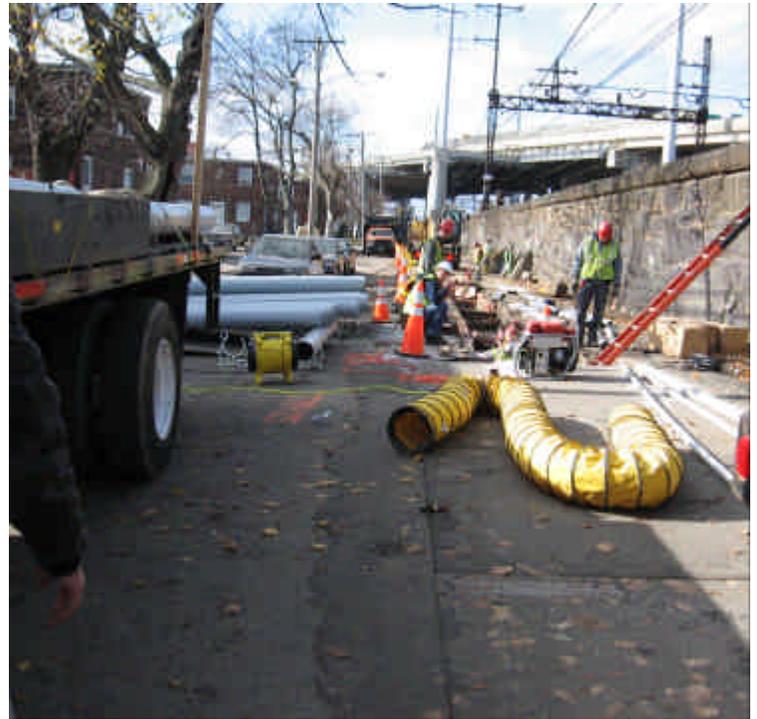
**Photograph of trenching activities located on Railroad Ave.
between South St. and Park St.**

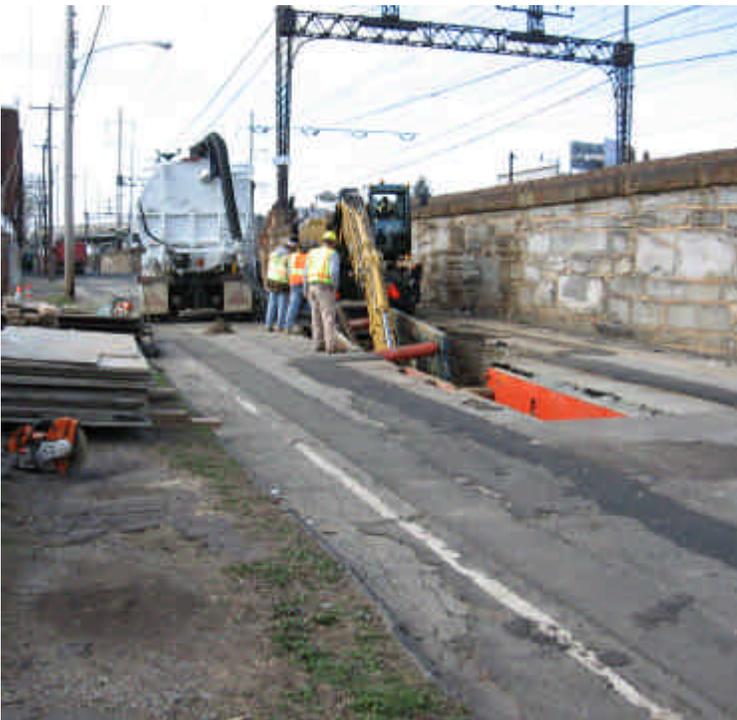
**Trenching activities on Railroad Ave. between Park St. and
Myrtle St. Vac truck being used to help excavate soil from trench.**

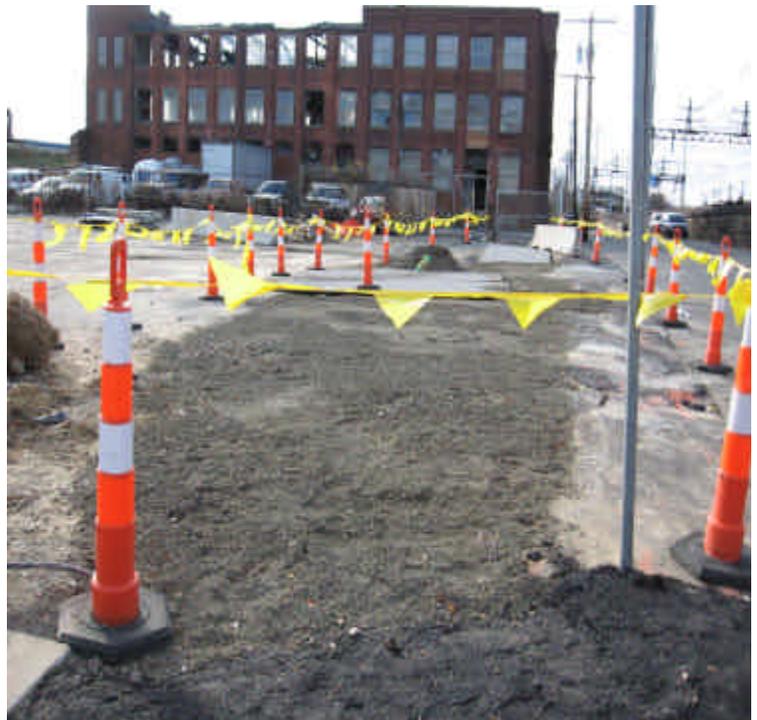
**Trenching activities at the intersection of Railroad Ave. and
Bostwick Ave. The majority of the trench is closed.**

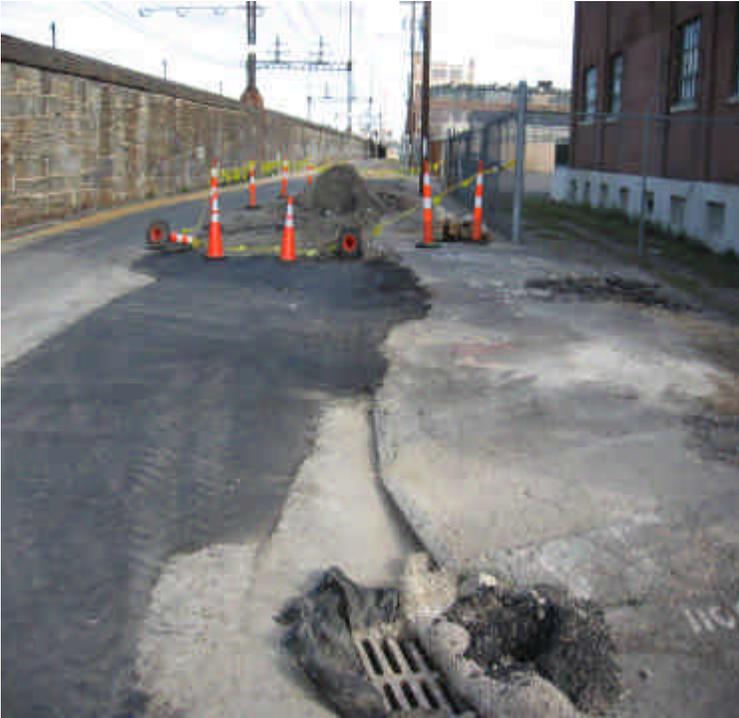
Areas of Inspection	Observation	Recommended Action	Corrected Action
Access Roads and Adjacent Roadways	<p>All work is within or adjacent to existing paved roadways at this time.</p> <p>The catch basin located at the intersection of Railroad Ave. and Bostwick Ave. appears to have been repaired or stabilized following a partial collapse last week. 11/20/06</p>	<p>See erosion control section.</p> <p>Continue to evaluate if further repairs are necessary. 11/20/06</p>	<p>Not Applicable (NA)</p> <p>The structure appears to be stable.</p>
Vault Openings and Trench Construction Bridgeport	<p>Trenching activities continue: on Railroad Ave. between Iranistan Ave. and South Ave; near the intersection of Railroad Ave. and Bostwick Ave.; near the intersection of Broad St. and Atlantic Ave.; and in the portion of land between Broad St. and Main Ave. 11/20/06</p>	<p>Continue to monitor and be proactive. Continue to mulch/ temporarily stabilize areas as they are completed. Continue to sweep roadways as soon as feasible. 11/20/06</p>	<p>Catch basins are protected.(Proactively)</p>

Photo taken on Railroad Ave. at the intersection with Bostwick Ave. Soil pile in background should be controlled if it will remain. The catch basin in the foreground appears to have been repaired following partial collapse last week.

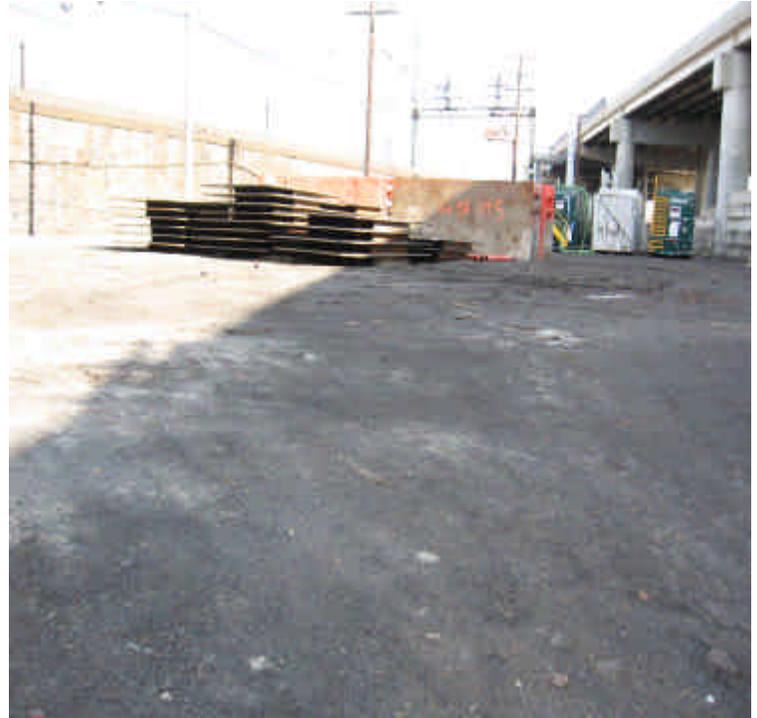
Photo of the Iranistan Ave. temporary storage yard. The soil pile previously located in yard has been removed.

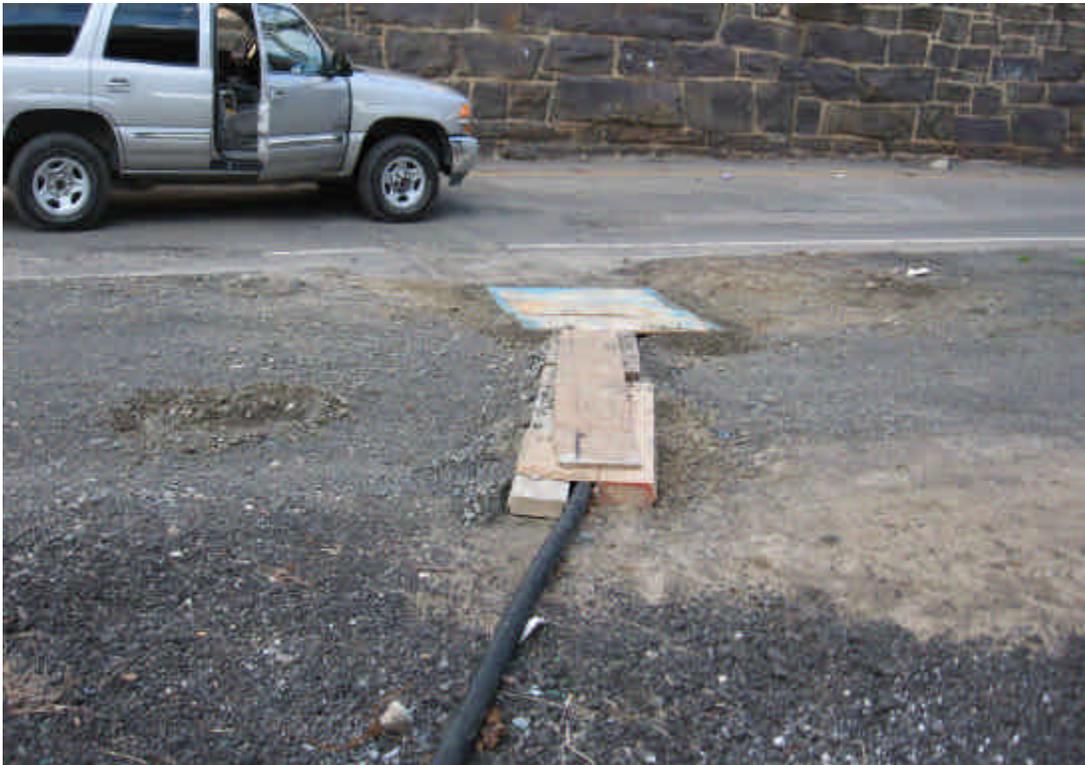
Areas of Inspection	Observation	Recommended Action	Corrected Action
	sewer system via PVC pipe. Attempts have been made to protect the pipe inlet and prevent sediment from readily entering the system 11/20/06		
Blasting	No blasting has been proposed. 11/20/06	None 11/20/06	NA
Spills and Material Storage	<p>Spill cleanup materials/kits were observed in the storage yard and on job trucks. 11/20/06</p> <p>Excavated railroad ties are piled up and stored off the roadway to be removed from the site. 8/17- 11/20/06</p> <p>The equipment attachment containment area located along the western boundary of the laydown yard was not fully enclosed. 11/08- 11/20/06</p> <p>The material pile located on the side of the yard adjacent to the resource area was being relocated during inspection. 11/20/06</p>	<p>None 11/20/06</p> <p>None 8/17-11/20/06</p> <p>Continue to improve and enclose the containment area. 11/15- 11/20/06</p> <p>Continue to monitor this side of the yard for improvements to storage. 11/20/06</p>	<p>NA</p> <p>Removal of ties continues.</p> <p>Needs attention when feasible.</p> <p>Material was being moved.</p>

Water from the trench work is filtered in frac tanks and then discharged appropriately to the sanitary sewer system via PVC pipe. Attempts have been made to protect the inlet so that sediment will not readily enter the system.

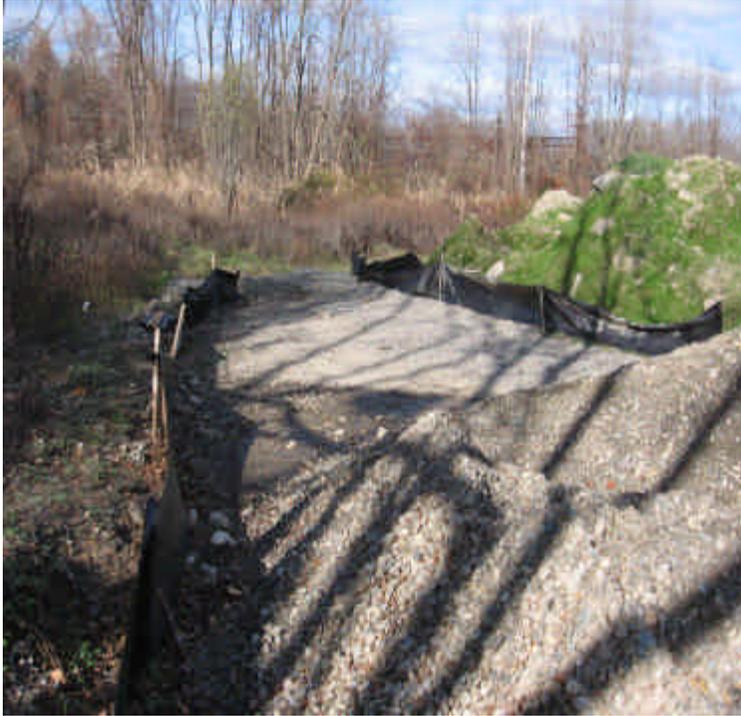
Perimeter fence along the majority of the yard has been restored. Please note that vegetative cover is establishing on the soil stockpile shown in the right top corner of the photo.

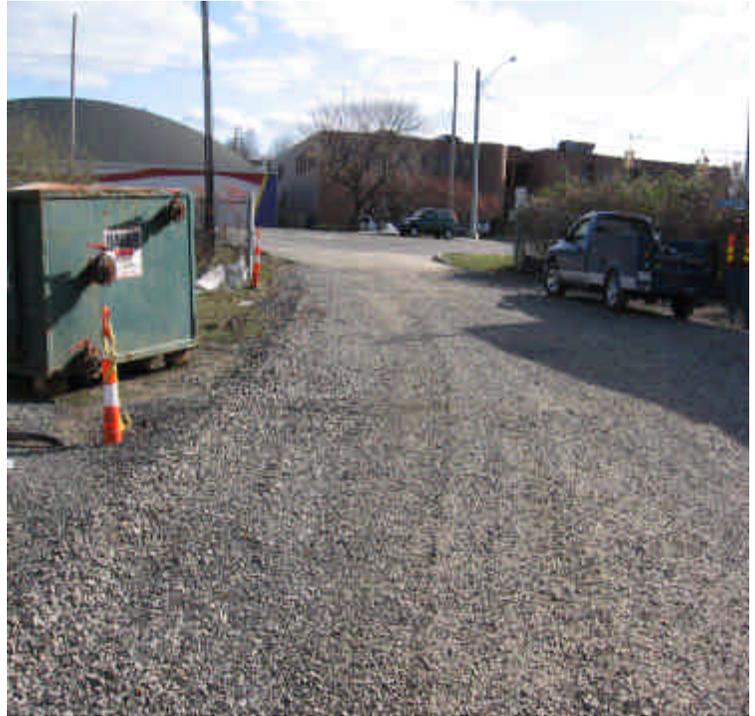
Construction entrance stone has been refreshed and no notable tracking was observed during the inspection.

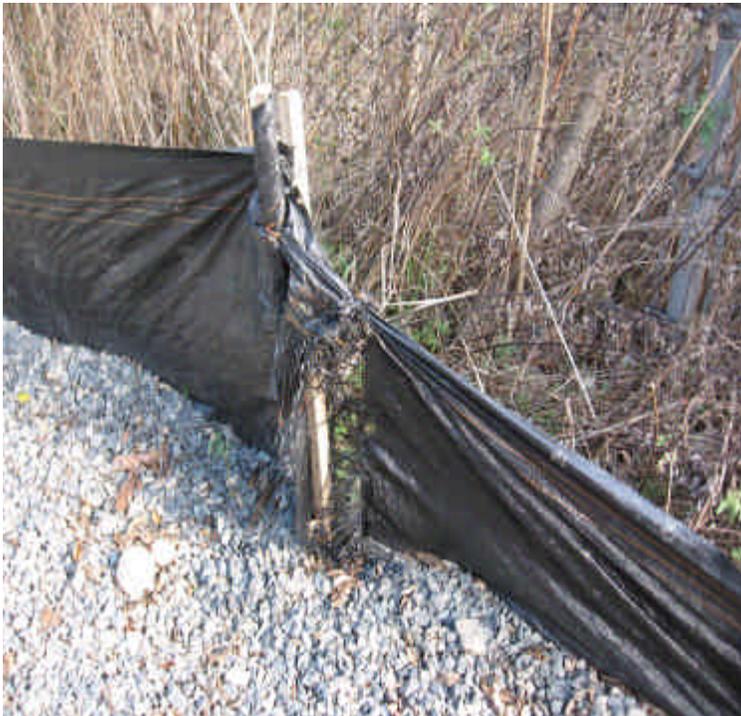
Photo of a portion of the perimeter fence, on the side of the yard adjacent to resource areas, which is in need of repair.

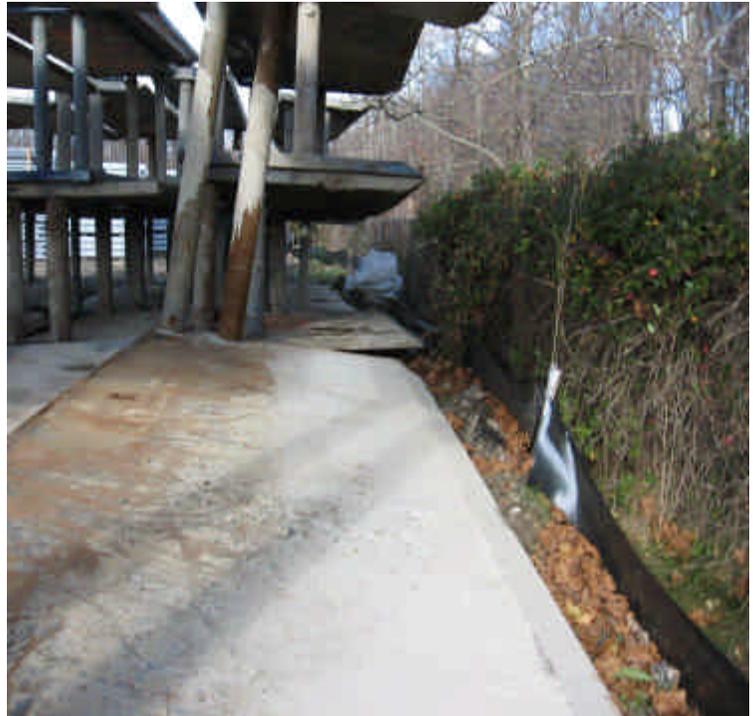
A pile of plastic materials was placed on the perimeter silt fence on the side of the yard adjacent to resource areas. Pull the materials back to restore the controls.

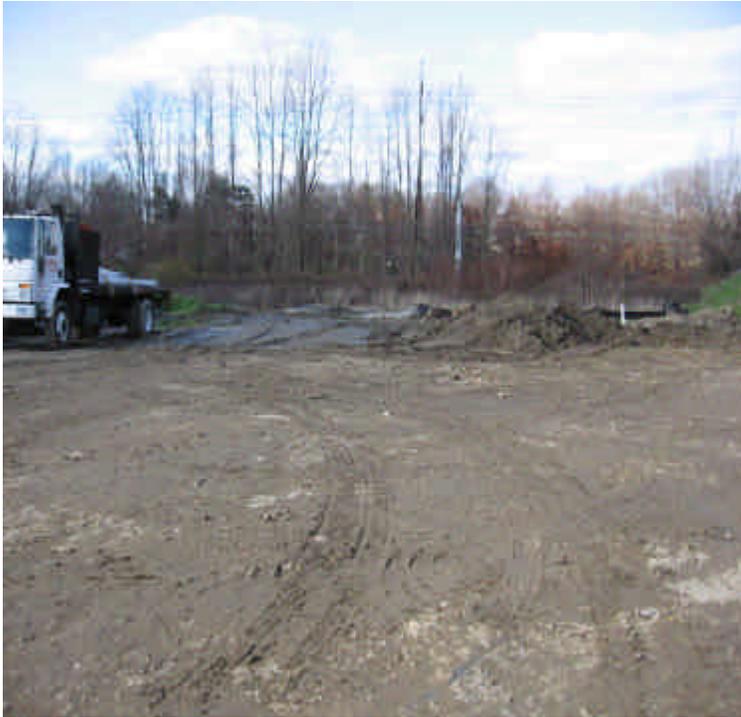
Former location of the concrete washout basin. Area was being re-worked/graded during the inspection.

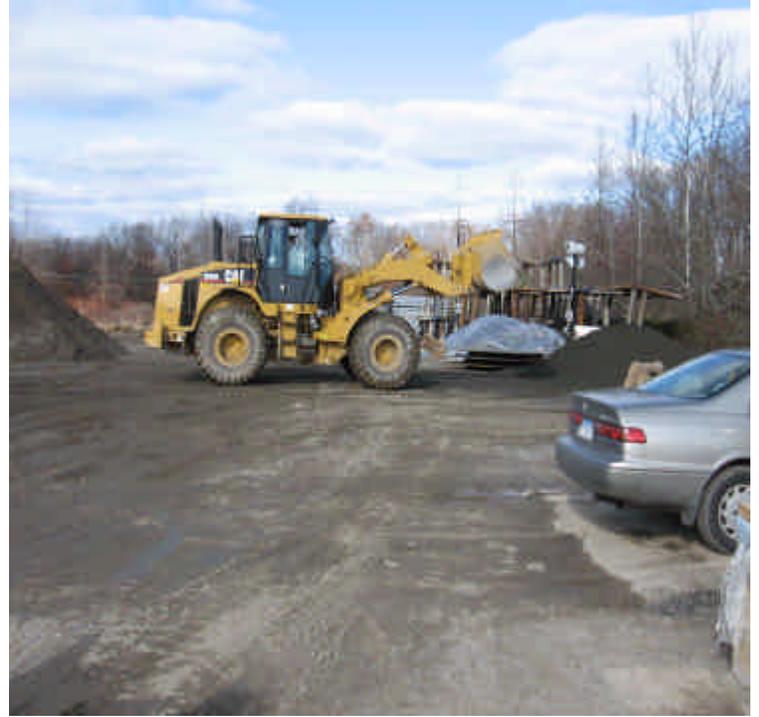
The stockpile of material (stone dust) located on the side of the yard adjacent to resource areas is being moved back.

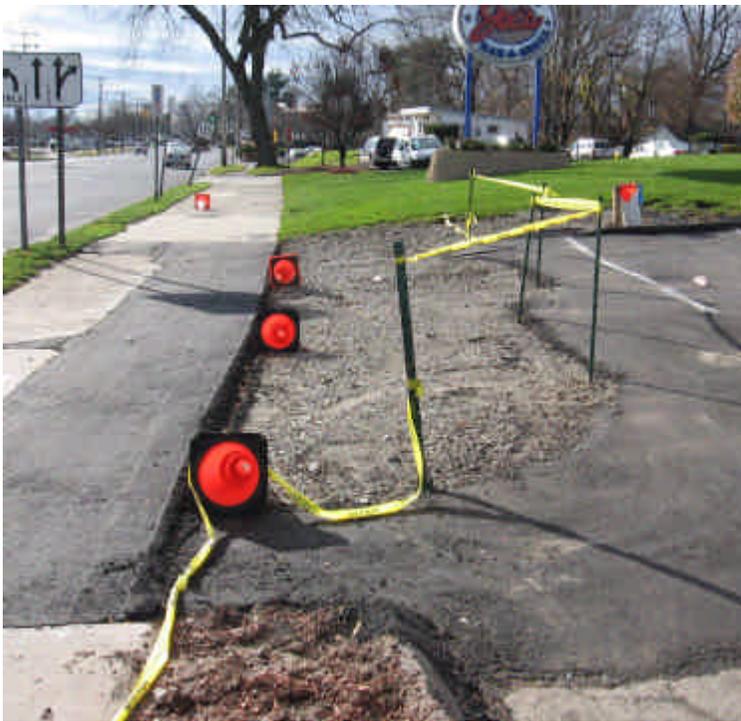
Photo of Vault # 7536 installation activities. Following the rain, it was observed that the remaining exposed soil is a stable, hard material. No additional stabilization is required.

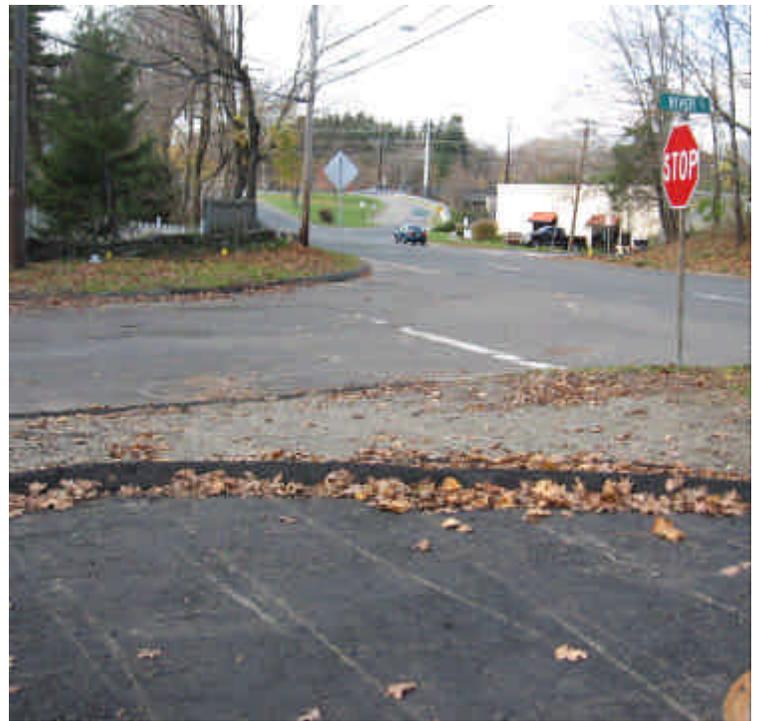
Photo of Vault #5430 installation activities. The exposed soils here are also of a similar hard pack material and no additional stabilization is required.
