**Docket No. 272 – Development and Management Plan Inspection**

**Segment 4b Underground Line**

**Date:** November 20, 2006

**Location:** Fairfield/Westport Town Line to Westport Avenue in Norwalk

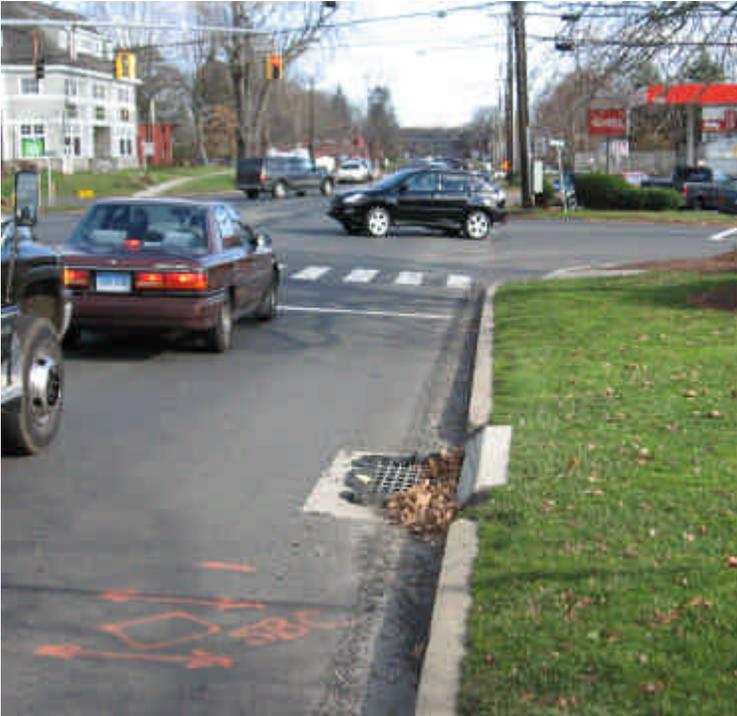
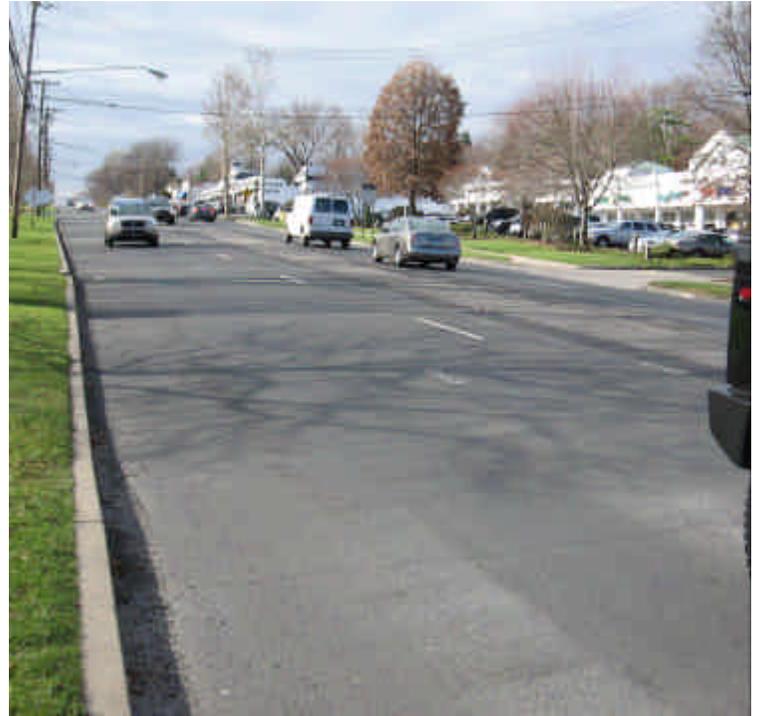
**Both photos taken on Rt. 1 near the Buckley Ave. intersection.  
Trenching activities continue and all catch basins have been protected as necessary.**

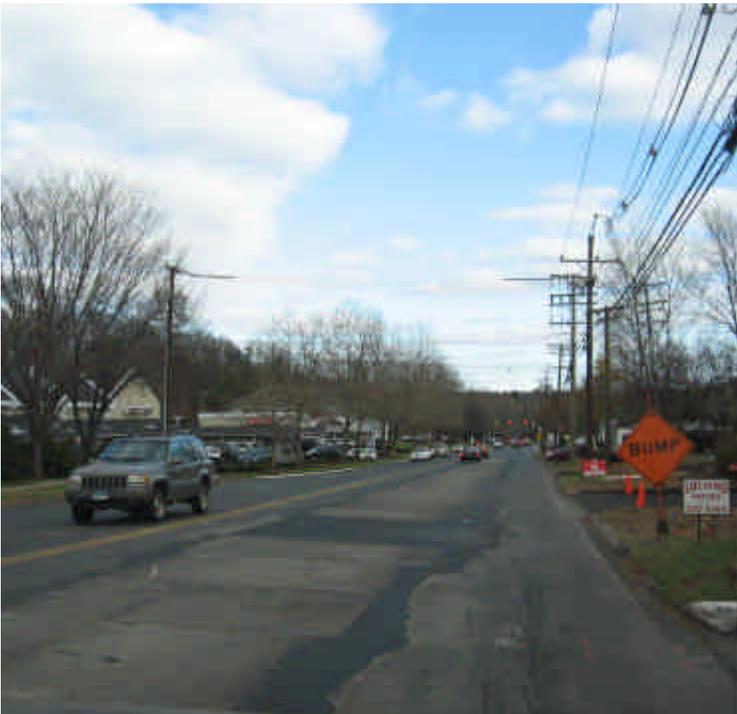
**Photo taken of the trenchwork located along Rt 1 near the  
intersection with Wakenor Rd**

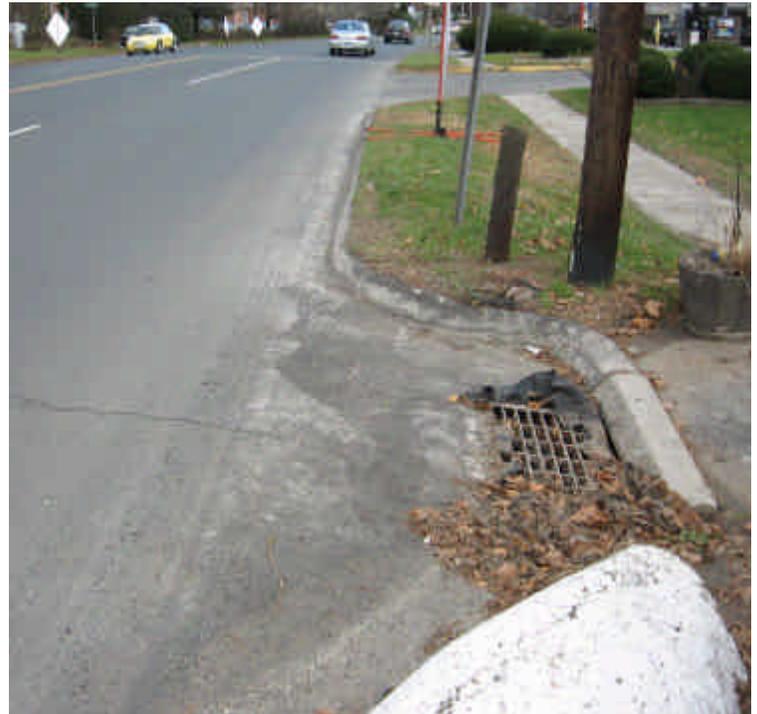
**Protected catch basin located downgradient of construction  
activities on Rt. 1 near Church St. Other unrelated  
construction activities are occurring in the area, resulting in  
additional sediment**

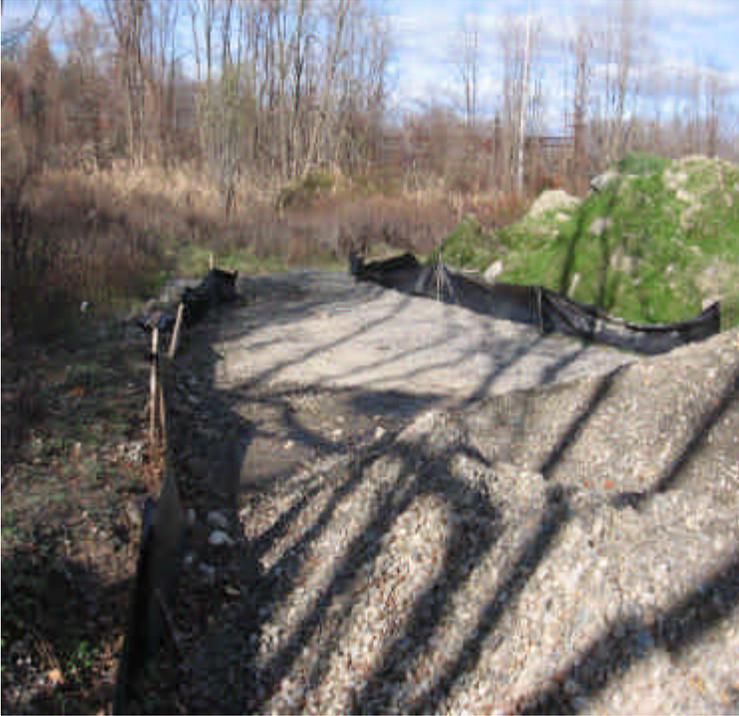
**Perimeter fence along the majority of the yard has been restored. Please note that vegetative cover is establishing on the soil stockpile shown in the right top corner of the photo.**

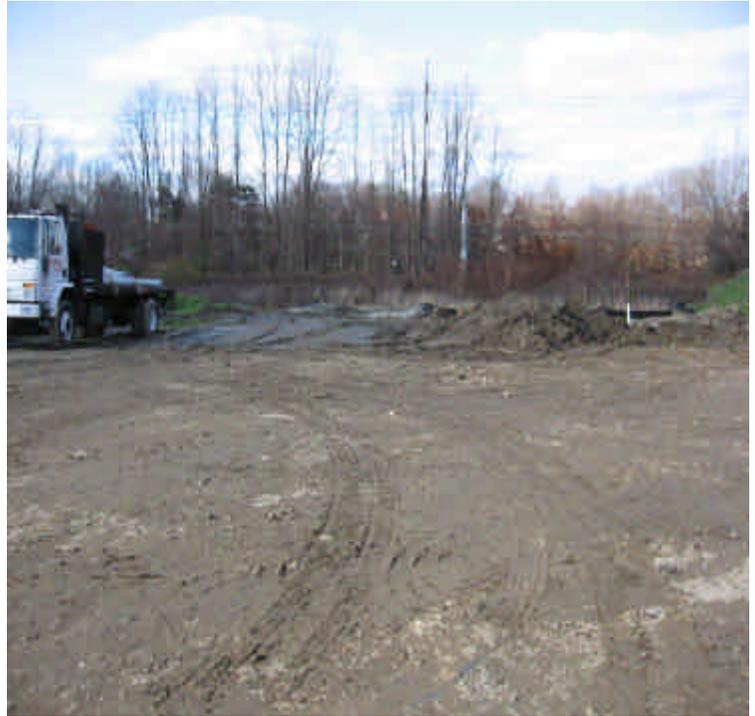
**Former location of the concrete washout basin. Area was being re-worked/graded during the inspection**

Kings Highway Lay-down Yard (Off Kings Highway, near Rt. 1	The entire washout basin area was being re-	Continue to maintain washout area as	The area was being worked.

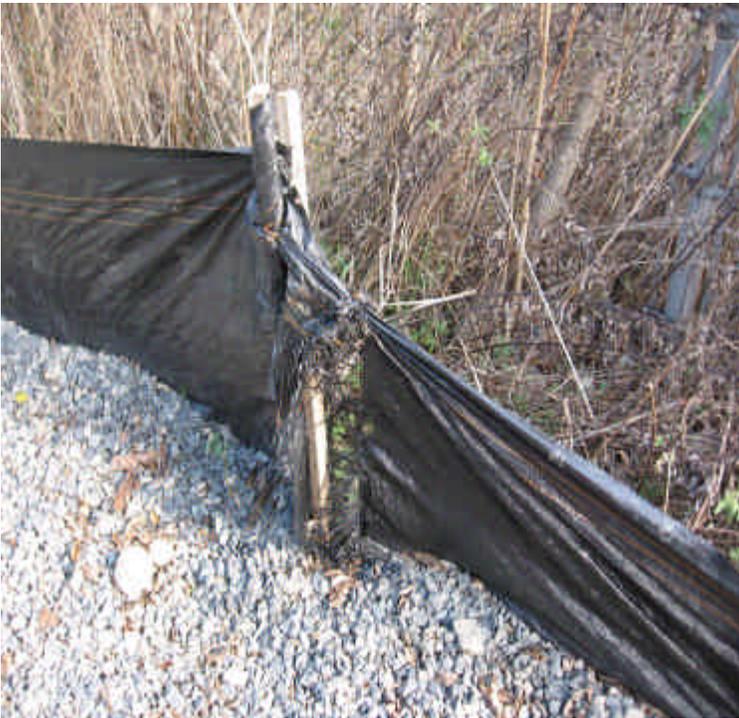
**Photo of a portion of the perimeter fence, on the side of the yard adjacent to resource areas, which is in need of repair. In another spot, materials were placed on the fence pushing it down.**

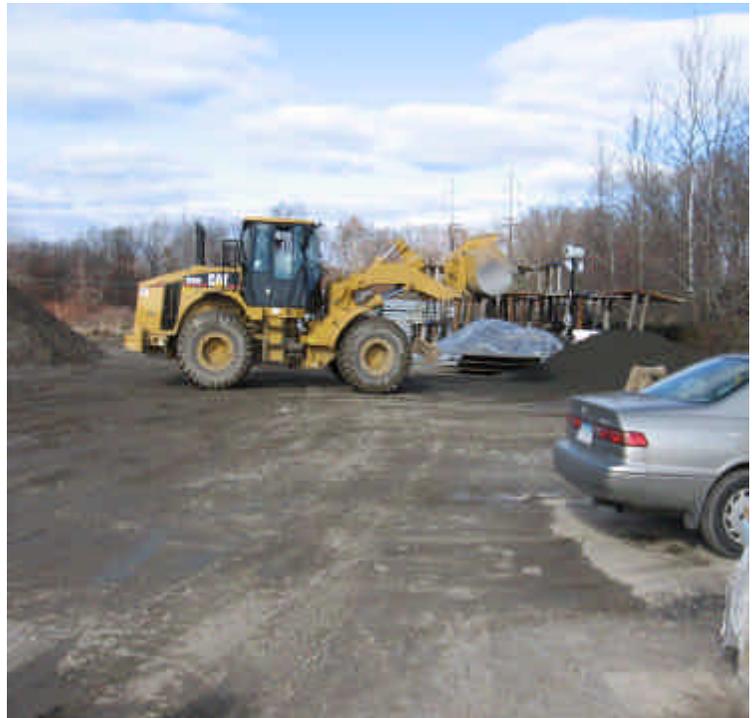
<b>The material pile located on the side of the yard adjacent to the resource area was being relocated during inspection. 11/20/06</b>	<b>Continue to monitor this side of the yard for improvements to storage. 11/20/06</b>	<b>Material was being moved.</b>
<b>Additional Observations</b>	<b>None 11/20/06</b>	<b>None 11/20/06</b>	<b>NA</b>

**The stockpile of material (stone dust) located on the side of the yard adjacent to resource areas is being relocated.**
