Docket No. 272 – Development and Management Plan Inspection

Segment 4b Underground Line

Date: November 29, 2006

Location: Fairfield/Westport Town Line to Westport Avenue in Norwalk

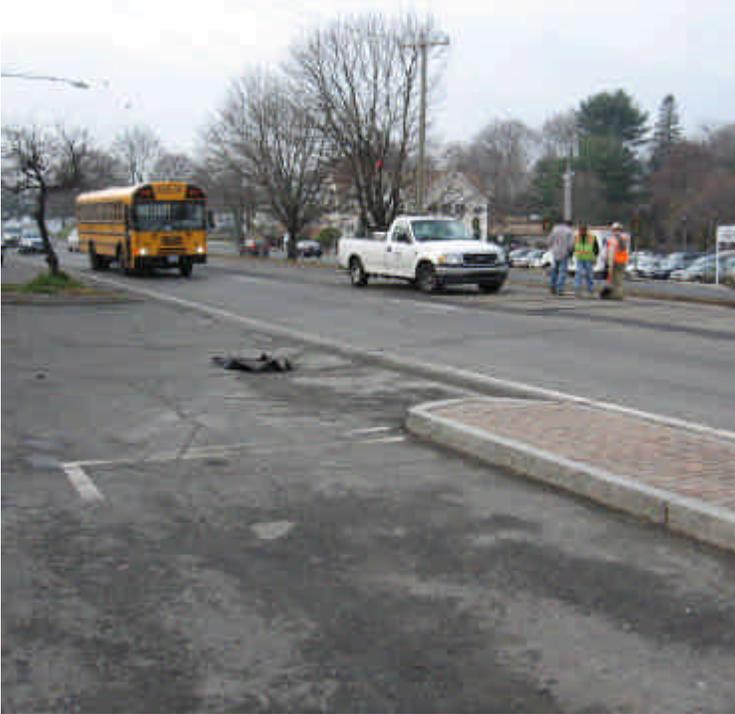
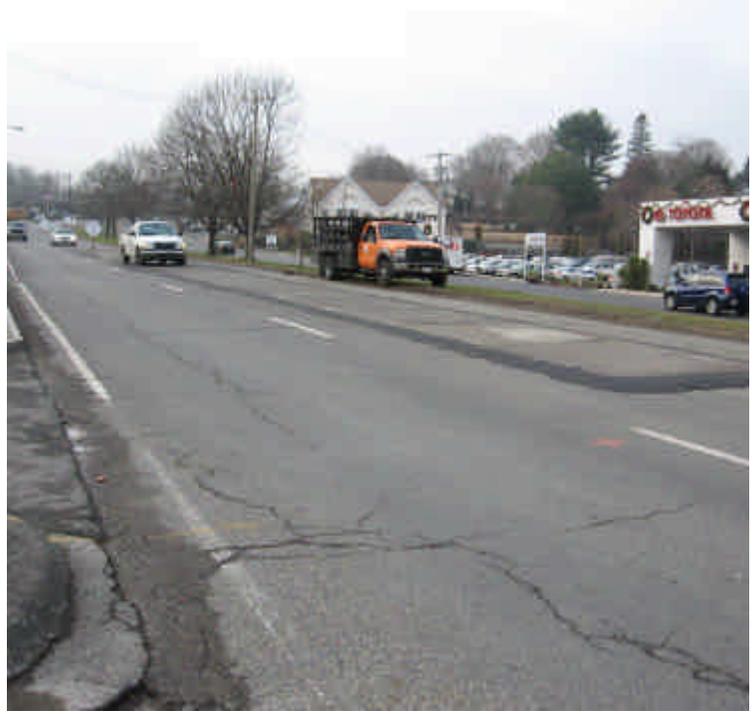
**Both photos taken on Rt. 1 between Hillspoint Rd. and Long Lots Rd.
Trenching activities continue and all catch basins have been protected as necessary.**

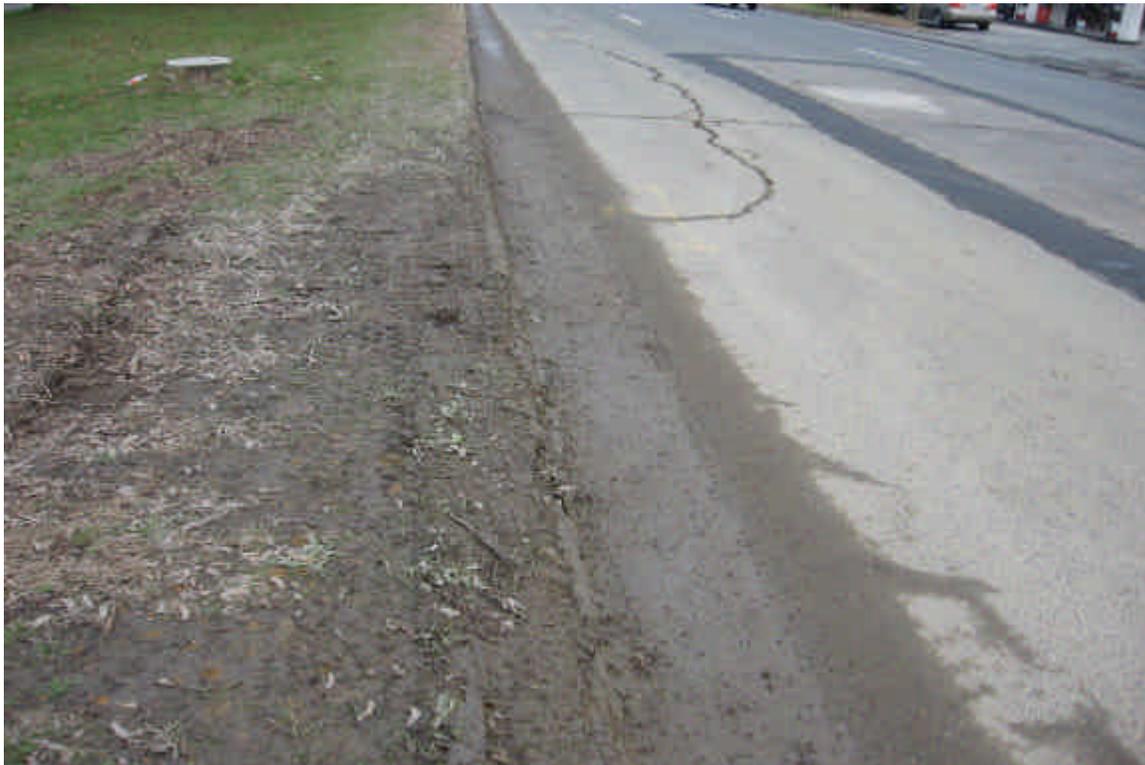
Attempts were made to sweep the slurry created by sawcutting activities, but an accumulated layer was noted in the gutters	Clean gutters by hand as necessary. Attending to slurry immediately when it is created may help the situation in the future.	Needs attention when feasible.

Photo taken on Rt. 1 between Hillspoint Rd. and Long Lots Rd. Attempts were made to sweep up slurry created during sawcutting. However, an accumulated layer remains in the gutter which likely needs to be removed by hand. Attending slurry immediately during the work may help this situation.

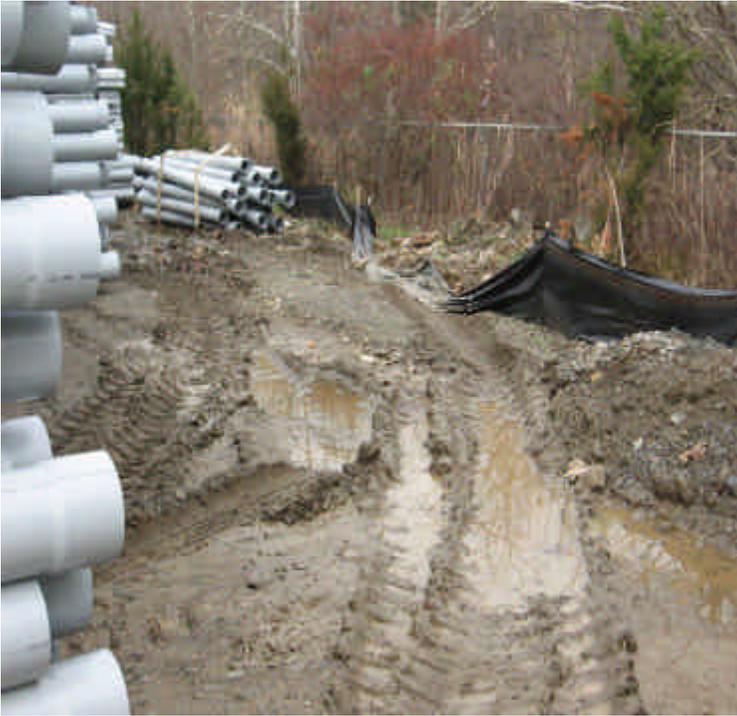
King's Highway Laydown Yard

Photo shows a portion of the perimeter silt fence on the side of the yard adjacent to the sensitive area that is in need of repair.

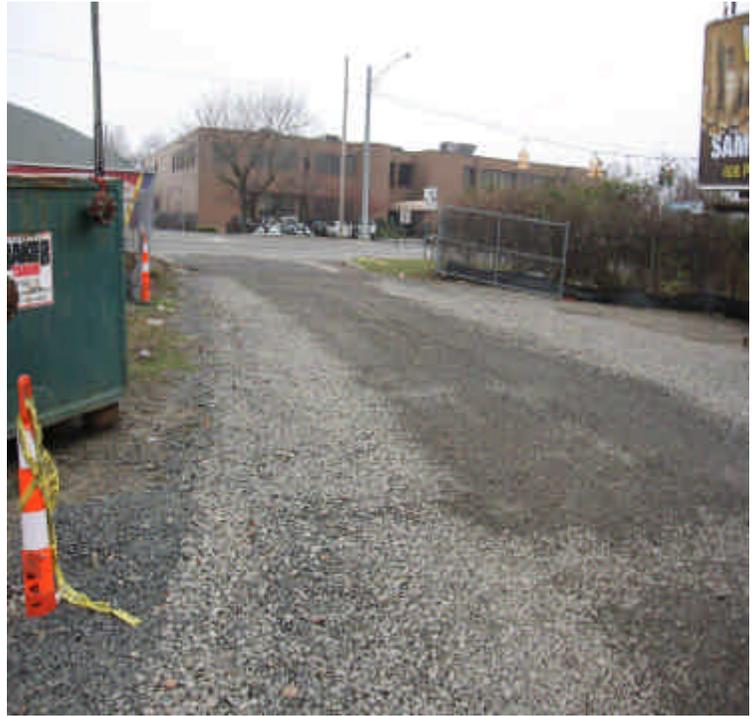
The construction entrance is well maintained and no evidence of sediment tracking was observed.

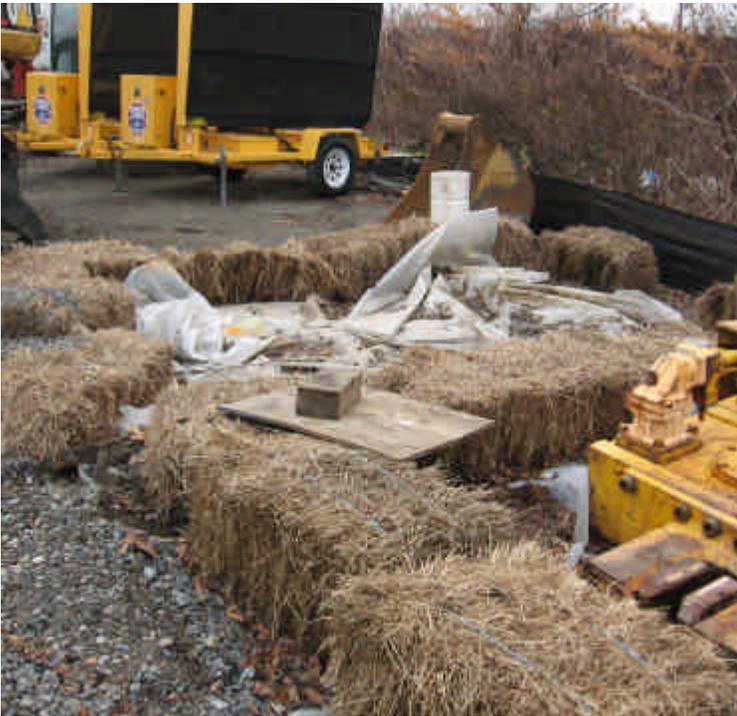
Attachment containment area in western side of the yard is not fully enclosed with controls.
