**Docket No. 272 – Development and Management Plan Inspection**

**Beseck Switching Station Inspection**

**Date:** October 30, 2007

**Location:** Beseck Switching Station

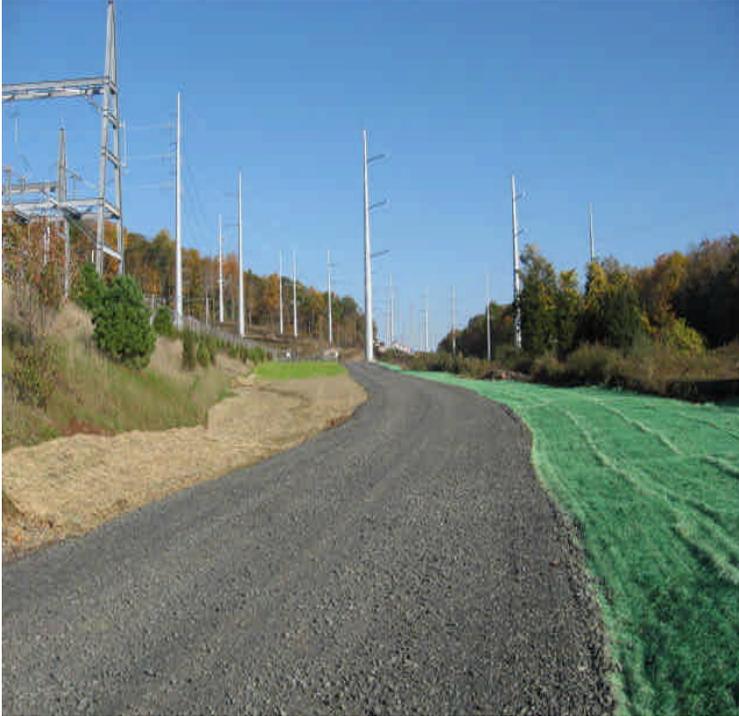
**Eastern side of the site, view from Carpenter Lane. Exposed areas have been covered with seed and erosion control mats.**

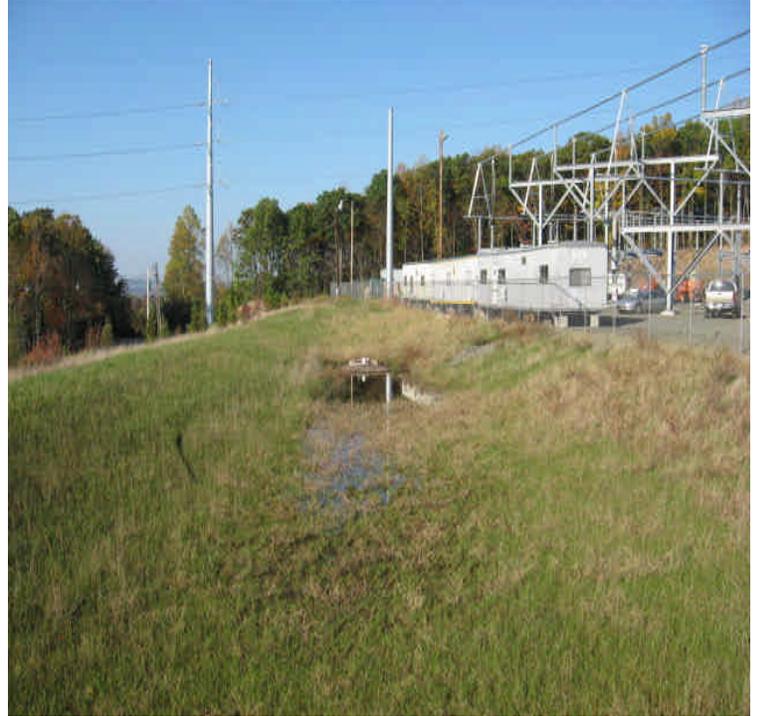
**Clear standing water noted at the drain inlets within the detention basin.**

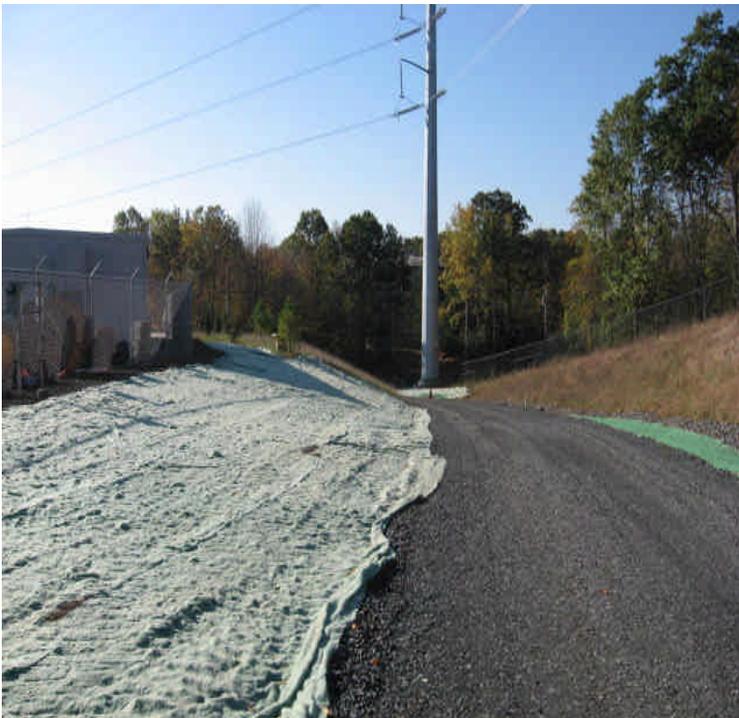
**Road base was installed at final grade and a drainage swale remains along the western access road. Erosion control mats have been installed over exposed soil.**

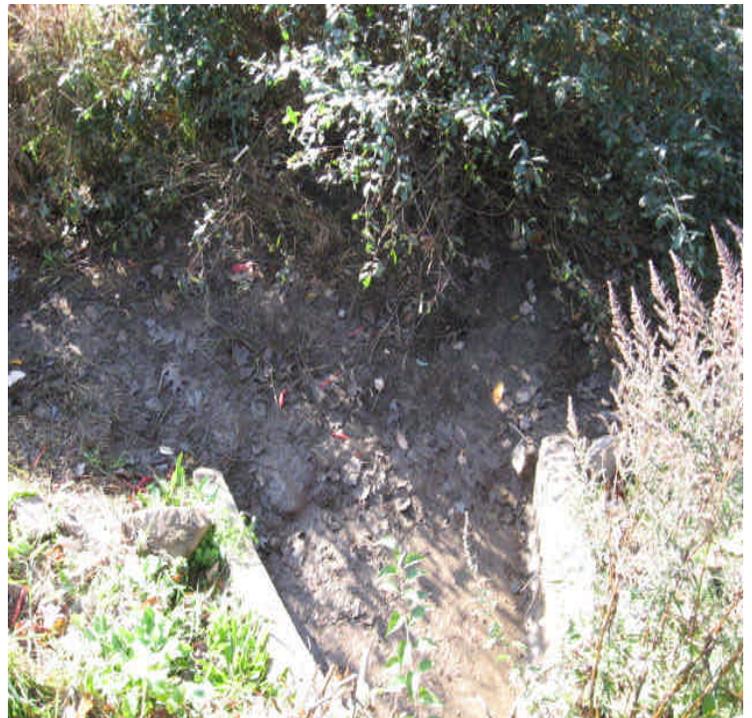
Areas of Inspection	Observation	Recommended Action	Corrected Action
	outlet pipe at the wetland across Carpenter Lane (10/23). Water within the outlet and wetlands was clear. Accumulated sediment from beneath the haybales remains at the outlet. 10/23-10/30/07	filtered by the haybales and deteriorated hay from the wetlands and outlet. 10/23-10/30/07	removal.
<b>Inland Wetland and Watercourse encroachment and mitigation</b>	Haybales have been removed from the outlet and the wetlands across Carpenter Lane (10/23). Sediment accumulation was noted within and around the outlet where the haybales had been. 10/23-10/30/07	Continue to remove all visible sediment from within and around the outlet (and whatever is feasible from within the pipe). Seed the area with a wetland seed mix for final stabilization. Access roads are not fully stabilized/paved, therefore haybales may need to be replaced during heavy rain. 10/23-10/30/07	Replace controls as needed. Sediment needs some additional attention.

**Haybales were removed from the outlet across Carpenter Lane. Effort should be made to remove all visible sediment at the outlet and within the pipe. Seed the disturbed area with wetland mix.**
