Docket No. 272 – Development and Management Plan Inspection

Beseck Switching Station Inspection

Date: November 6, 2007

Location: Beseck Switching Station

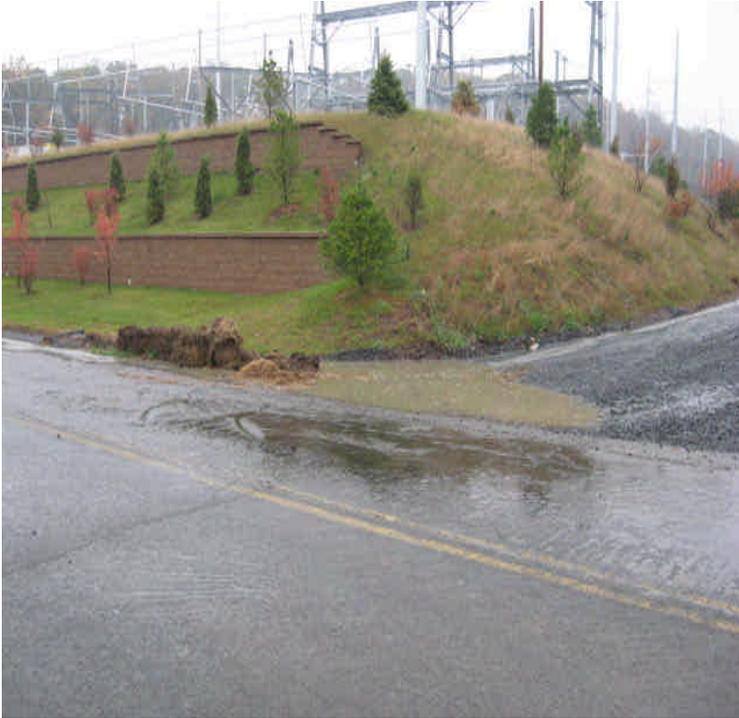
Eastern side of the site, view from Carpenter Lane. Exposed areas have been covered with seed and erosion control mats, however turbid water continues to leave the site during rain events.

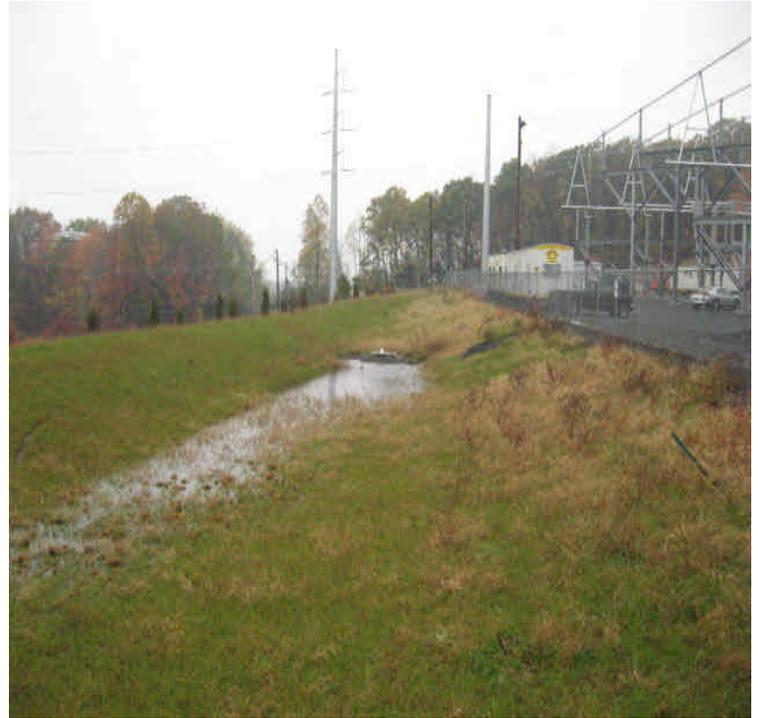
Clear, standing water noted at the drain inlets within the detention basin.

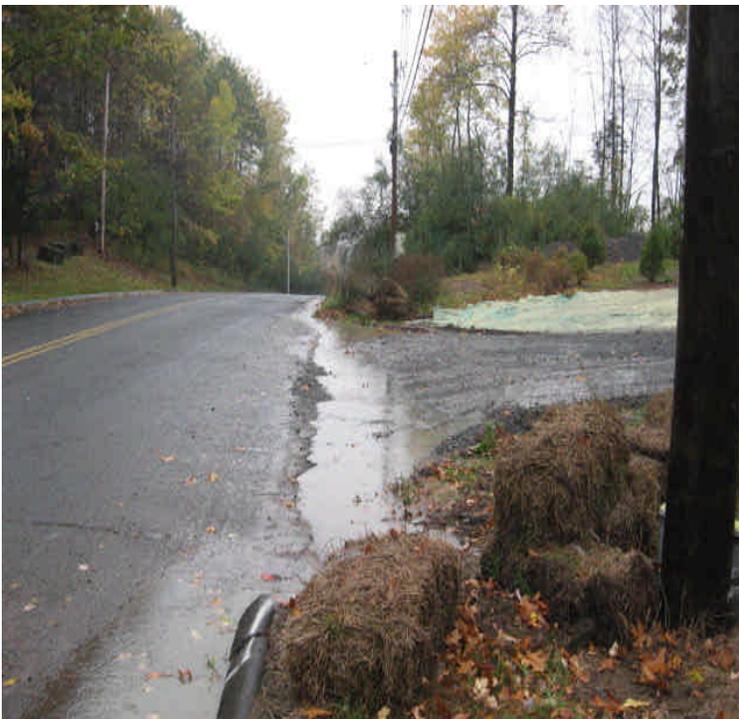
Road base was installed at final grade and a drainage swale remains along the western access road. Erosion control mats have been installed over exposed soil. Turbid water was still leaving the site despite the controls. Replace haybales as needed across all entrances.

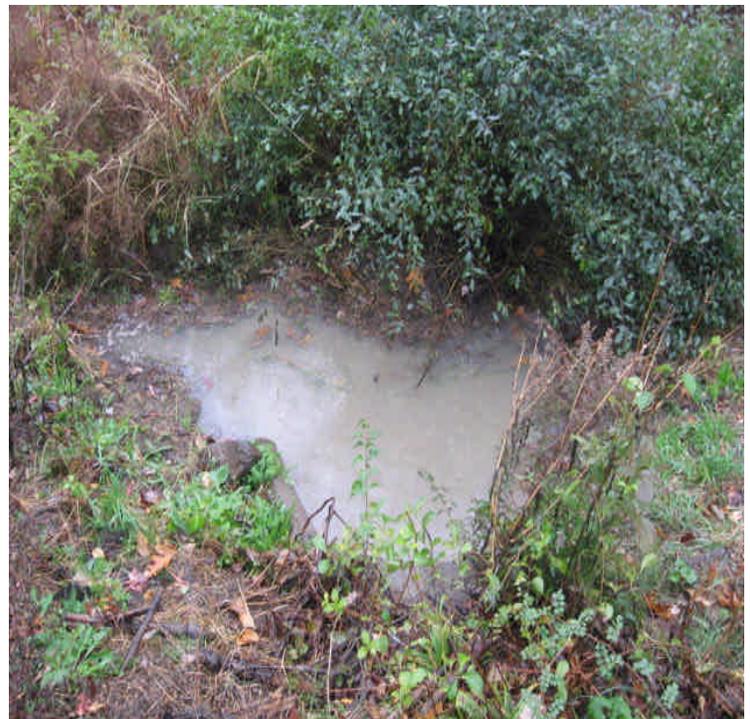
View of the outlet across Carpenter Lane where turbid water was still noted in the wetlands during a rain event. Efforts should be made to remove all visible, settled sediment at the outlet and within the pipe. Seed the disturbed area with wetland mix. Evaluate replacing haybales here until the site has final vegetative cover throughout and there is no further turbid run-off.
