**Docket No. 272 – Development and Management Plan Inspection**

**The Connecticut Light and Power Company Certificate of Environmental Compatibility and Public Need for the construction of a new 345-kV electric transmission line and associated facilities between Scovill Rock Switching Station in Middletown and Norwalk Substation in Norwalk, Connecticut, including reconstruction of portions of existing 115-kV and 345-kV electric transmission line, the construction of Beseck Switching Station in Wallingford, East Devon Substation in Milford, (and Singer Substation in Bridgeport), modifications at Scovill Rock Switching Station and Norwalk Substation, and the reconfiguration of certain interconnections.**

**Segment 1a Inspection**

**Date:** November 5, 2007

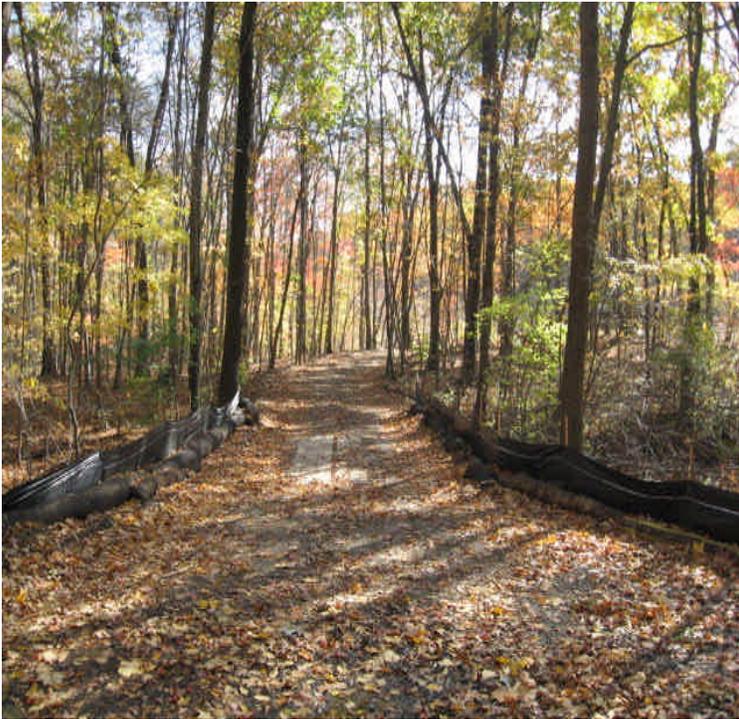
**Shumpike Rd: Controls are in place along a timber mat bridge crossing.**

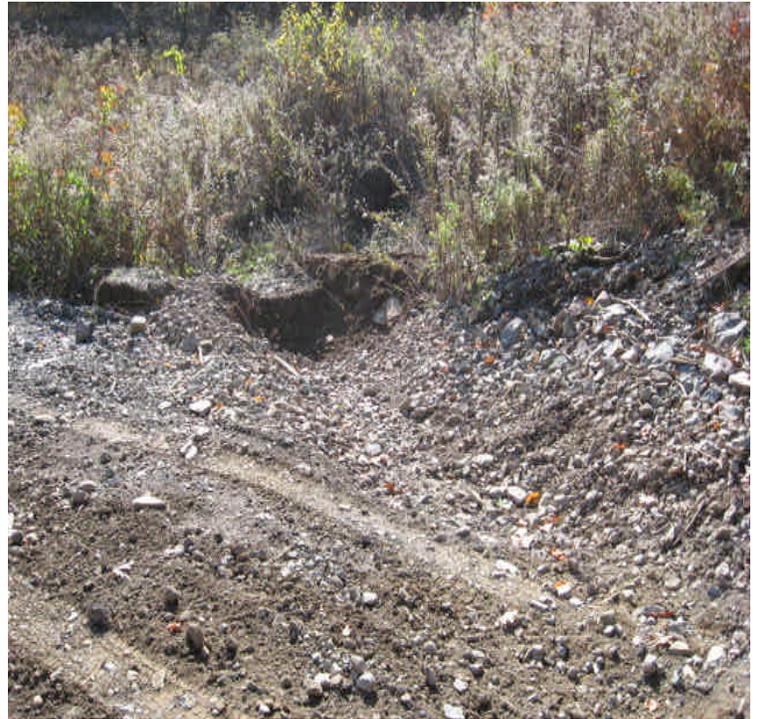
Slight turbidity remains in the wetland following run-off noted at one culverted crossing off Shumpike Rd last week. However, water bars had	Continue to monitor for effectiveness of the diversions and add fiber rolls or controls along the access road as needed upgradient from	Water bars were installed.

**Shumpike Rd: Water bars installed along the access road upgradient from the wetland crossing. Slightly turbid water remains in the wetlands.**

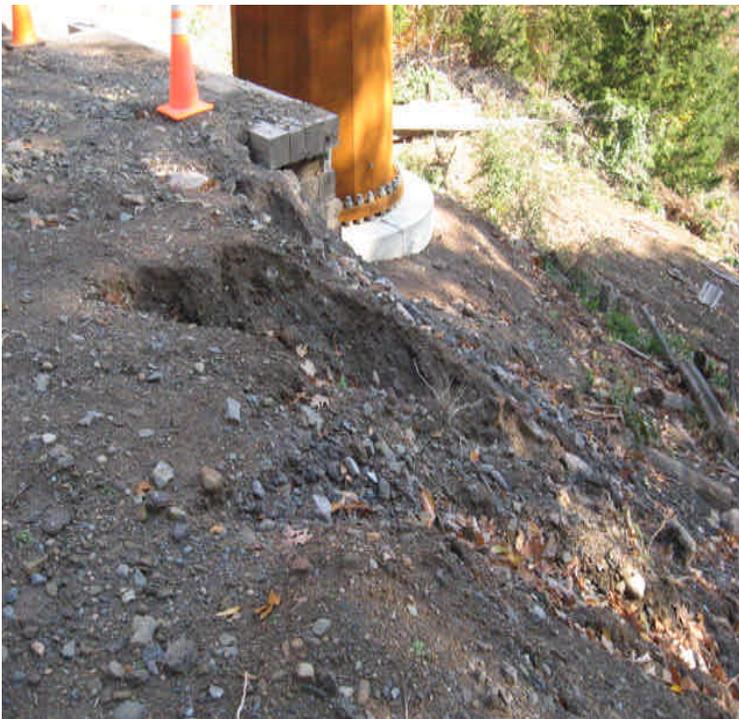
Black Walnut Dr.	An eroded washout was noted on the steep slope of the last pad site upgradient from Ball Brook despite past controls. 10/15-11/5/07	Adjust controls to protect the resource area downgradient. Consider an erosion control blanket if necessary to stabilize the slope and establish vegetative cover as soon as possible. 10/15-11/5/07	Needs attention
	The small deteriorated section of silt fence along the ROW has been repaired. 11/5/07	Continue to monitor controls and replace as needed. 11/5/07	Silt fence was repaired.
Contractor Receiving Yard and Storage Area	Silt fence and fiber rolls are in place at the perimeter of the yard and drainage areas/swales but several areas need repair. 4/23-11/5/07	Continue to add, maintain, and monitor controls as necessary. Repair deteriorating controls. 4/23-11/5/07	Needs repair when feasible. Existing vegetation helps contain/filter the area.
South of Contractor Yard Along Rte. 17 and Little Lane	Silt fence typically filters turbid run-off here before it leaves site. Timber mats are in place at the crossing and areas remain seeded. 11/5/07	Monitor and reinforce controls to ensure they adequately filter run-off. Monitor for stabilization. 11/5/07	NA

**Black Walnut Dr: Ruts and erosion noted along a steep slope on the last pad site upgradient from Ball Brook. Regrade and stabilize; consider adding an erosion control blanket due to the grade.**

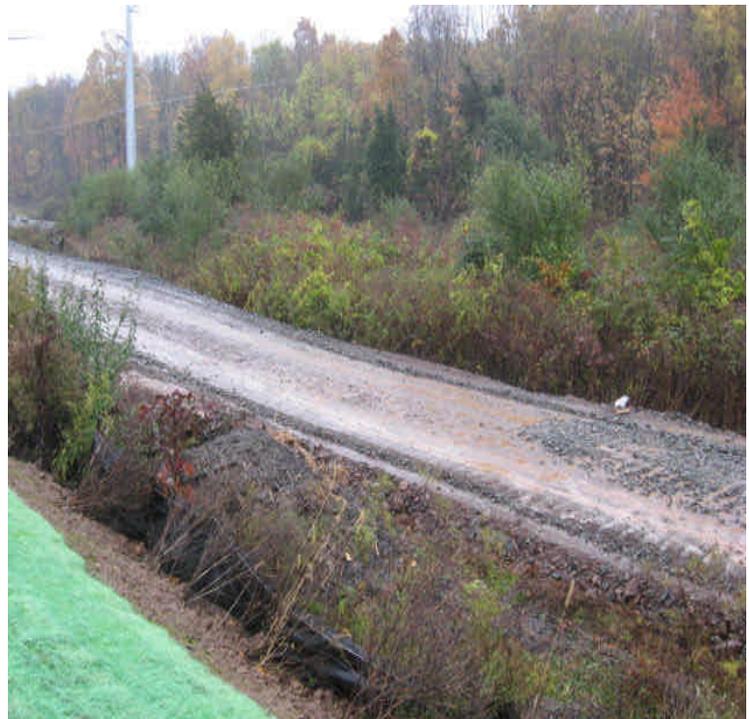
**East of Beseck SS: Stormwater flowing off site along the access road during heavy rains on 11/6/07**

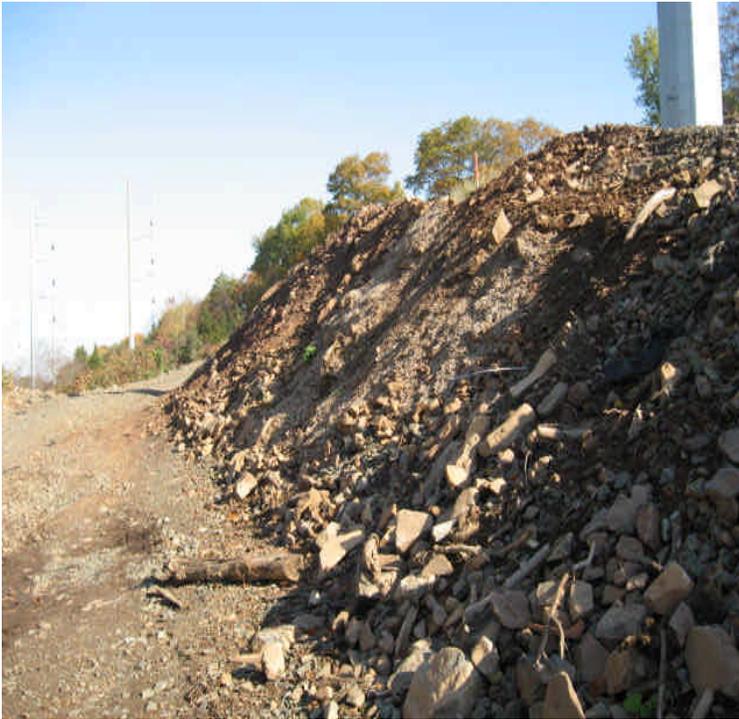
**East Meriden SS: Pad site at the edge of a steep slope needs controls.**

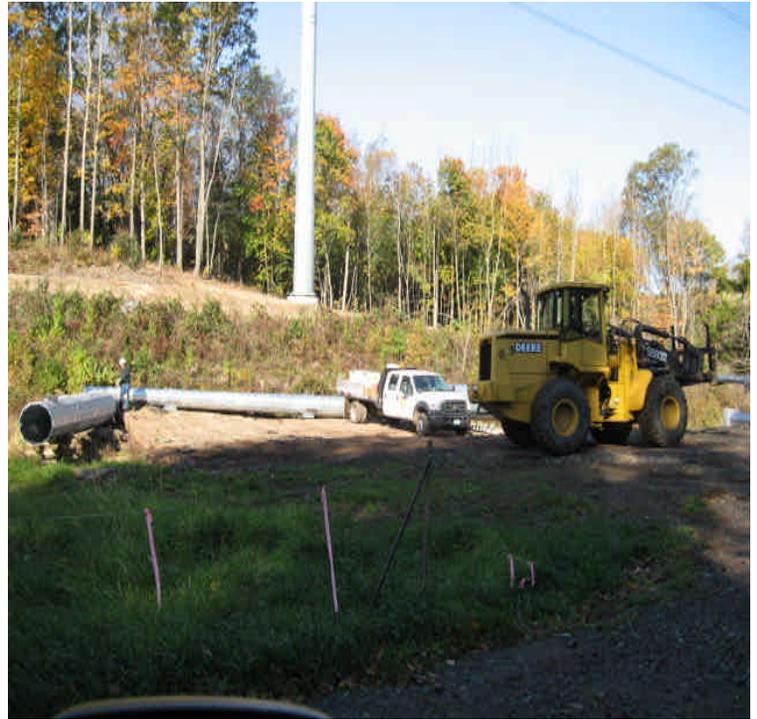
**N. of High Hill Rd: Crews were delivering structures. More controls needed upgradient from wetlands.**

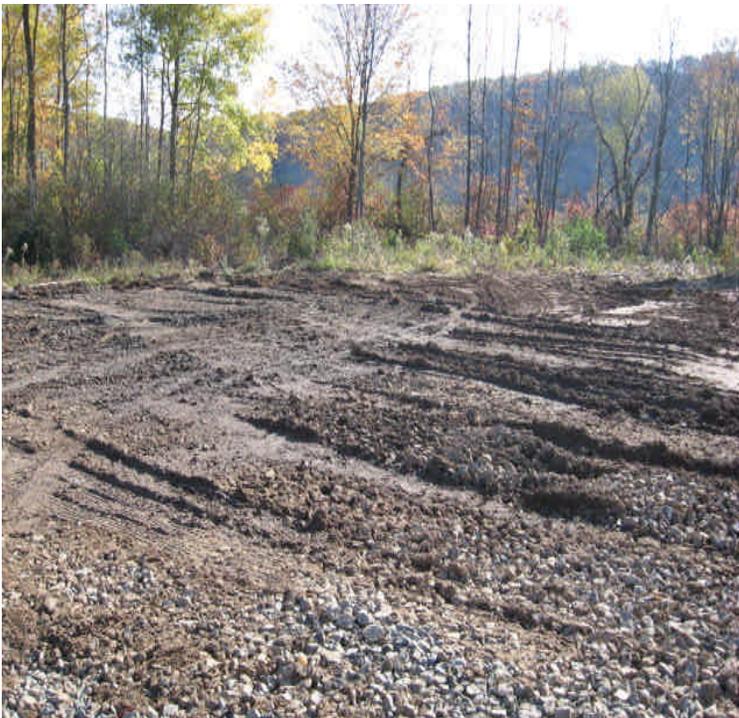
**South of East Main St: Large, disturbed soil area located upgradient from wetlands. Controls are needed here. Grade, remove stone, and temporarily stabilize the soils if work will not return in 21 days.**

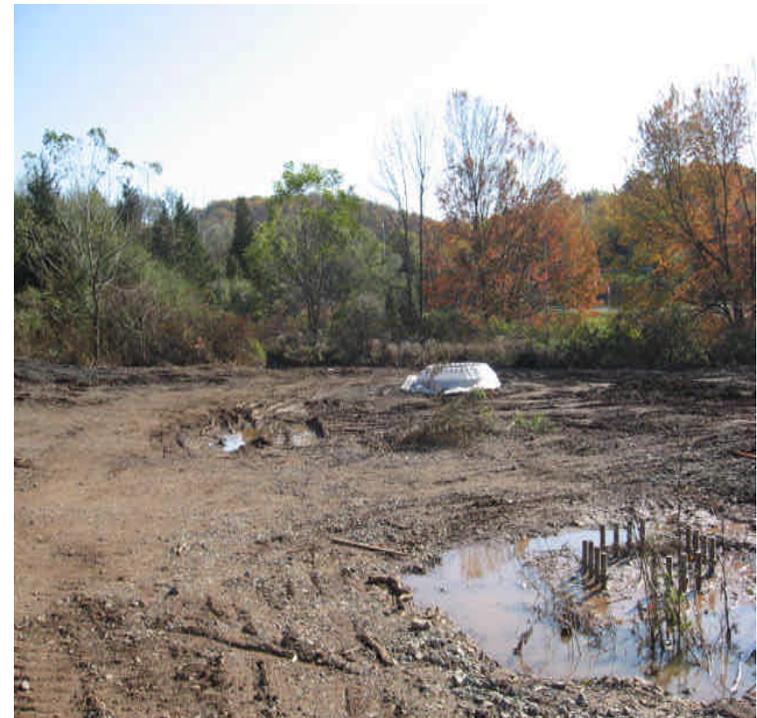
**North of East Main St: Disturbed area located within the wetlands as a result of construction. Controls are in place and working well. Area upgradient from foundations has been mulched and seeded. Temporarily stabilize area adjacent to foundations if work will not return in 21 days.**
