Docket No. 272 – Development and Management Plan Inspection

Segment 1b (Royal Oaks Bypass) Inspection

Date: October 29, 2007

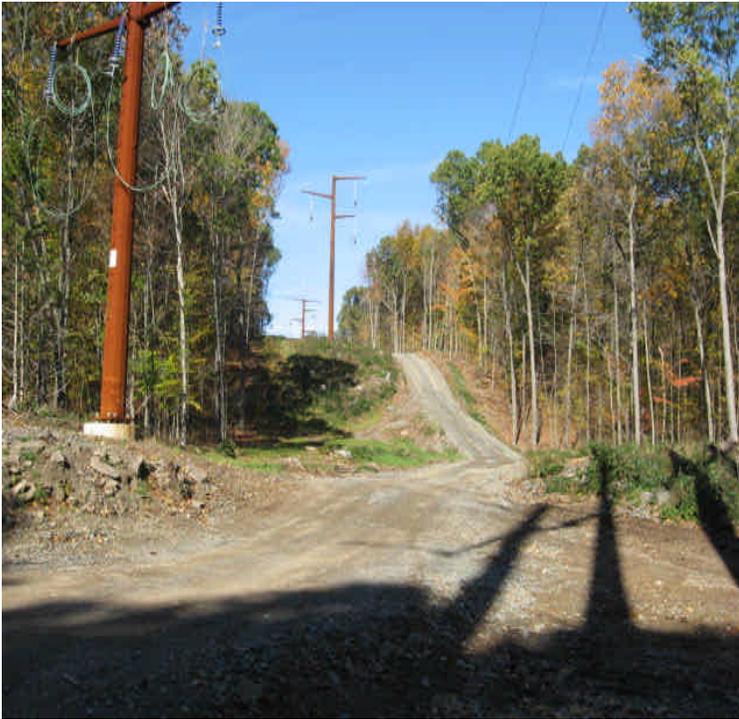
| Areas of Inspection | Observation | Recommended Action | Corrected Action |
|--|--|---|---|
| | Minor erosion was noted along the access road at the steep slope off Black Walnut Drive after heavy rains. 10/22-10/29/07 | The erosion is not affecting wetland areas but regrade road as feasible to prevent further washouts or consider stormwater diversions such as water bars. 10/22-10/29/07 | Needs attention when feasible. |

Minor erosion noted along the access road at the steep slope off Black Walnut Drive.

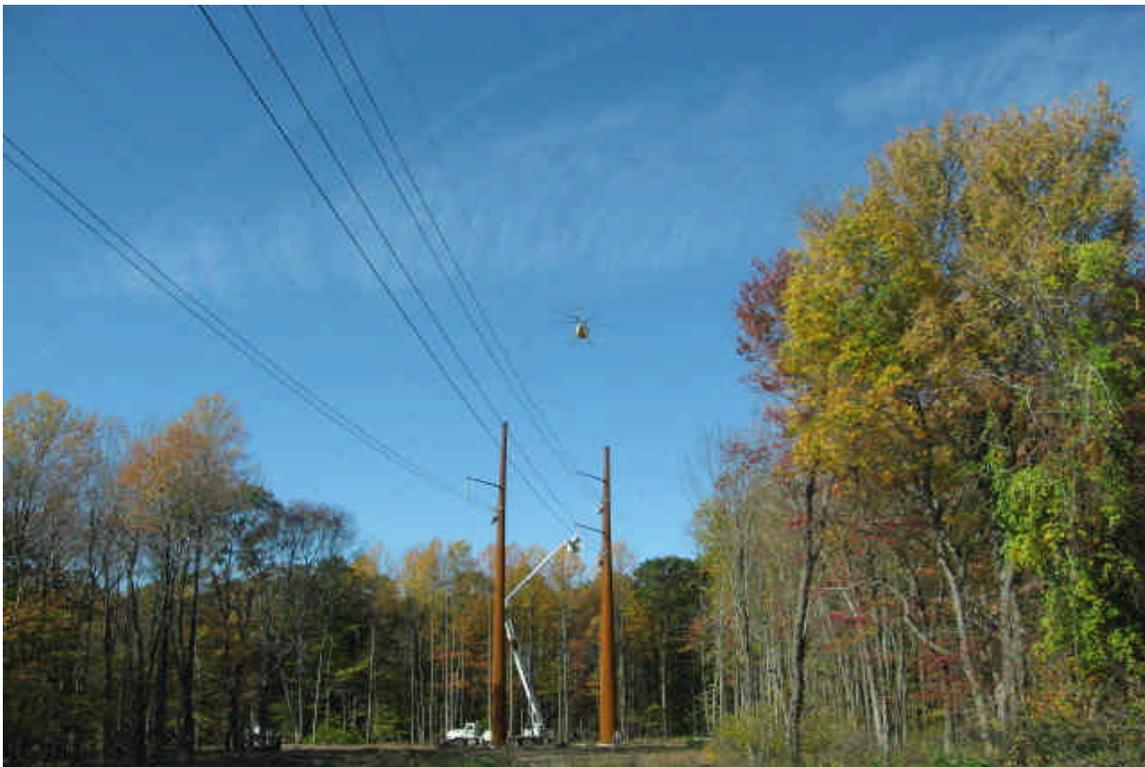
A view of the line pulling and work at the turn in the ROW adjacent to the contractor receiving yard.
