Docket No. 272 – Development and Management Plan Inspection

Segment 1b (Royal Oaks Bypass) Inspection

Date: November 5, 2007

Location: Segment 1b (Royal Oaks Bypass)

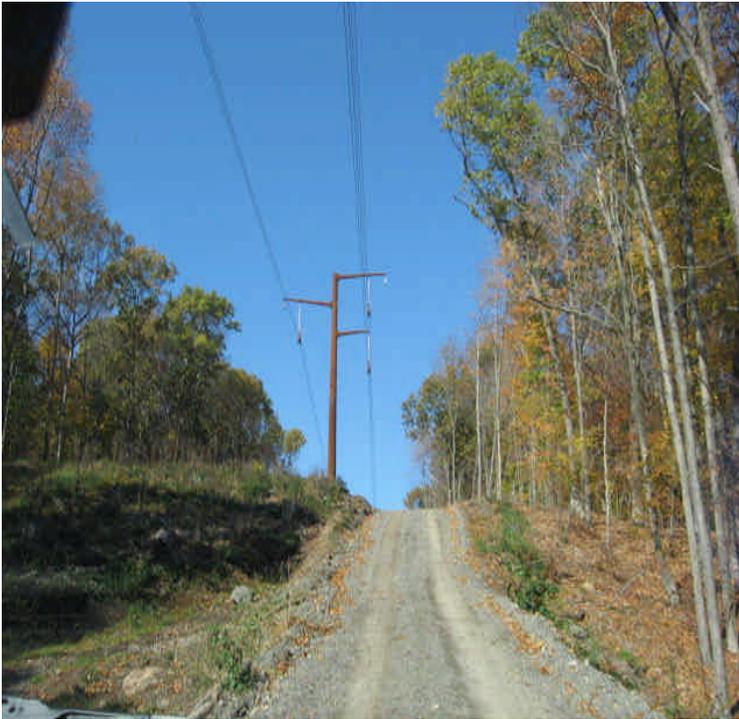
Minor erosion noted along the access road at the steep slope off Black Walnut Drive.

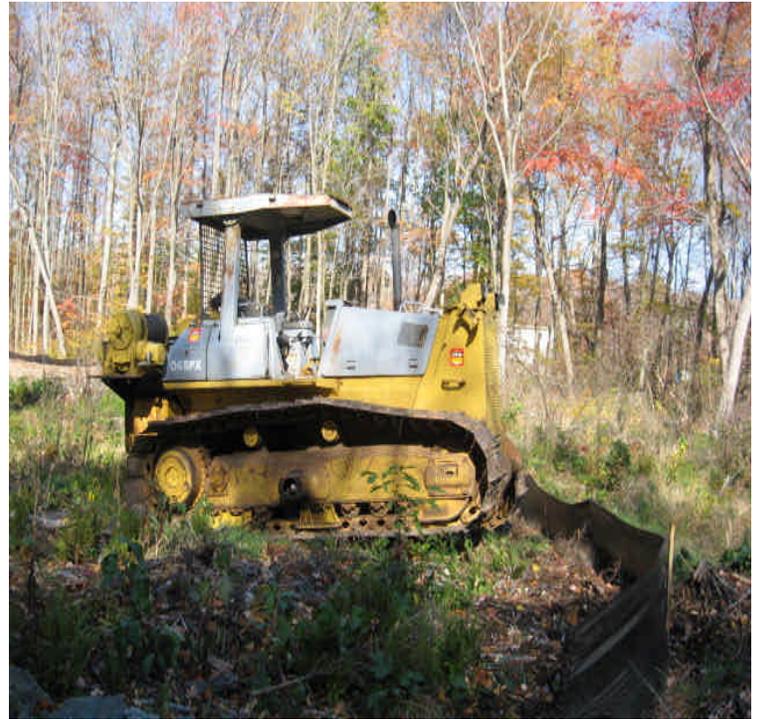
Areas of Inspection	Observation	Recommended Action	Corrected Action
	<p>Equipment was noted parked adjacent to the silt fence, near the wetland edge within the Laurel Brook watershed protection area. 11/5/07</p>	<p>area. 11/5/07 Relocate the equipment to a location over 100 feet from wetlands. 11/5/07</p>	<p>Needs attention.</p>
<p>Additional Observations</p>	<p>None. 11/5/07</p>	<p>None. 11/5/07</p>	<p>NA</p>

Equipment parked near the edge of the wetlands within the Laurel Brook Watershed Protection Area.

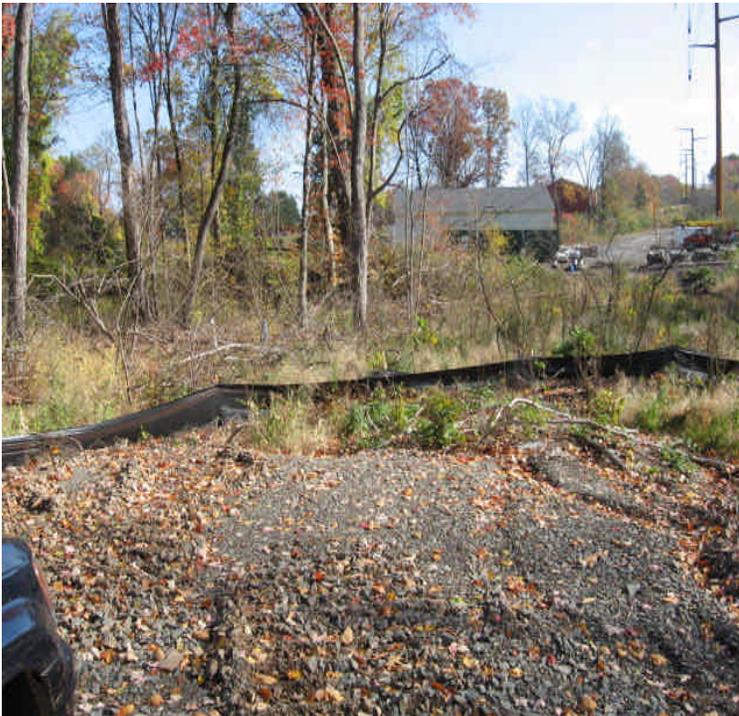
Areas of Inspection	Observation	Recommended Action	Corrected Action
	<p>One of the line pull areas is located within the 50-foot buffer to the wetlands. However, the contractor has confirmed that this area was approved by CSC. Controls remain in place. 11/5/07</p>	<p>In accordance with the D&M Plan, ensure that all other line-pulling areas are not placed within 50-feet of wetlands. This area is an exception. Continue to maintain controls carefully. 11/5/07</p>	<p>Contractor has confirmed the line pull location was approved by CSC.</p>
<p>Inland Wetland and Watercourse encroachment and mitigation</p>	<p>Access road is in place west of Rte 17 in the receiving yard wetlands. Three streams were crossed with culverts. Controls and mulch are in place adjacent to the roads, culvert flow was currently clear. 11/5/07</p> <p>Timber mat access road remains in place in wetlands west of Rte. 17 near Little Ln. 11/5/07</p> <p>The line-pulling area adjacent to the receiving yard is located approximately 15-20 feet from the edge of the wetland. This location was approved by the CSC, according to the contractor. 11/5/07</p>	<p>Monitor area closely for erosion and run-off. Add controls as needed to prevent road run-off. Wetland crossings are temporary and material will have to be removed when work is complete. 11/5/07</p> <p>See erosion control section. Continue to monitor until the area has stabilized. Disturbed area should be seeded. 11/5/07</p> <p>When considering placement, line-pulling areas should be not be located within 50-feet of wetlands per the D&M plan. However, this one is an exception. 11/5/07</p>	<p>NA at this time.</p> <p>NA at this time.</p> <p>NA at this time</p>

Edge of a line-pulling area within the 50-foot buffer to the wetlands. This area was later confirmed by the contractor as approved by the CSC.

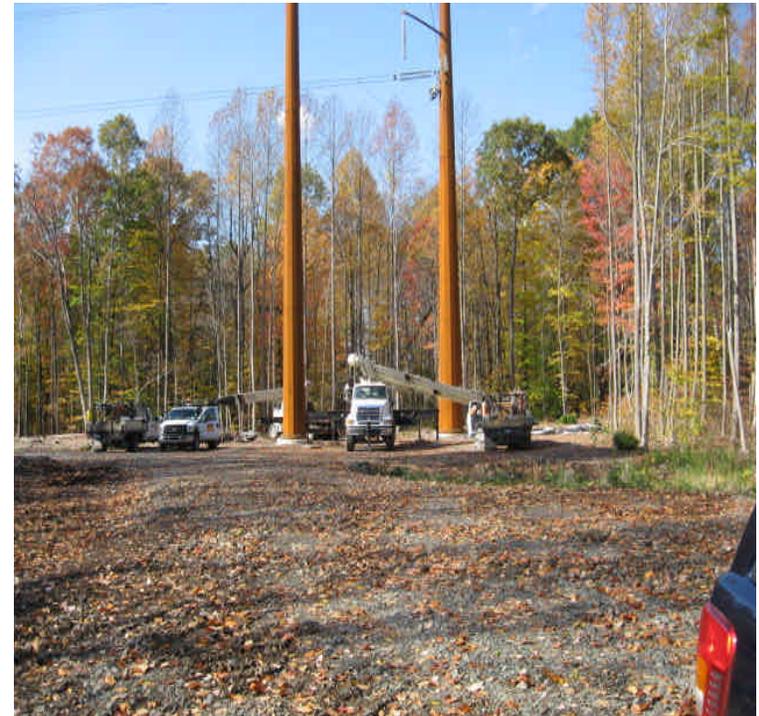
Line work was underway near the contractor receiving yard.
