Docket No. 272 – Development and Management Plan Inspection

Segment 2a Inspection

Date: October 30, 2007

Location: Segment 2a – Beseck Switching Station to Cheshire/Hamden Town Line

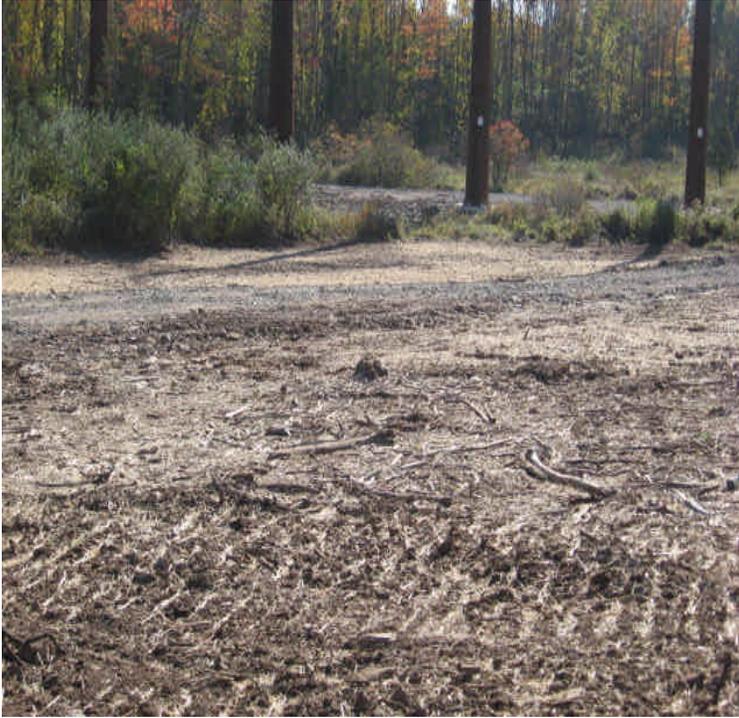
Carpenter Ln: Upland portion of the site has been mulched and seeded.

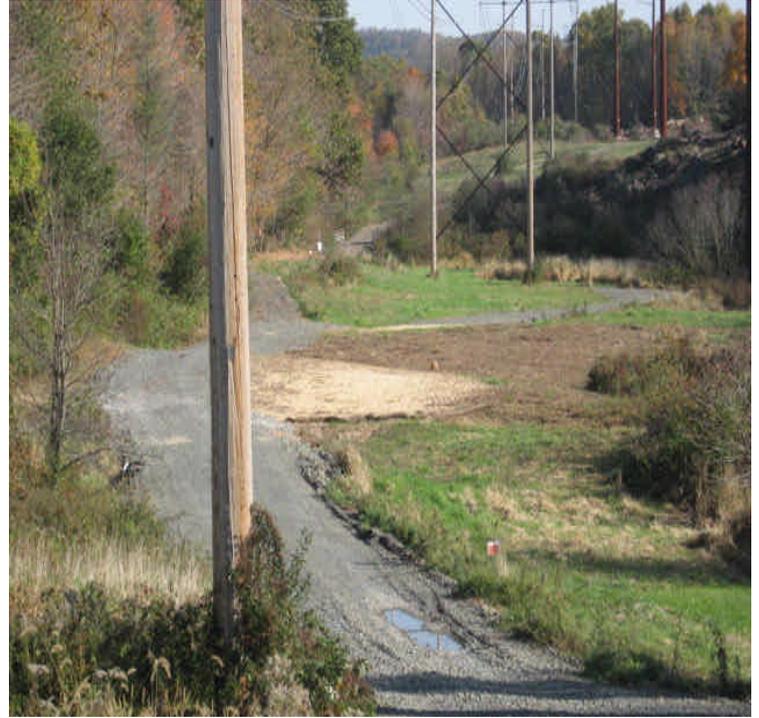
Liney Hall Rd: Exposed areas have been graded and mulched. However, not all exposed soils have been seeded.

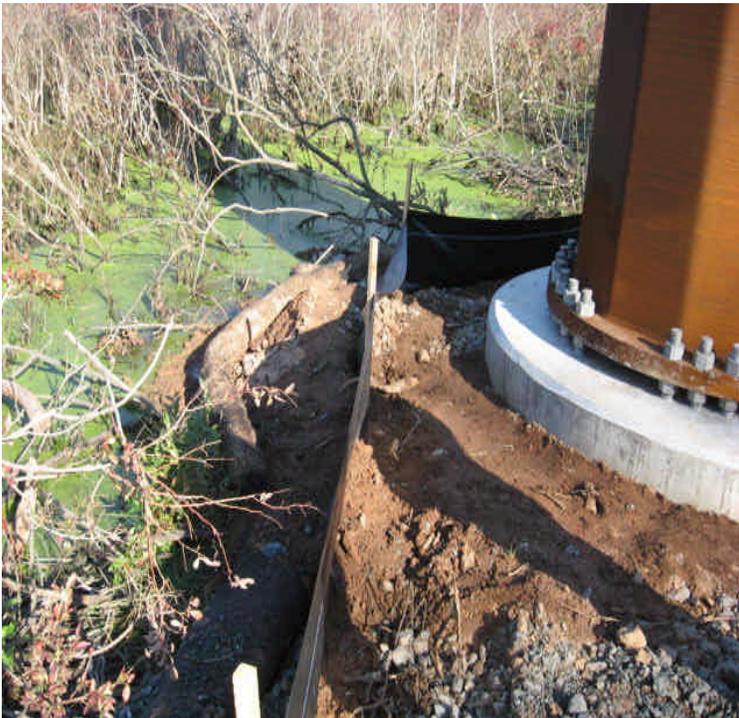
Tamarack Swamp Rd: The sediment pushed beyond the original controls during the foundation installation were contained with additional controls. Remove any remaining sediment beyond the new silt fence.

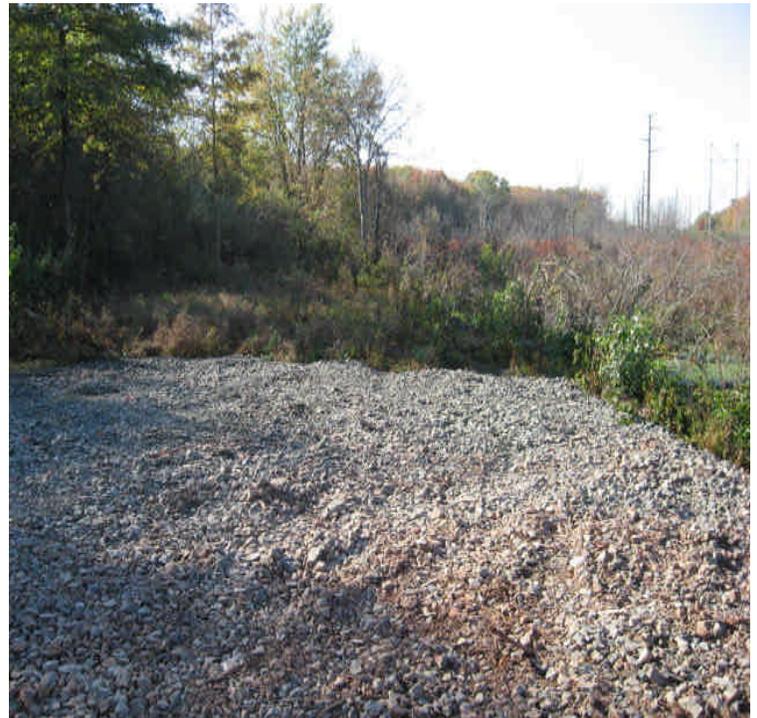
Tamarack Swamp Rd: Three spill stains and the equipment stored adjacent to the wetlands have been removed from the site.

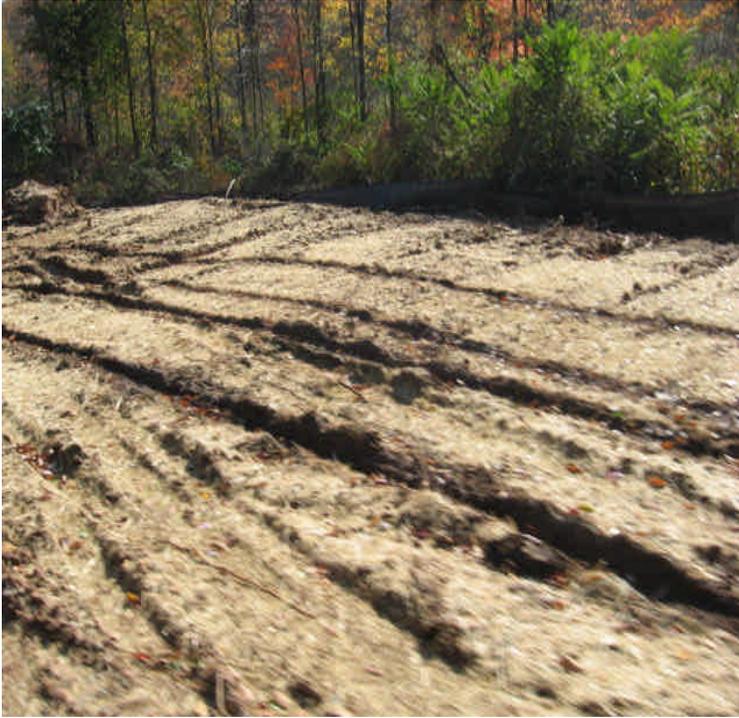
Woodhouse Ave: Soils were graded, mulched, and seeded. However, vehicle tracks were noted in the restored area.

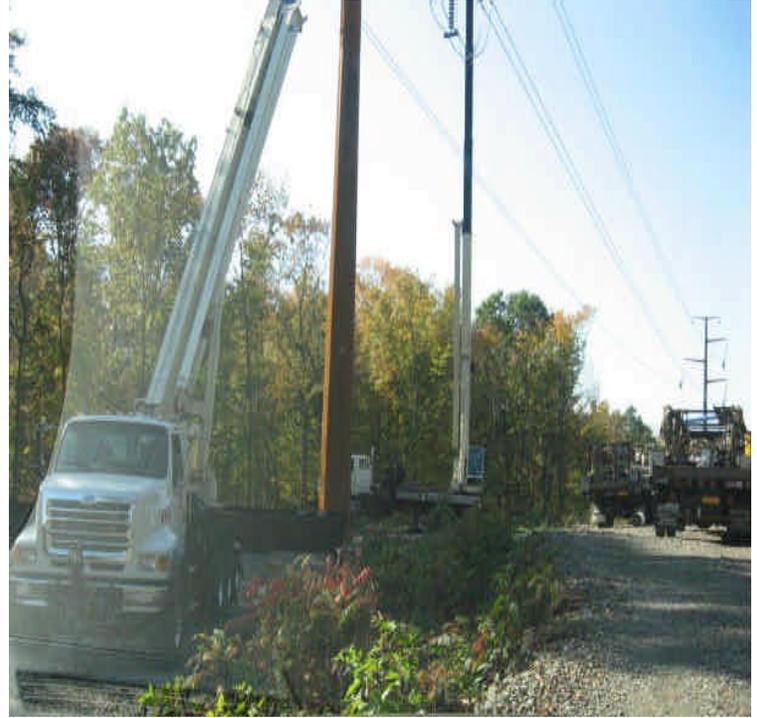
Woodhouse Ave: Line work was underway.

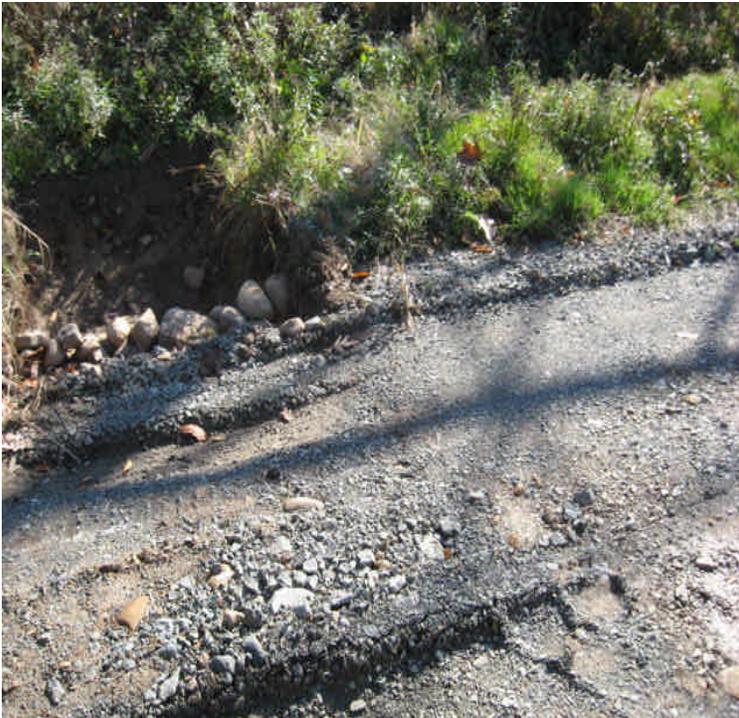
Mansion Rd Apple Orchard: View of the culvert in place to reduce ponding on the access road.

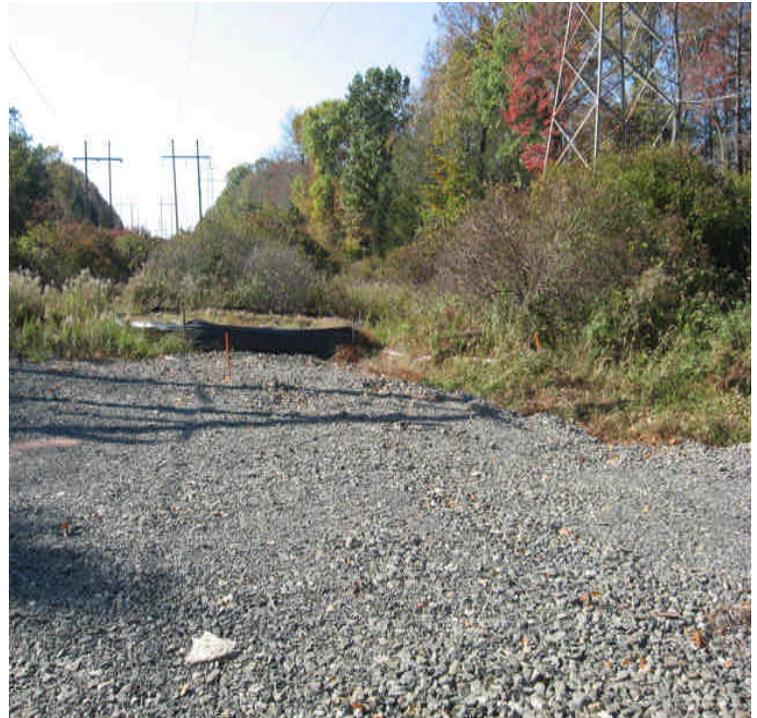
Old Farms Rd: View of a slurry retention area and the adjacent areas of vegetated ROW.
