Docket No. 272 – Development and Management Plan Inspection

Segment 2b Inspection

Date: November 2, 2007

Location: Segment 2b – Cheshire/Hamden Town Line to East Devon Substation

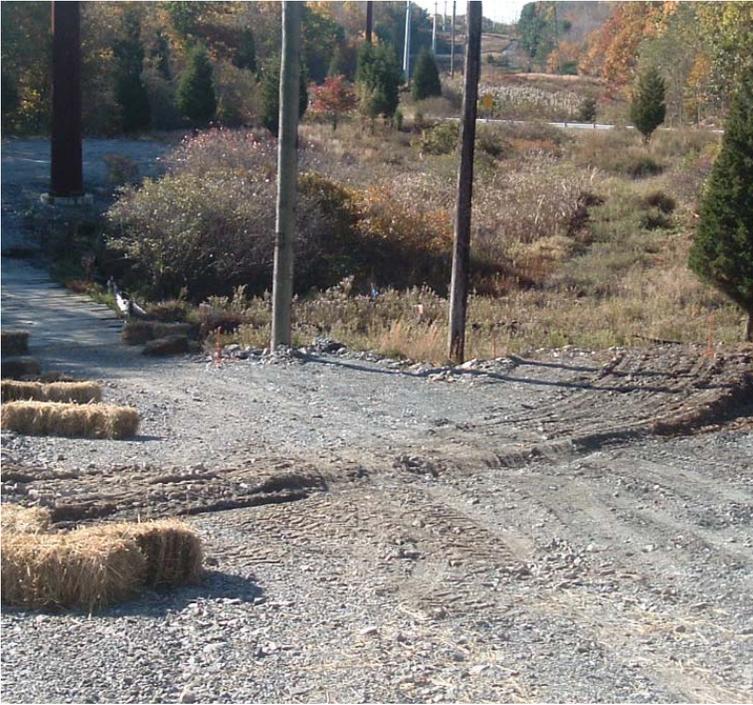
Litchfield Turnpike (Bethany): View of the newly constructed/installed waterbars and haybale sediment traps.

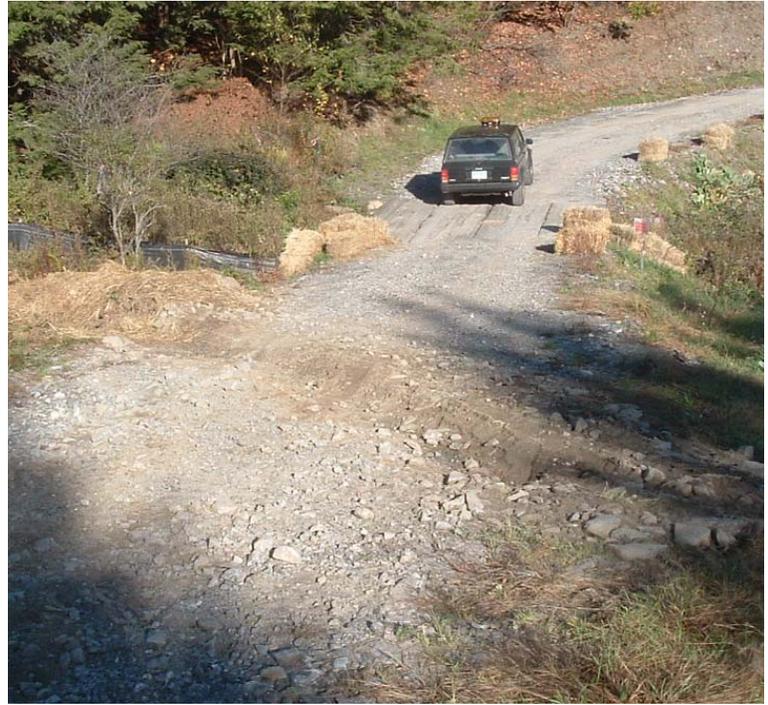
Litchfield Turnpike: Additional view of the waterbars and haybale sediment traps along the access road.

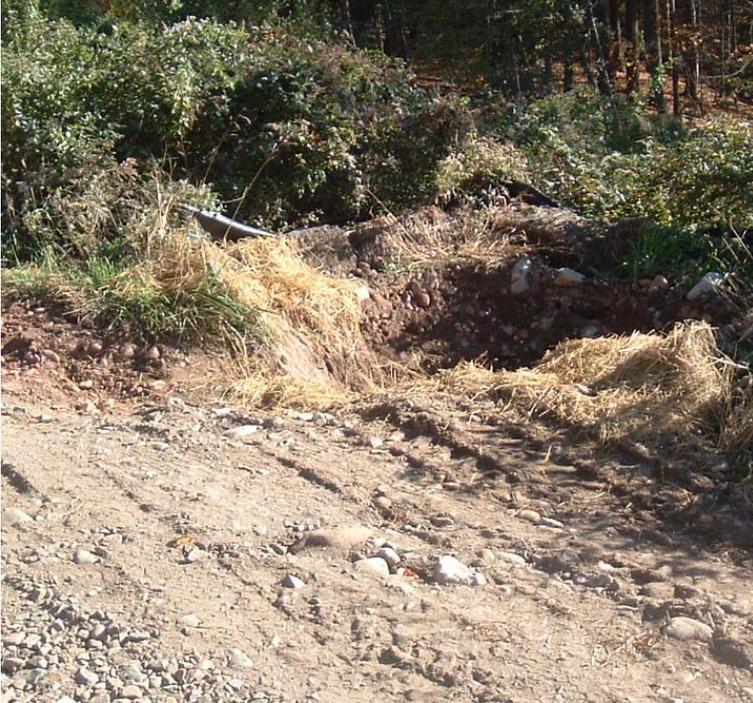
Glen Dam (Woodbridge): Sediment has been removed from the stone lined sediment trap in order to restore capacity and allow for continued filtration of stormwater runoff.

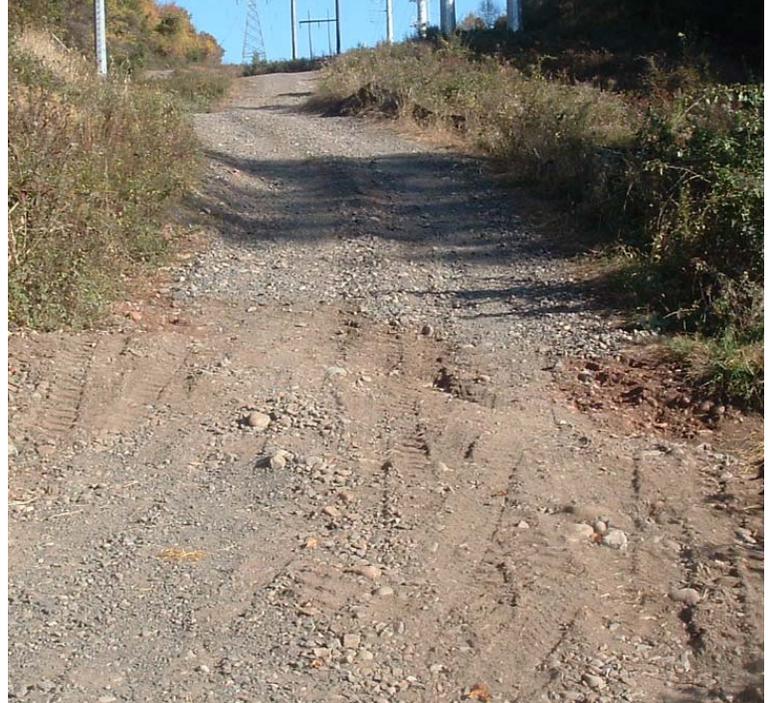
Glen Dam: Waterbars have been replaced/repared in an effort to control stormwater runoff.

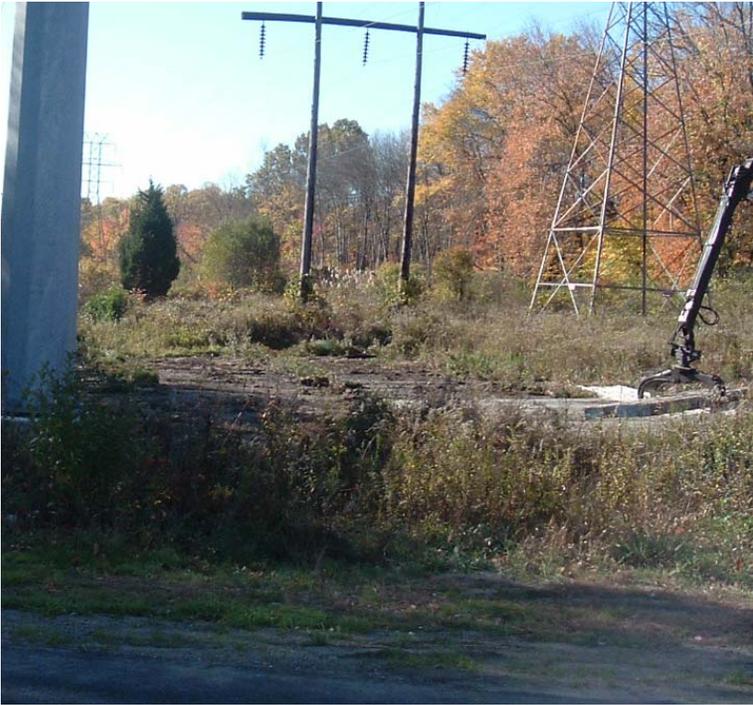
Manville Rd (Woodbridge): The timber mat crane pads have been removed from the wetlands here.

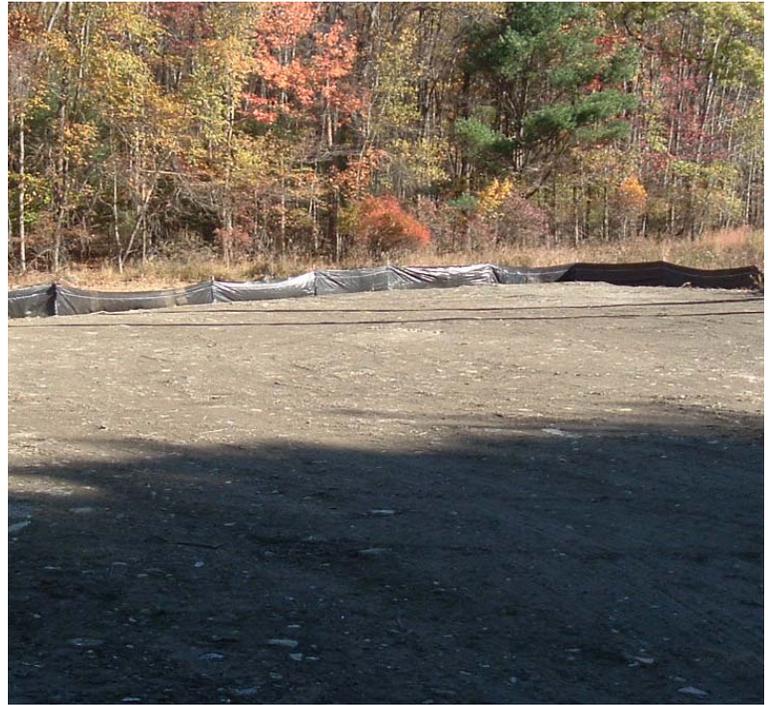
Clearview Ln (Woodbridge/Orange): View of structure #3899. Pad reclamation is complete.

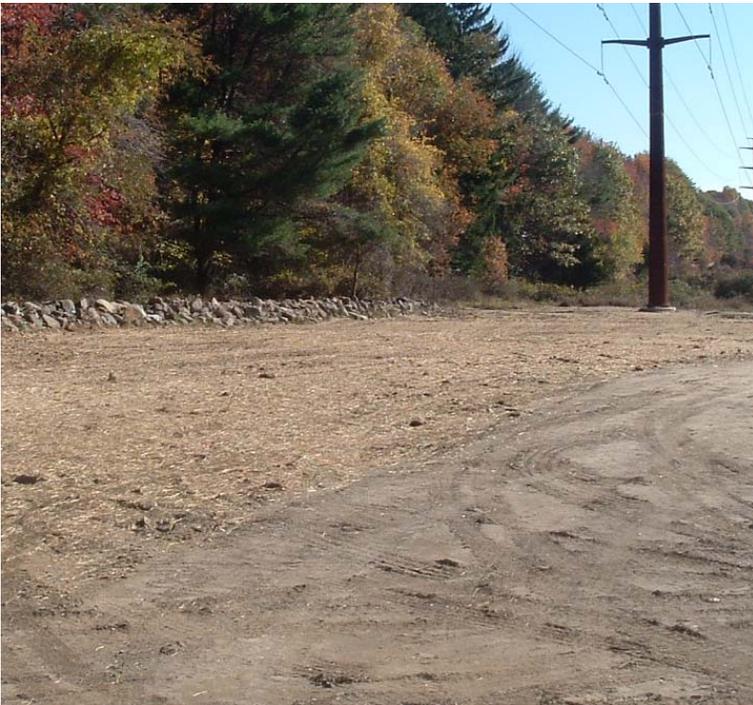
Clearview Ln: View of structure #3900. Pad reclamation is complete.

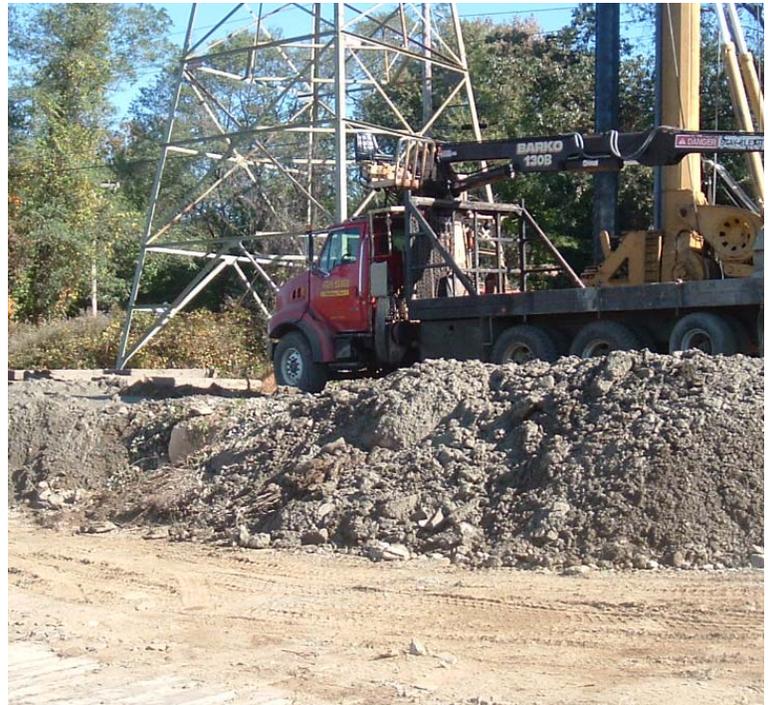
Naugatuck Ave (Milford): Foundation work continues in this section.
