**Docket No. 272 – Development and Management Plan Inspection**

**Segment 2b Inspection**

**Date:** November 8, 2007

**Location:** Segment 2b – Cheshire/Hamden Town Line to East Devon Substation

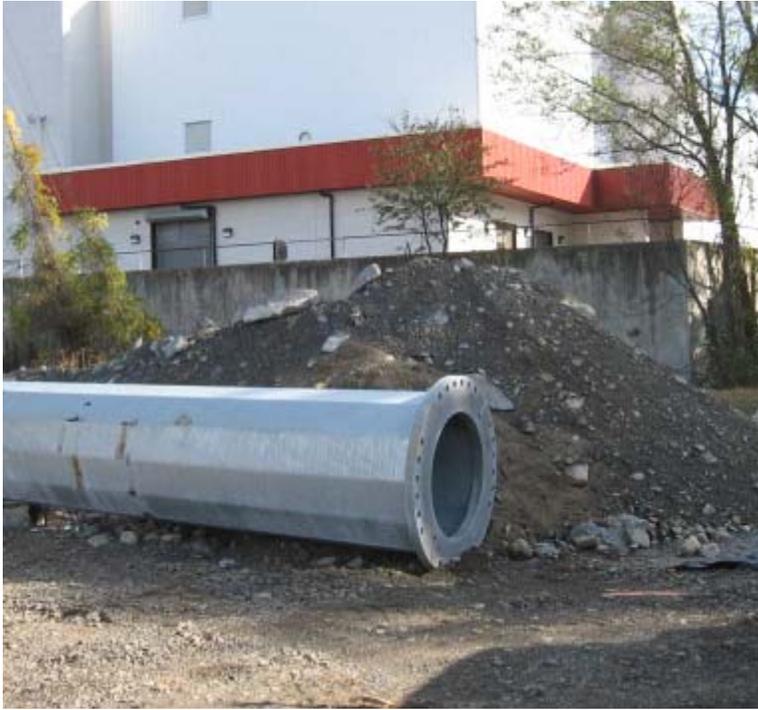
Caswell St south (Milford): Spoil piles remain in the ROW near structure #3807. Spoils appear to be contained on site.

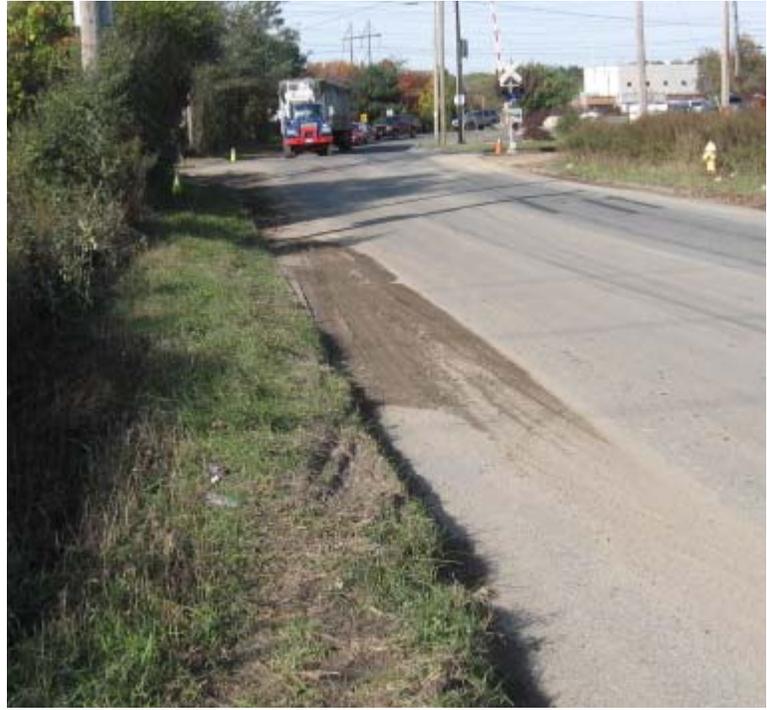
Milford, CT	Sediment tracking from the overhead access road was observed on the	Stabilize the overhead access road with a stone pad and/or provide catch	Needs attention

Caswell St: View of the sediment tracking within the roadway here.

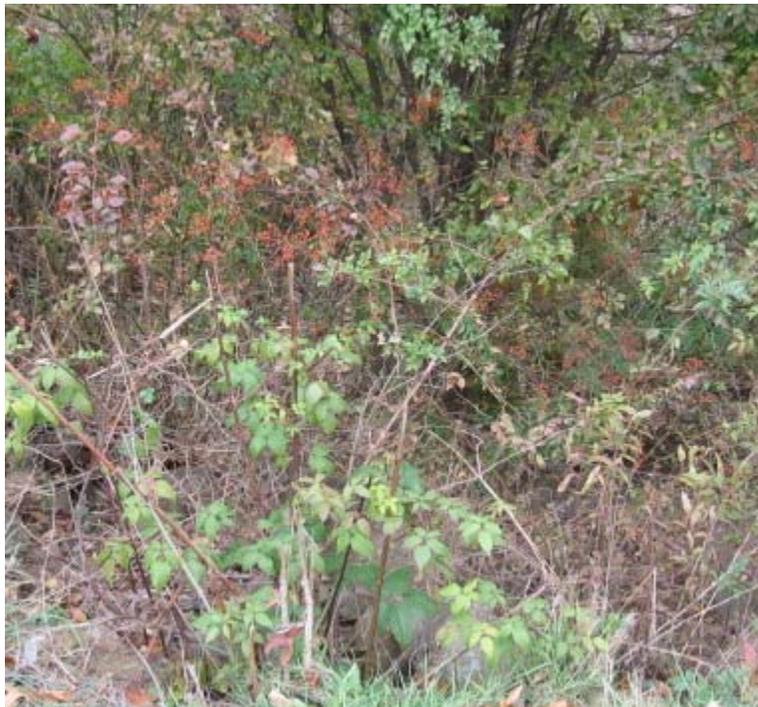
Old Ln (Hampden): A view of the outlet from the catch basin on Old Ln. A small amount of sediment was observed in the wetland.
