Docket No. 272 – Development and Management Plan Inspection

Segment 3 Underground Line

Date: November 8, 2007

Location: East Devon Substation to the Housatonic River Crossing

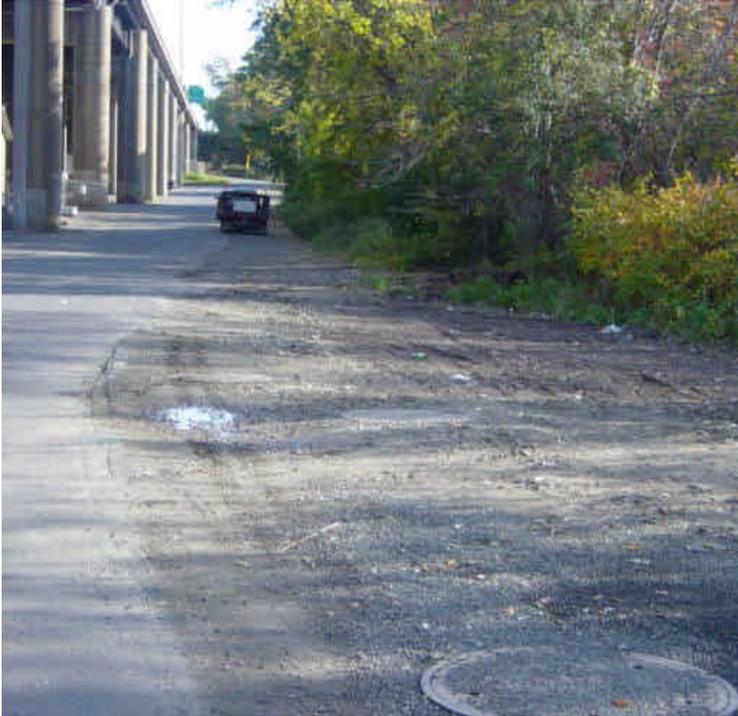
Heavy construction equipment not related to the M/N project has been removed from the area near sta. #1015 to #1020 (vault #1). Concrete washouts previously observed have been removed and the area has been restored.

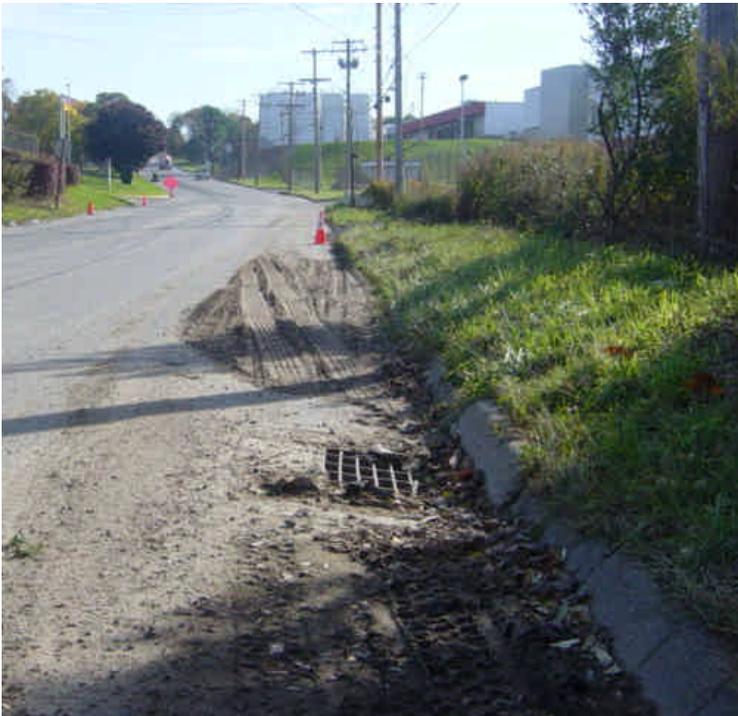
Tracking was evident along Caswell Street, but does not appear to be associated with this portion of the project. The catch basin was protected previously, but the silt sack is torn and in need of repair. See the 2B report for more information.

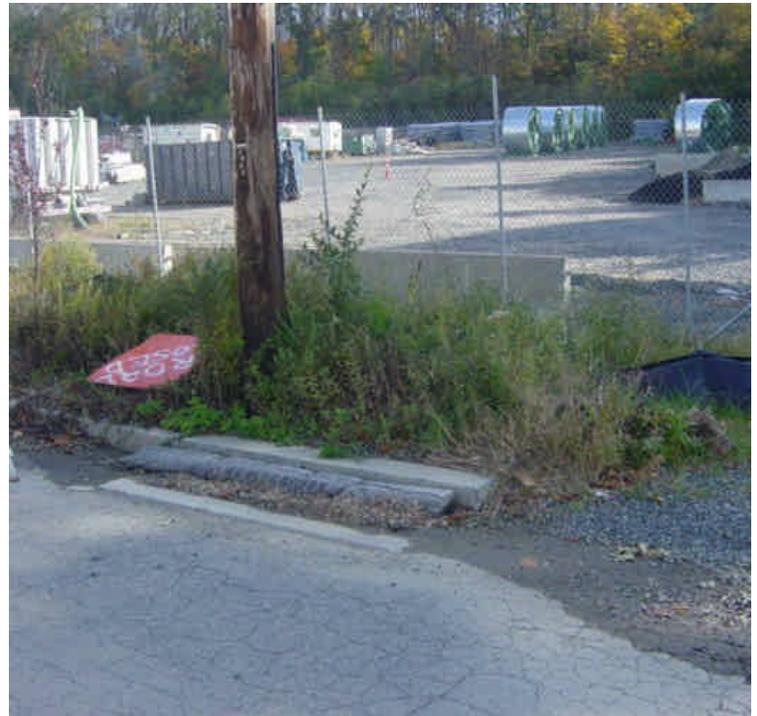
Shelland St. laydown yard remains inactive as work has shifted to other areas of the project. Gutter buddy remains in place near the entrance to the yard. The catch basin grate was blocked by leaves and debris, which have been removed. There was no evidence of ponding.
