Docket No. 272 – Development and Management Plan Inspection

Segment 3 Underground Line

Date: November 15, 2007

Location: East Devon Substation to the Housatonic River Crossing

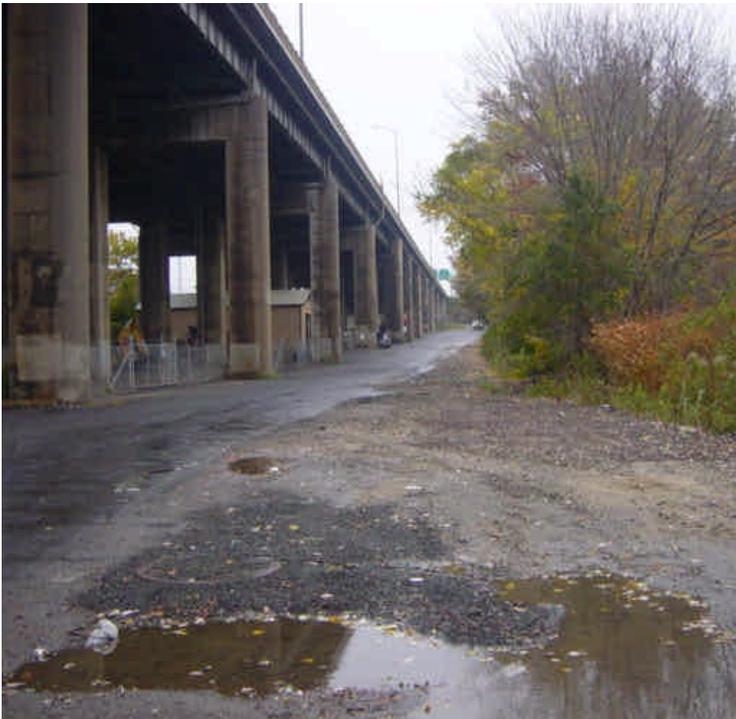
Construction equipment not related to the M/N project has been removed from the area near sta. #1015 to #1020 (vault #1) Minor ruts were observed in some areas, but generally, the area has been restored.

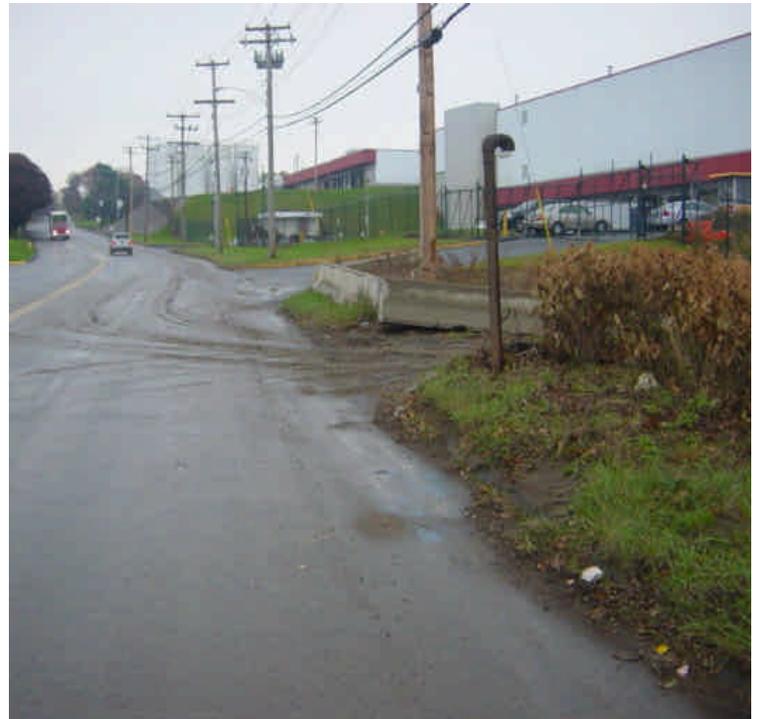
Sediment tracking was observed near the entrance to the right-of-way near sta. #1080. Tracking does not appear to be associated with this portion of the project. The stone construction entrance area has deteriorated and needs to be refreshed with new stone. This responsibility should be coordinated with overhead contractors.

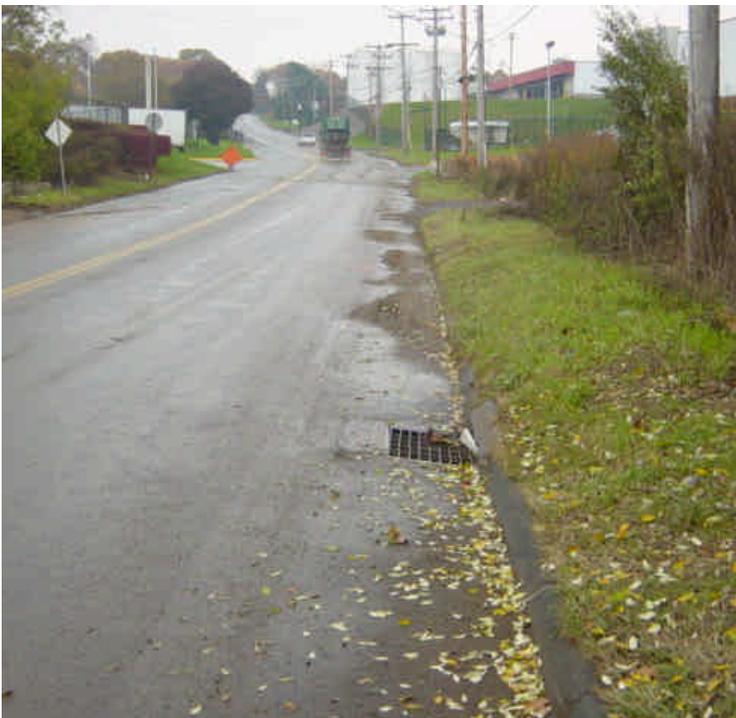
Tracking was previously observed along Caswell Street, but did not appear to be associated with this portion of the project. The street appears to have been recently swept and only a minor amount of sediment remains along the roadway. The torn silt sack has been removed from the catch basin but was not replaced. Again, responsibility should be coordinated with overhead crews.

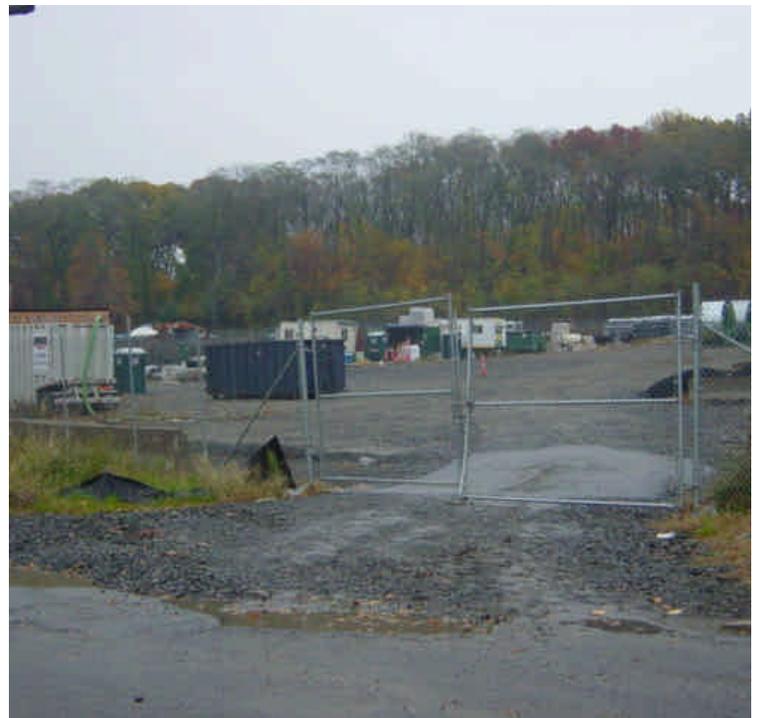
Shelland St. laydown yard remains inactive as work has shifted to other areas of the project.
