Docket No. 272 – Development and Management Plan Inspection

Segment 4a Underground Line

Date: November 1, 2007

Location: Singer Substation to Fairfield/Westport Town Line

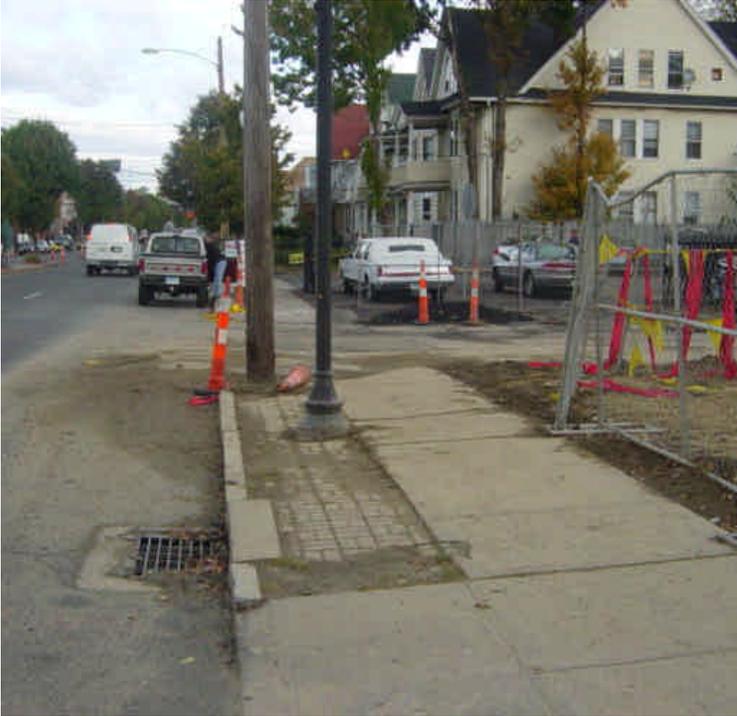
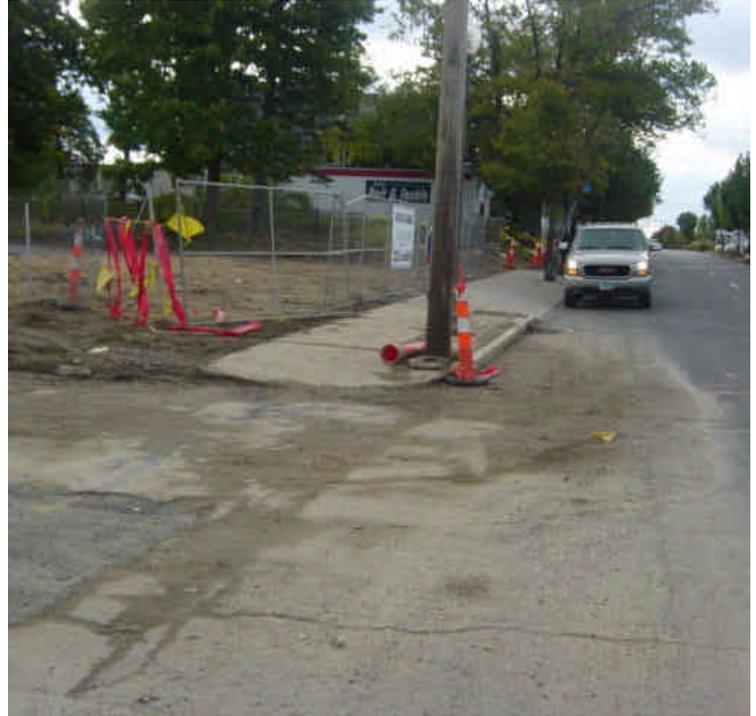
Heavy sediment accumulation was previously observed near sta. #695 (vault #42) along the shoulder and sidewalk areas (see top photos – taken 10/25/07). The sediment accumulation was attributable to repair of a natural gas line that the contractor ruptured on 10/25/07. The roadway has since been swept and the accumulated sediment has been removed (bottom photo).
