Docket No. 272 – Development and Management Plan Inspection

Segment 4a Underground Line

Date: November 8, 2007

Location: Singer Substation to Fairfield/Westport Town Line

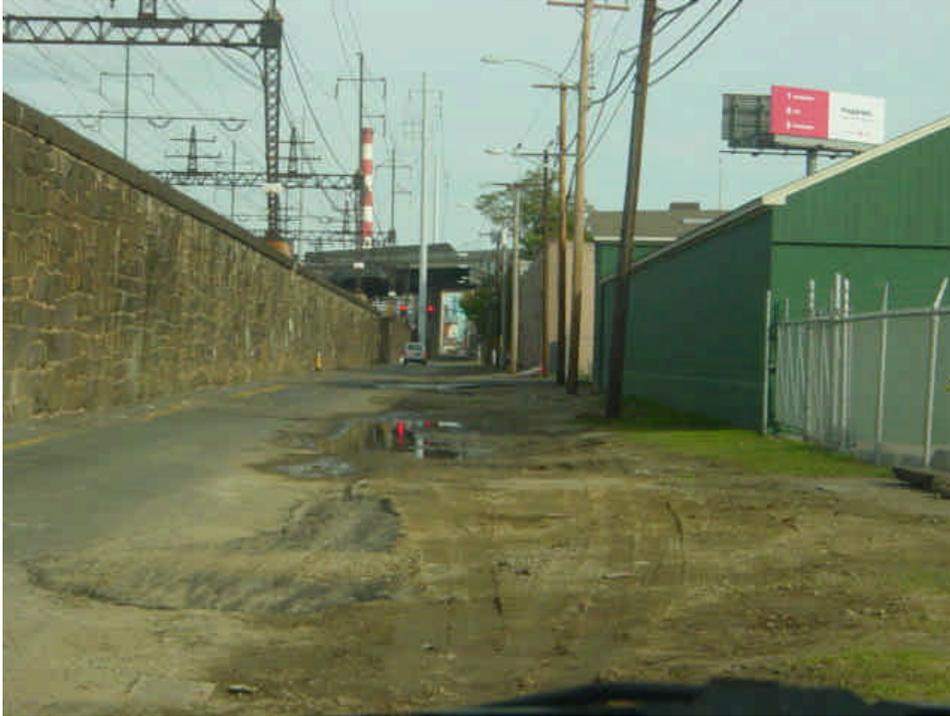
Minor tracking was observed along Railroad Ave. Hard pack remains in place along the roadway shoulders but the area is becoming rutted. If necessary, evaluate solutions that are acceptable with the city. Tracking was not a major issue this week.

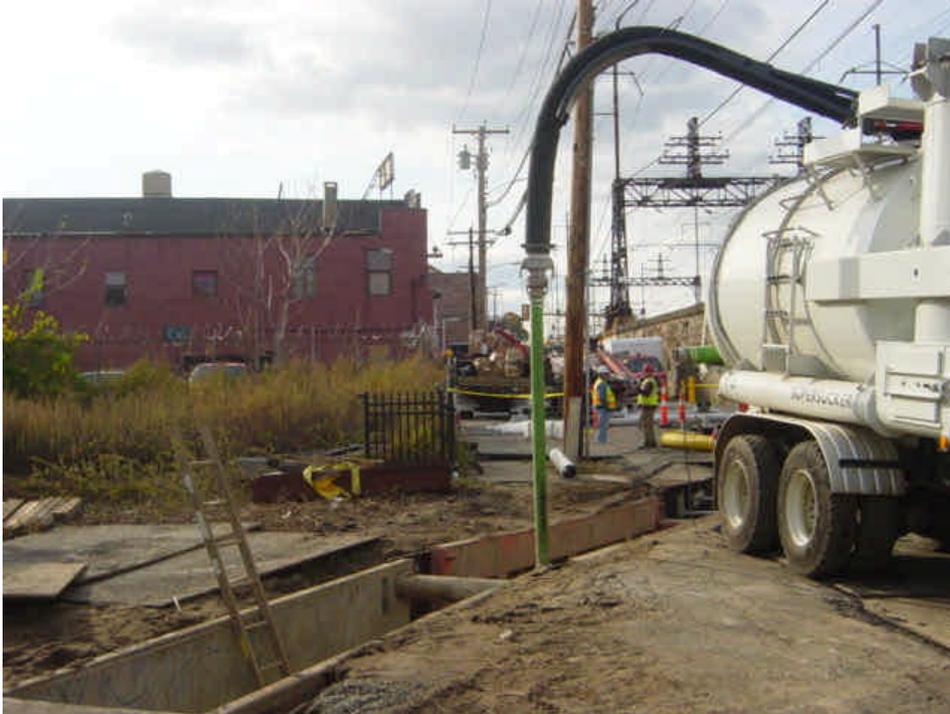
Active trenching and dewatering activities were on going at sta. #794-795.
