Docket No. 272 – Development and Management Plan Inspection

Segment 4a Underground Line

Date: November 15, 2007

Location: Singer Substation to Fairfield/Westport Town Line

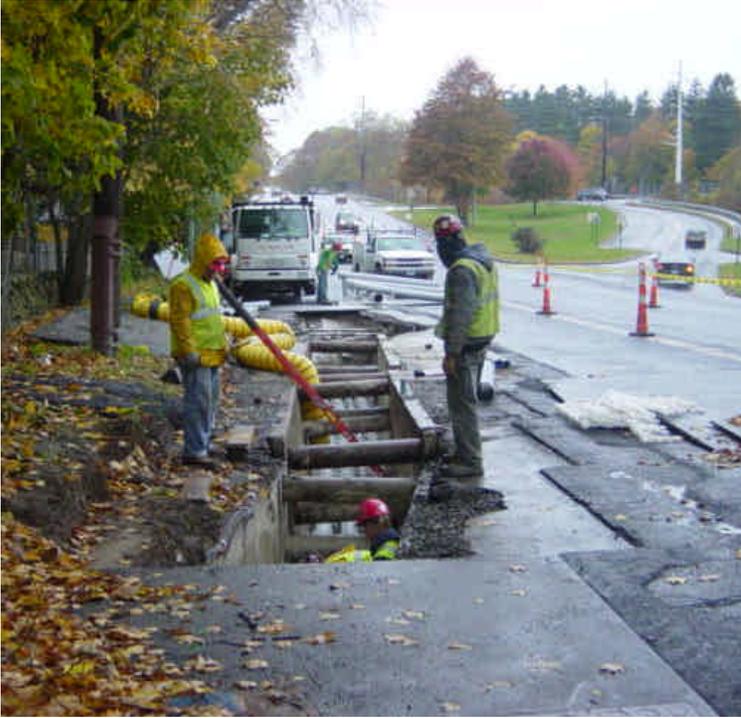
Crews working to install conduit near sta. #501-503.

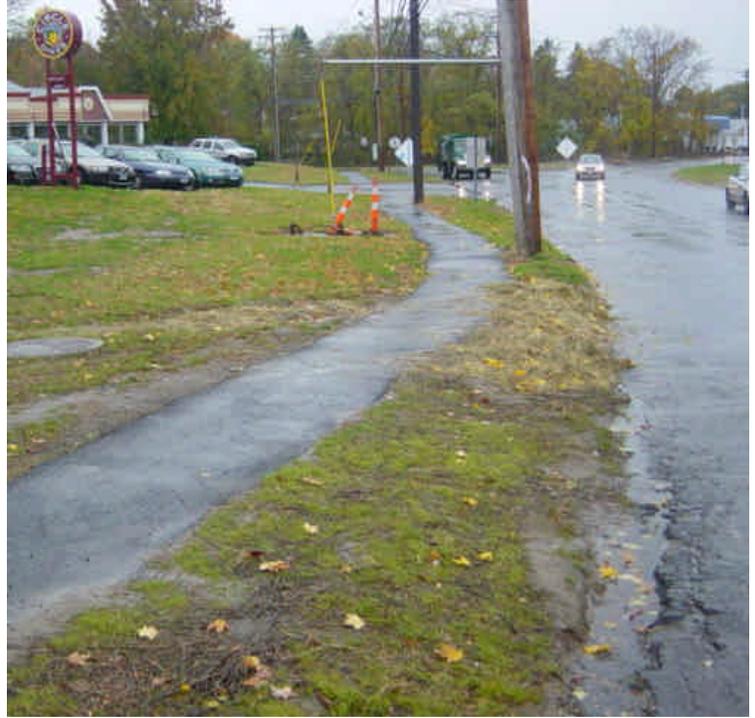
| Areas of Inspection | Observation | Recommended Action | Corrected Action |
|--|--|---|---|
| Fairfield | aware of the potential.<br>11/15/07<br><br>Minor ruts in the area near vault #37 (Fairfield Inn) have been stabilized with hay mulch. 11/15/07 | immediately. If exposed soils are not to be worked within 30 days, they should be stabilized within 7 days of the last activity. 11/15/07<br><br>The remainder of the area is stable. 11/15/07 | Ruts have been temporarily stabilized. |

Ruts/vehicle tracks near sta. #613 have been stabilized with hay mulch.

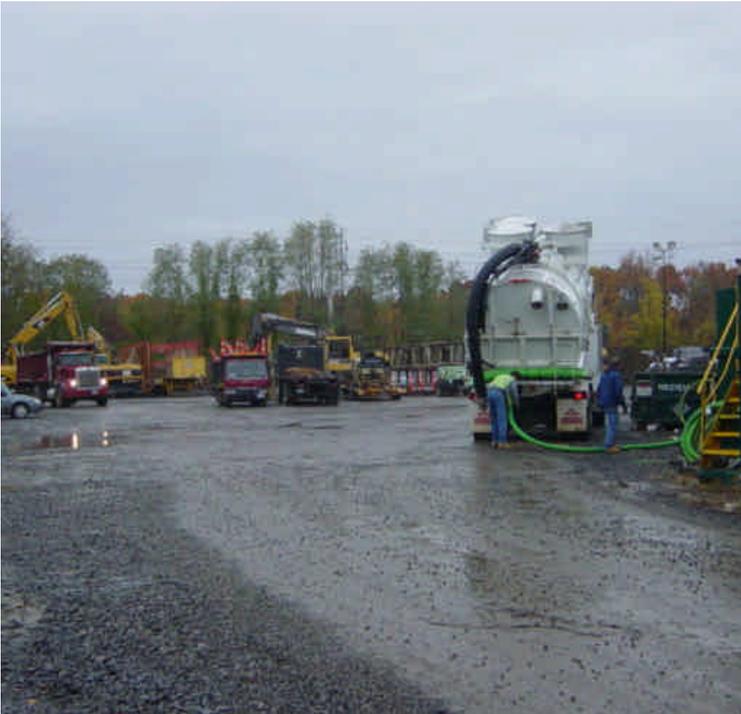
| Areas of Inspection | Observation | Recommended Action | Corrected Action |
|---|---|--|---|
| Dewatering | Dewatering activities were not observed during the inspection, however a vac truck was being emptied into frac tanks at the Kings Highway yard. 11/15/07 | Continue to properly contain and/or filter discharge water when dewatering is required. Frac tanks were being used for containment. 11/15/07 | NA |

Vacuum truck is being emptied into the frac tanks at the Kings Highway lay-down yard. The yard is generally well maintained and no major issues were observed.

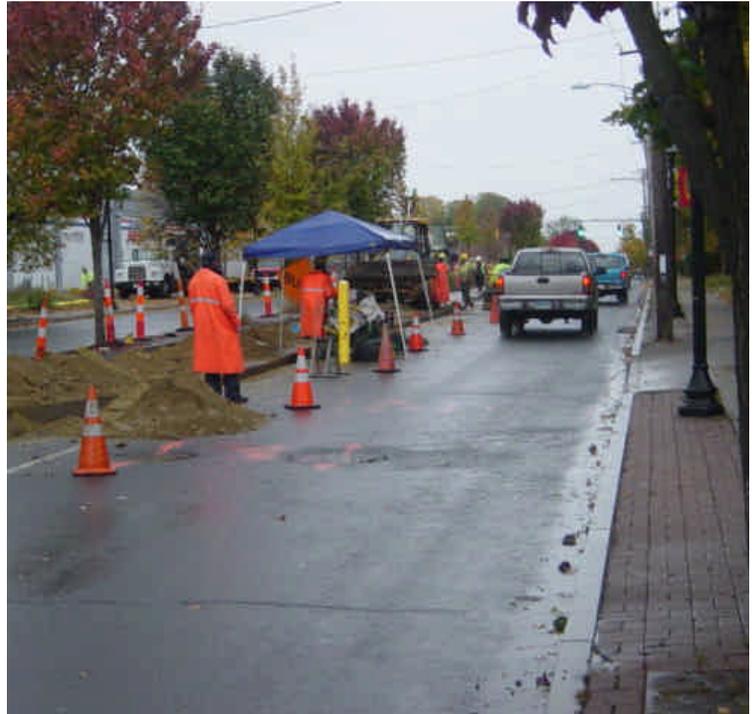
| Areas of Inspection | Observation | Recommended Action | Corrected Action |
|---|---|--|---|
| Additional Observations | <p>Catch basins near the storage yard at Railroad Ave. and Myrtle Ave., associated with the Glenbrook Cable project remain protected with silt sacks. Sediment tracking was evident along the roadway. 11/15/07</p> <p>Utility relocation/installation was ongoing between sta. #690-695. Work was being performed by C. Brito Construction and did not appear to be directly covered by the M/N project D&amp;M plan. Adjacent catch basins were not protected. 11/15/07</p> | <p>Noted for the record since a portion of the project route overlaps this area. This yard is not jurisdictional to the M/N project. 11/15/07</p> <p>Noted for the record since a portion of the project route overlaps this area. This work is likely not covered by the D&amp;M for the M/N project. However, if work was necessitated by the M/N project, consider asking contractors to use BMPs. 11/15/07</p> | <p>NA</p> <p>NA</p> |

Utility installation/ relocation was being performed near sta. #690-695 by C. Brito Construction. This work may not be directly covered by the D&M plan for this project.
