Docket No. 272 – Development and Management Plan Inspection

Segment 4b Underground Line

Date: November 8, 2007

Location: Fairfield/Westport Town Line to Westport Avenue in Norwalk

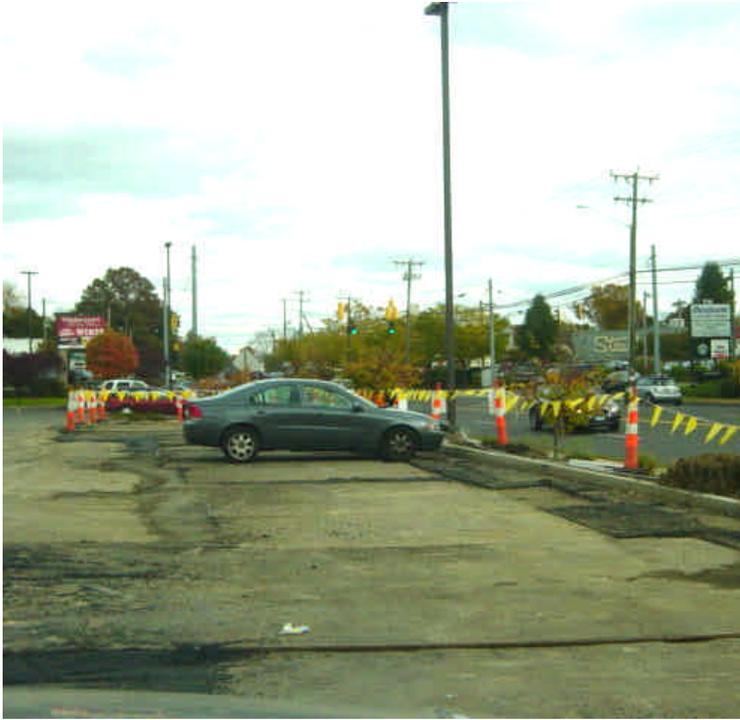
Steel plates are in place over the exposed trench near sta. #96, as tie-in work continues at vault #6. The silt sack in the catch basin has been replaced but minor sediment accumulation remains in the parking lot area.

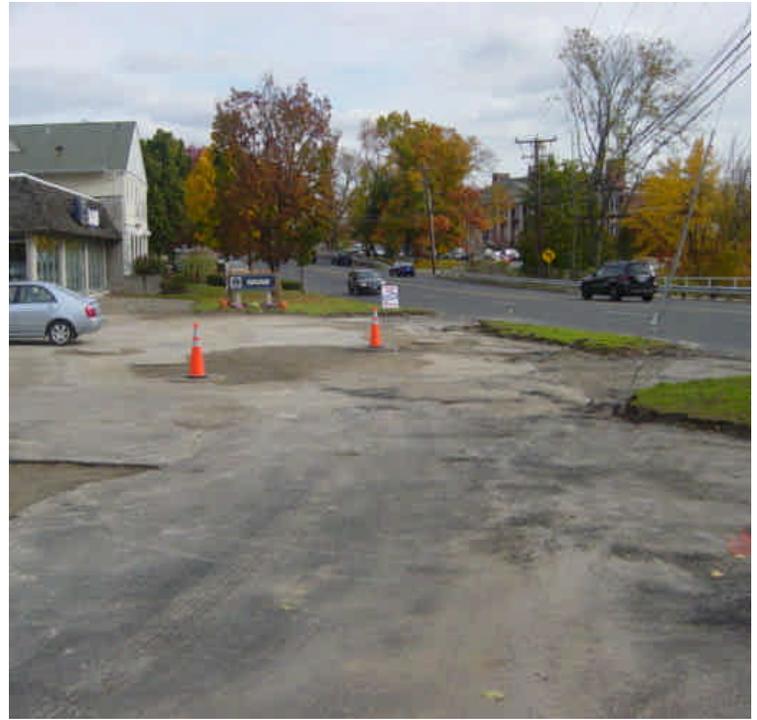
Parking lot area near sta. #219 (vault #13) has been milled in preparation for paving.

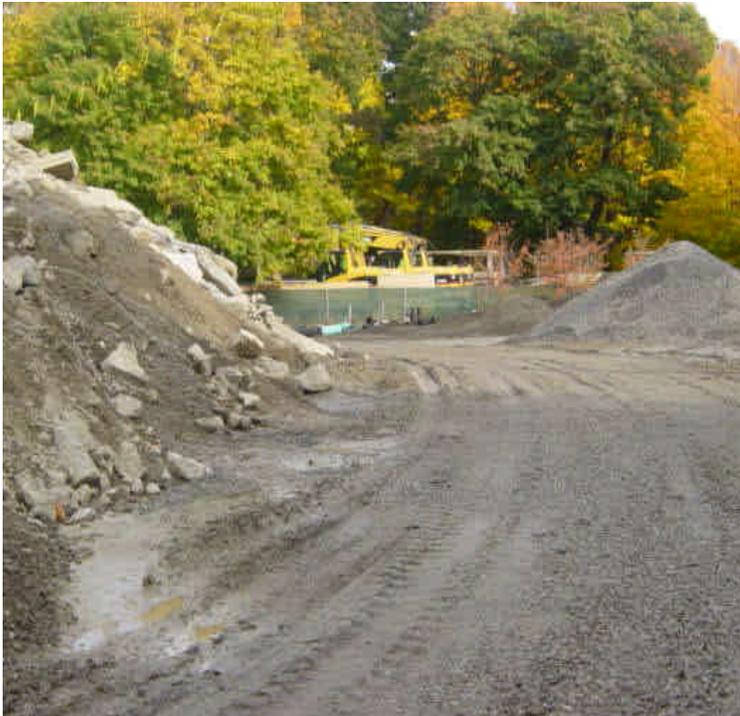
Stockpile of debris material in the Sherwood Island lay-down yard has been consolidated, the access road around the pile was restored and the yard surface has been refreshed with crushed stone.

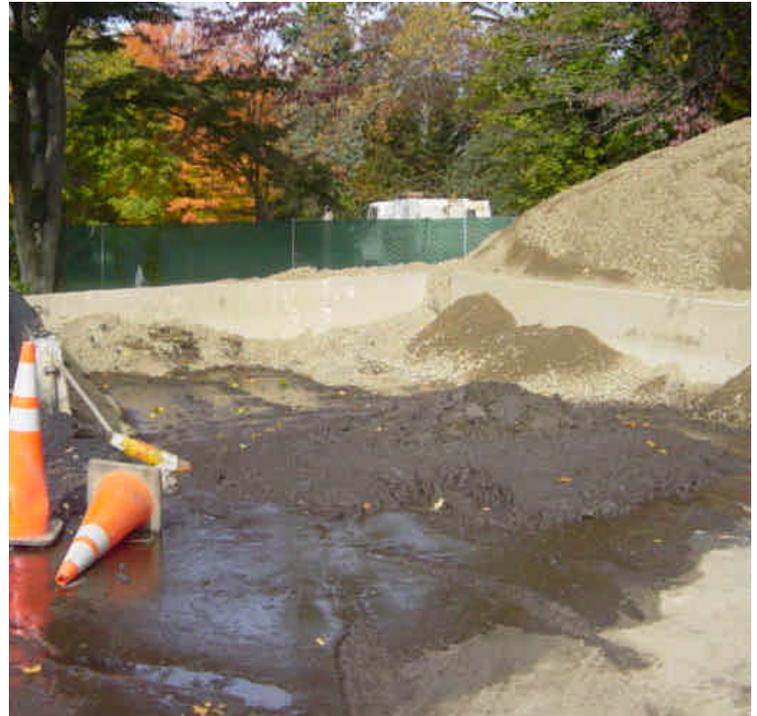
Slurry material was dumped near the front of the material storage bin. Push material towards the back of the bin, bind with processed material and properly dispose of the material.
