Docket No. 272 – Development and Management Plan Inspection

Segment 4b Underground Line

Date: November 15, 2007

Location: Fairfield/Westport Town Line to Westport Avenue in Norwalk

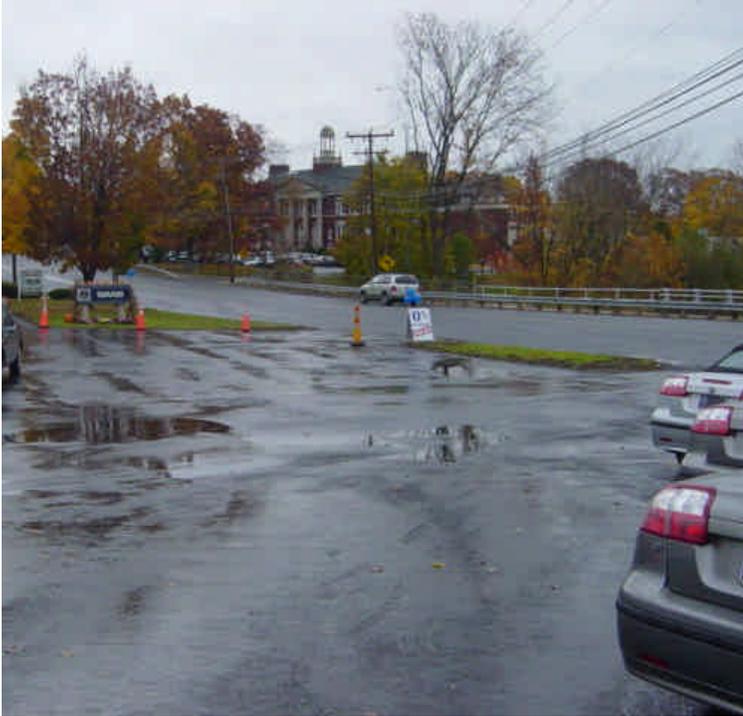
The parking lot area near sta. #219 (vault #13) has been paved.

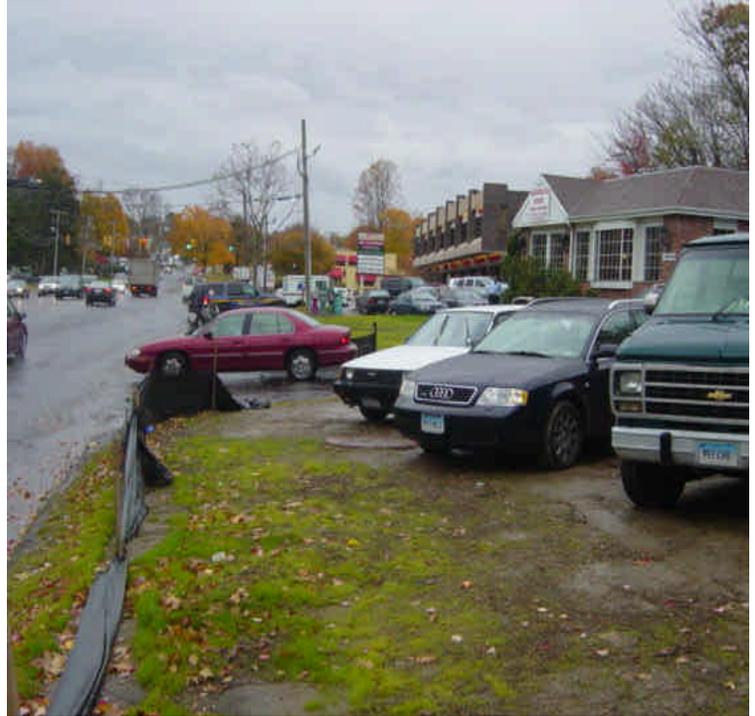
Vehicles continue to park on the seeded areas of exposed soils near sta. #334 (vault #20).

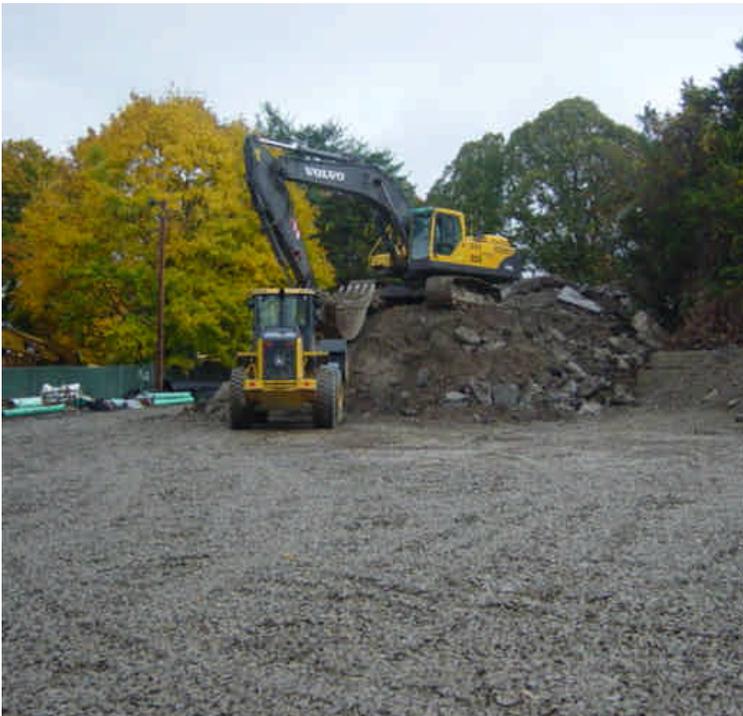
Stockpile of debris material in the Sherwood Island lay-down yard continues to be consolidated. Minor tracking was observed along the access road to the lay-down yard.

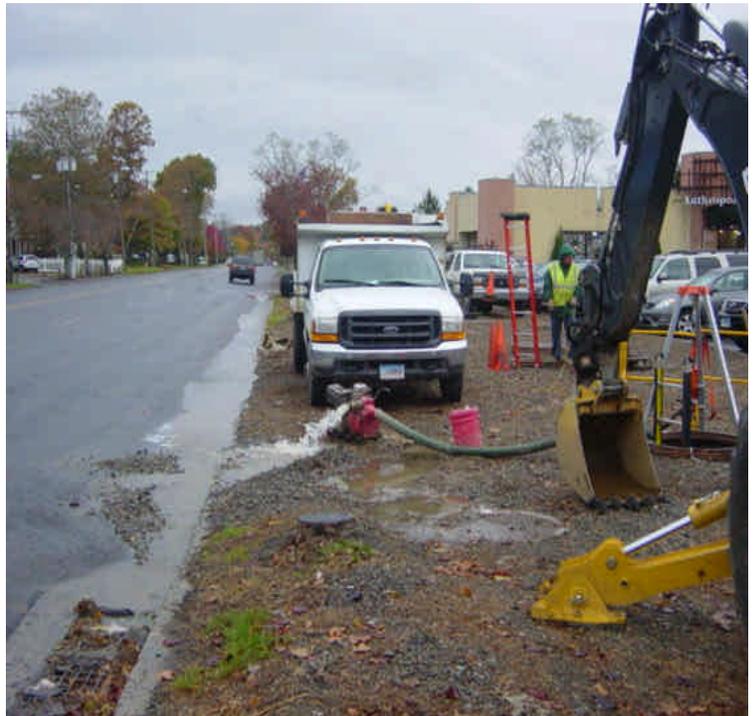
Crews were observed dewatering vault #23. The discharge was being directed over an area of exposed soil and then into the roadway. The catch basins were protected but sediment appeared to be entering through the curb inlet which did not have controls. (This discharge consists of stormwater internal to the completed vault.)
