Docket No. 272 – Development and Management Plan Inspection

Segment 4c Underground Line

Date: November 1, 2007

Location: Westport Avenue to the Norwalk Substation in the City of Norwalk

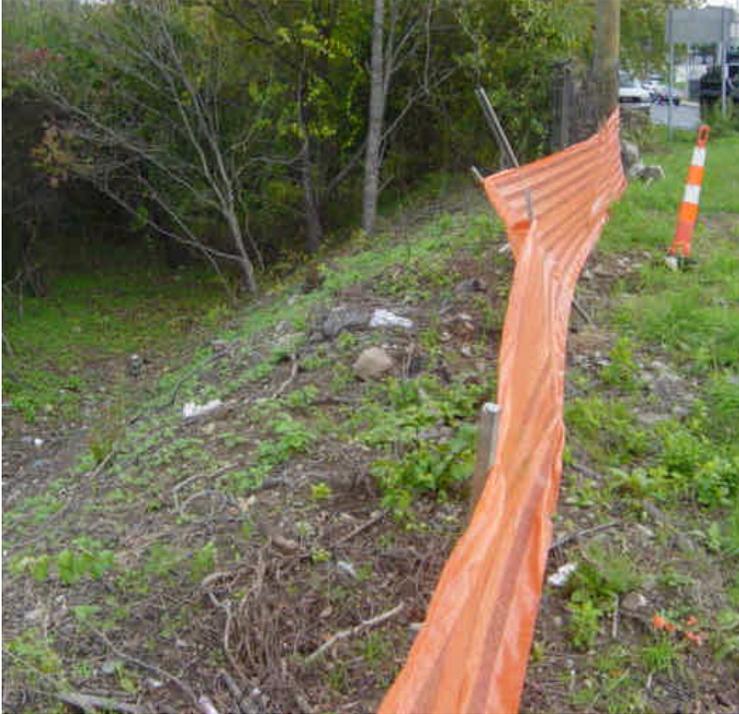
Clearing work has begun near sta. #16-18 along a fairly steep slope. Silt fence should be installed along the down gradient side of the slope proactively to contain exposed soils within the work zone.

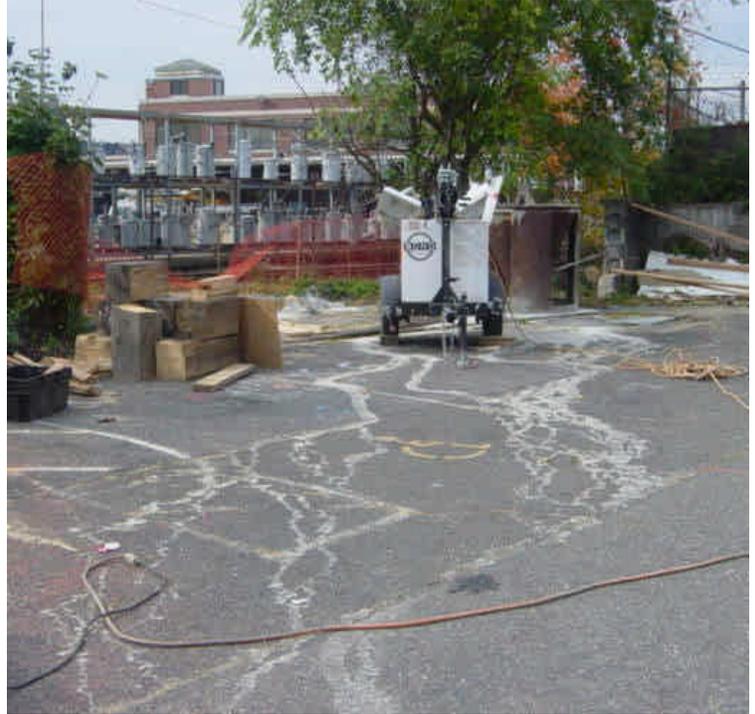
Slurry residue was observed on the paved areas surrounding the work zone near sta. # 29. The downgradient catch basin did not have controls in place.

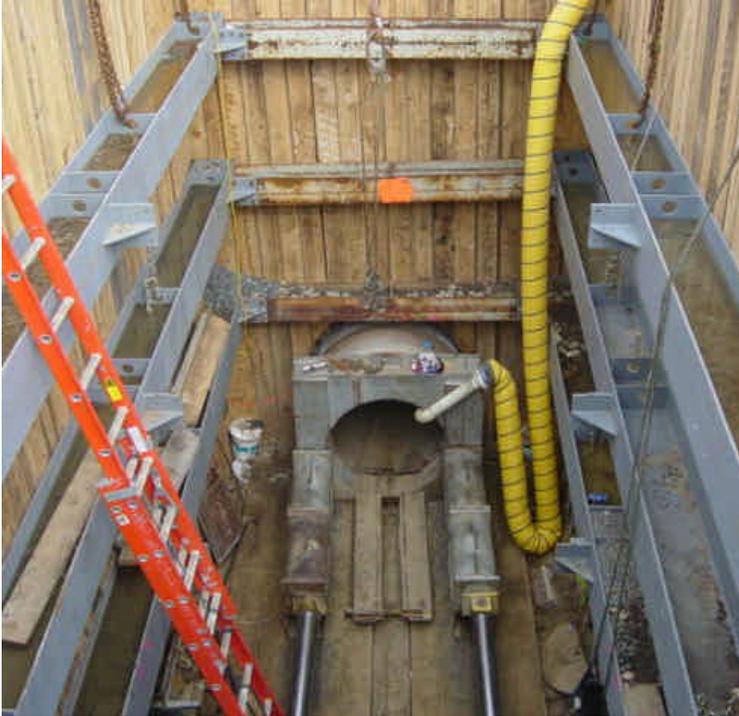
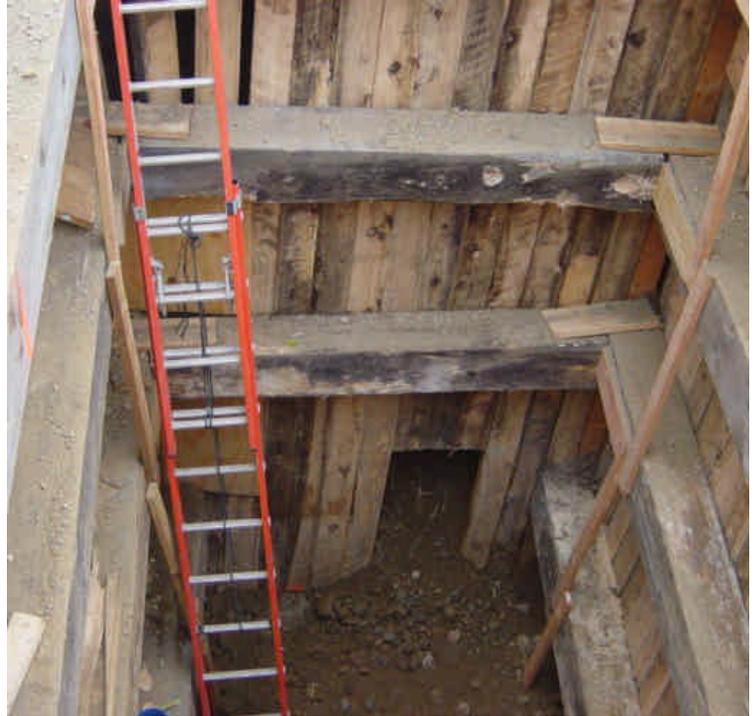
The jack and bore is nearly completed between sta. #27 to #29. The jacking shaft is shown in the photo on the left and the receiving shaft is shown on the right.
