Docket No. 272 – Development and Management Plan Inspection

Segment 4c Underground Line

Date: November 21, 2007

Location: Westport Avenue to the Norwalk Substation in the City of Norwalk

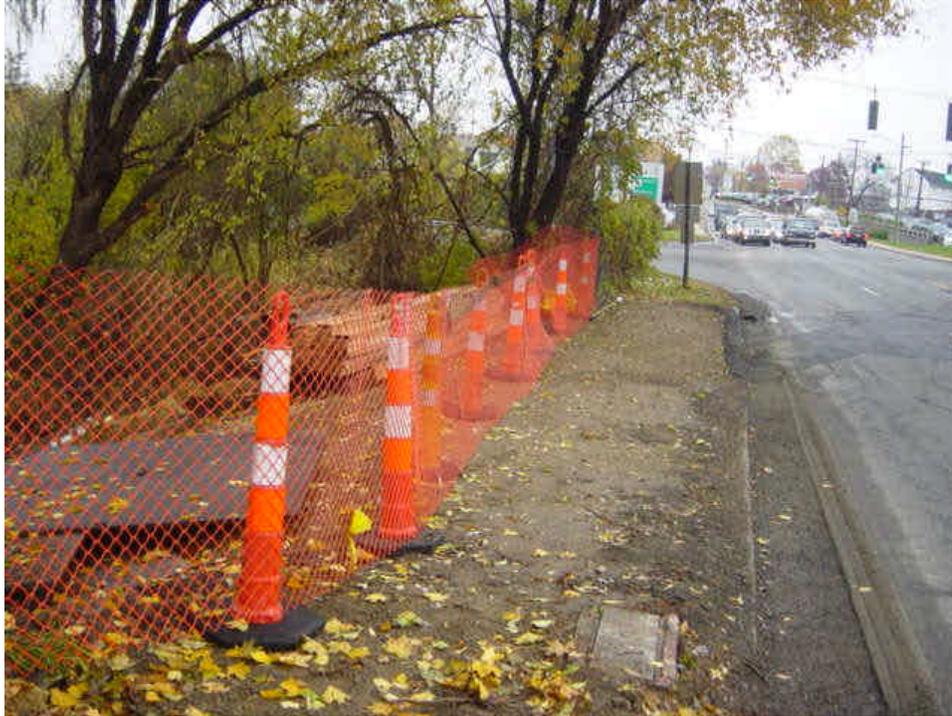
| Areas of Inspection | Observation | Recommended Action | Corrected Action |
|--|--|---|---|
| | Haybales remain along the slope downgradient | Continue to monitor the controls. See vegetation | Needs restoration within timelines. |

| Areas of Inspection | Observation | Recommended Action | Corrected Action |
|--|--|---|---|
| Vegetative clearing (including trees to save or danger trees noted) or stabilization | The work area at sta. #16-18 was recently backfilled and exposed soils are present. 11/21/07 | Stabilize as required by the D&M plan within 7-14 days if activities will not return within 21 days. Apply a sufficient mulch cover for the winter months. 11/21/07 | Needs stabilization within the timelines. |

Trench work near sta. #16-18 has been backfilled with only a small portion being covered with steel plates. Haybales remain in place downgradient from the work area along the adjacent slope. Materials also remain here. Ensure that exposed soils have sufficient mulch cover for the winter months as soon as possible and that materials are removed when work is complete.

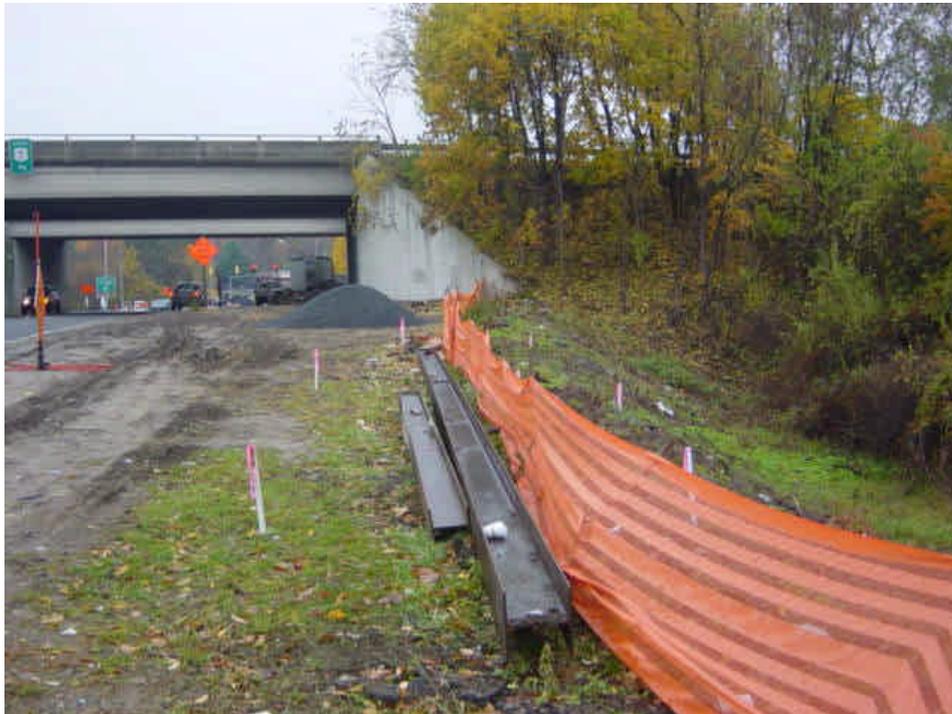
Construction stakes have been placed between sta. #15-16 in preparation for trench work.
