Docket No. 272 – Development and Management Plan Inspection

Underground Line Watercourse and Railroad Crossings

Date: November 15, 2007

Location: Crossings of Watercourses and Railroads in Segments 3, 4a and 4b

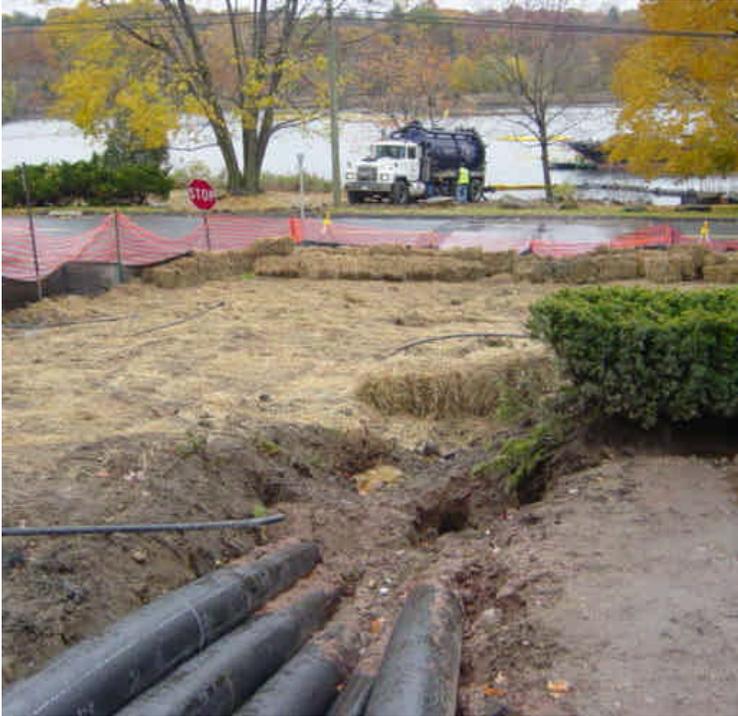
On the west side of the Saugatuck river, the drilling pit remains temporarily stabilized with hay mulch. Final clean-up efforts are occurring in the river:

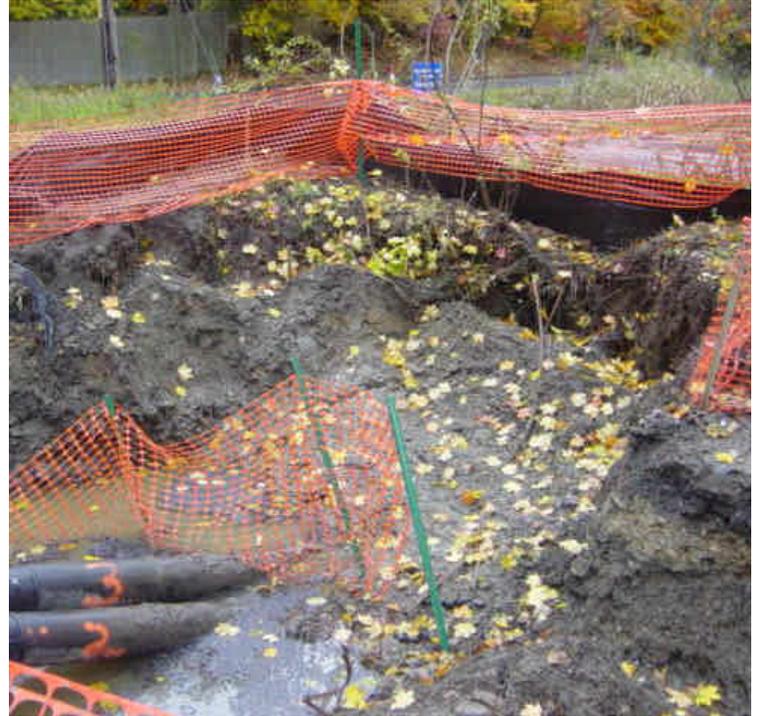
On the east side of the Saugatuck River, silt fence has been restored around the drilling pit, which provides proper containment.

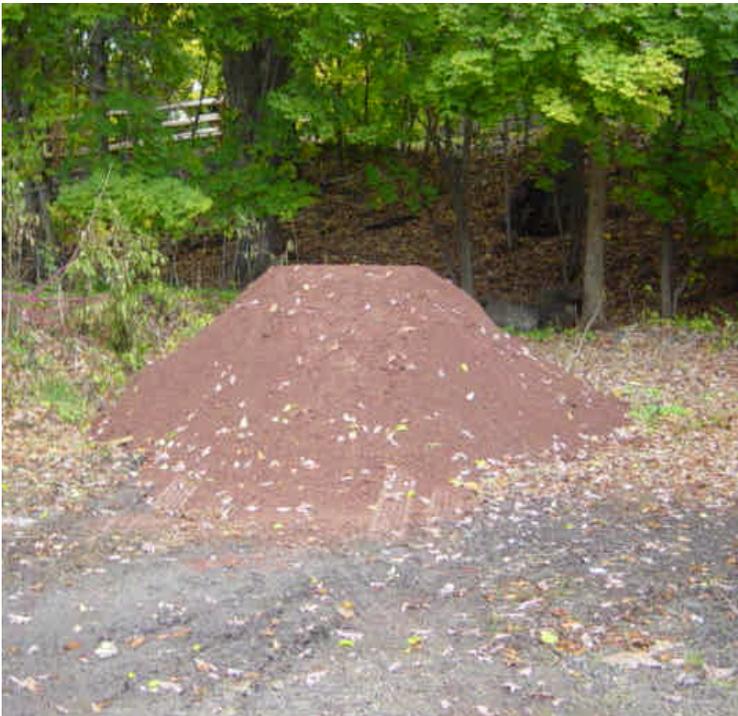
Sandy material has been stockpiled near the entrance to the staging area on the east side of the Saugatuck River. Erosion controls were not in place but should be used to contain the stockpile.

Dewatering	Crews were preparing to dewater the installed conduit sections, which were filled with fresh water to facilitate the installation process. 11/15/07	Continue to ensure that material is contained appropriately and treated according to the groundwater handling plan as referenced in the D&M. 11/15/07	NA
Blasting	No blasting has been proposed. 11/15/07	None 11/15/07	NA
Spills and Material Storage	<p>Reserve spill cleanup materials/kits were observed in the staging area. 11/15/07</p> <p>Slurry material was observed on the ground near a frac tank in the staging area on the east side of the Saugatuck River. 11/15/07</p> <p>Sand material has been stockpiled near the entrance to the staging area on the east side of the Saugatuck River. No controls are in place around the stockpile. 11/15/07</p>	<p>Continue to bring spill kits to active work sites. 11/15/07</p> <p>Remove and properly dispose of slurry material. 11/15/07</p> <p>Install erosion controls to properly contain the stockpiled material. 11/15/07</p>	<p>NA</p> <p>Needs attention.</p> <p>Needs attention.</p>

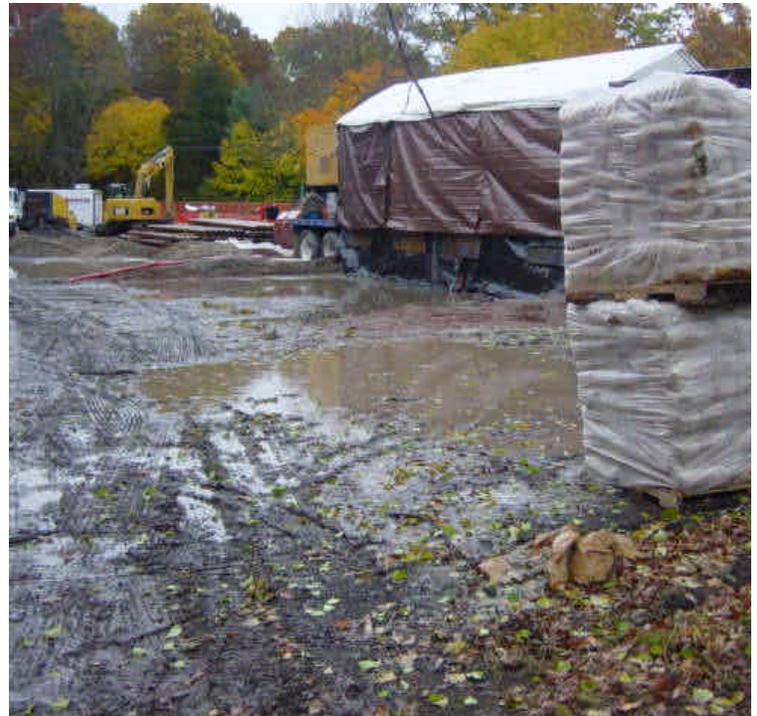
Several bags of Max-Gel remain torn and spilled on the ground near the entrance to the staging area on the east side of the Saugatuck River. The bentonite reclamation machine and other stockpiled materials have proactively covered.

Areas of Inspection	Observation	Recommended Action	Corrected Action
	<p>Several bags of Max-Gel were torn and had spilled on the ground near the entrance to the staging area on the east side. 11/08-11/15/07</p>	<p>Although non-toxic, remove the spilled Max-Gel and use caution to prevent future spills and minimize unnecessary impacts. 11/08-11/15/07</p>	<p>Needs attention</p>
<p>Additional Observations</p>	<p>None. 11/15/07</p>	<p>None. 11/15/07</p>	<p>NA</p>

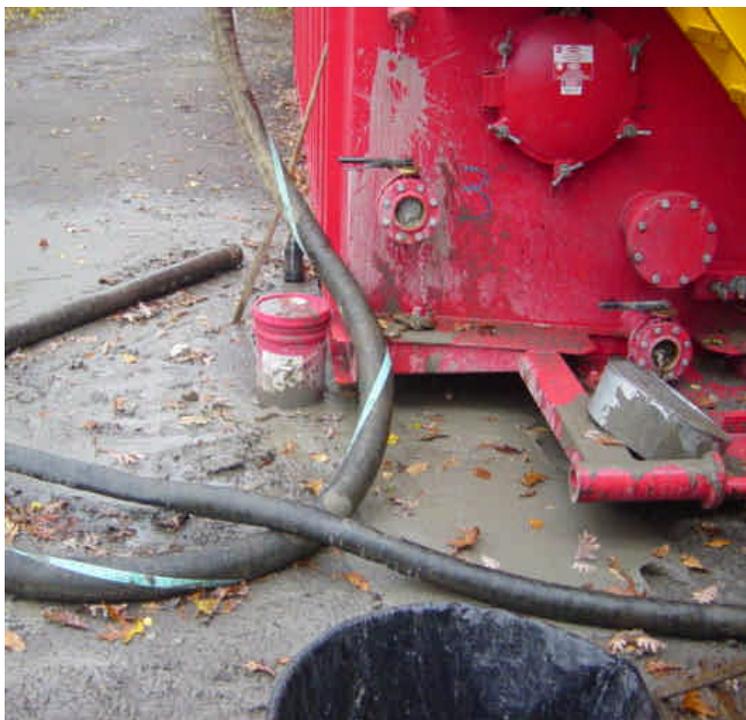
Slurry material has been discharged/spilled near the frac tank in the staging area on the east side of the Saugatuck River.

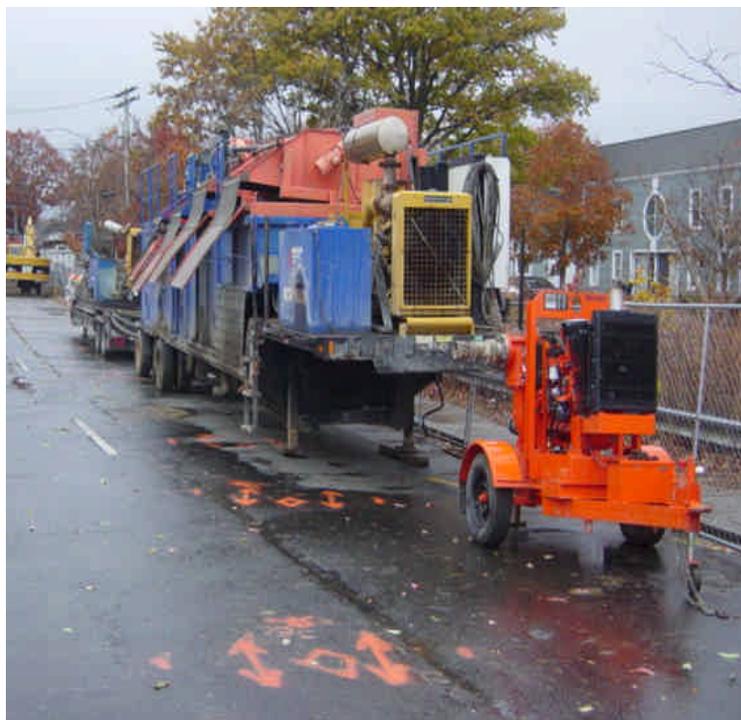
A bentonite reclamation machine has been set up along Old Post Road in preparation for drilling activities near Ash Creek.

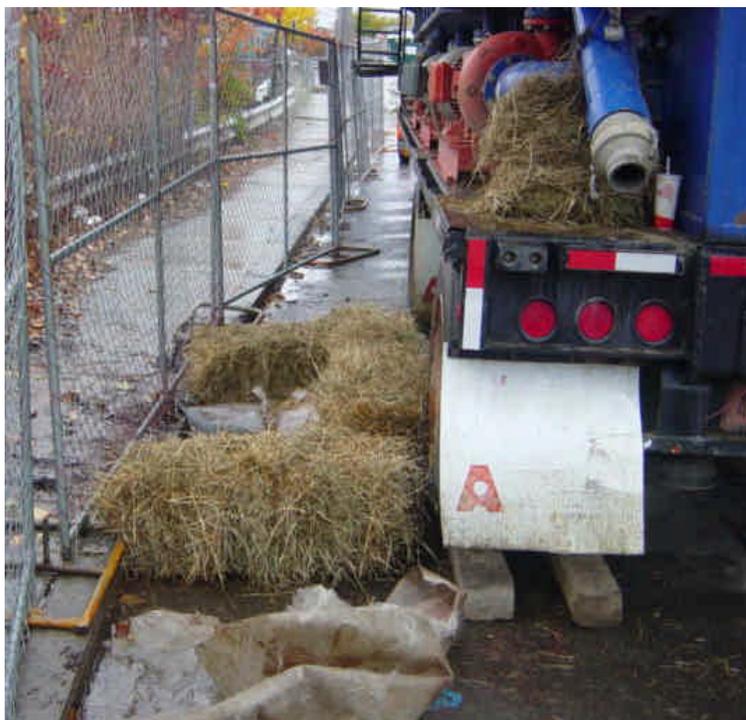
Catch basins along Old Post Road/Fairfield Avenue have been proactively protected in preparation for drilling activities near Ash Creek.

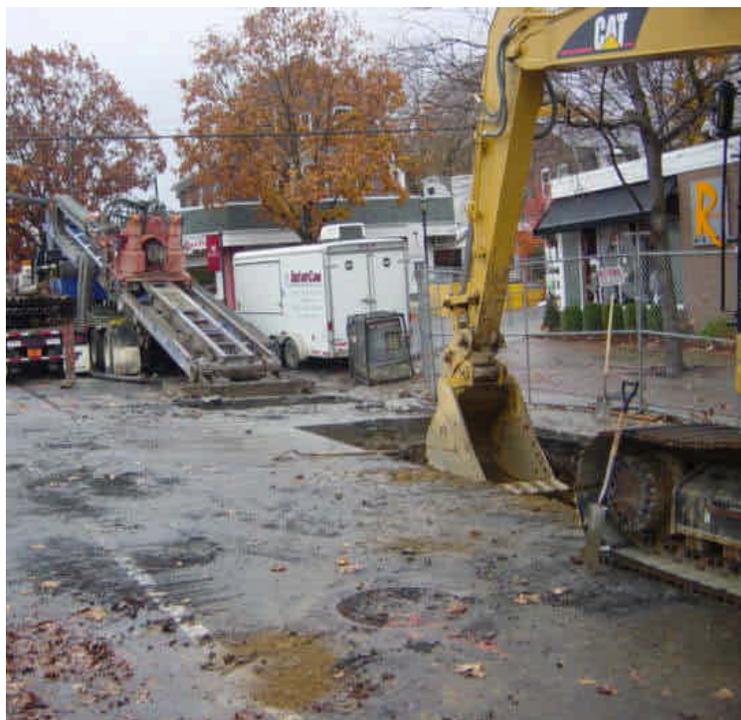
Excavation has begun on the drilling pit on the southwest side of Ash Creek.
