Docket No. 272 – Development and Management Plan Inspection

Underground Line Watercourse and Railroad Crossings

Date: November 21, 2007

Location: Crossings of Watercourses and Railroads in Segments 3, 4a and 4b

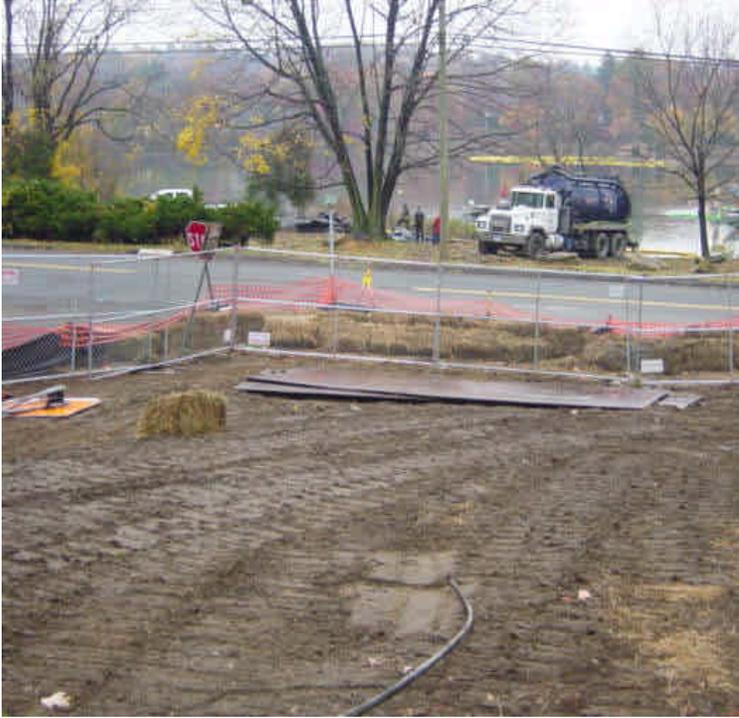
On the west side of the Saugatuck River, the drilling pit has been re-graded, leaving the soil exposed. Erosion and sediment control measures remain in place around the perimeter of the work zone.

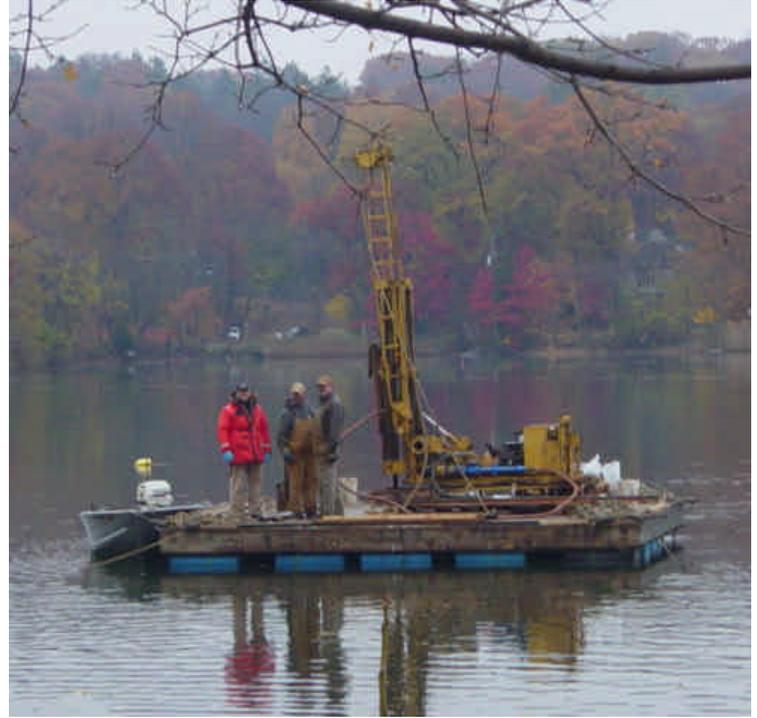
Geotechnical borings are being performed within the Saugatuck River to provide better data and minimize the number of frac-outs that may occur while boring the second hole.

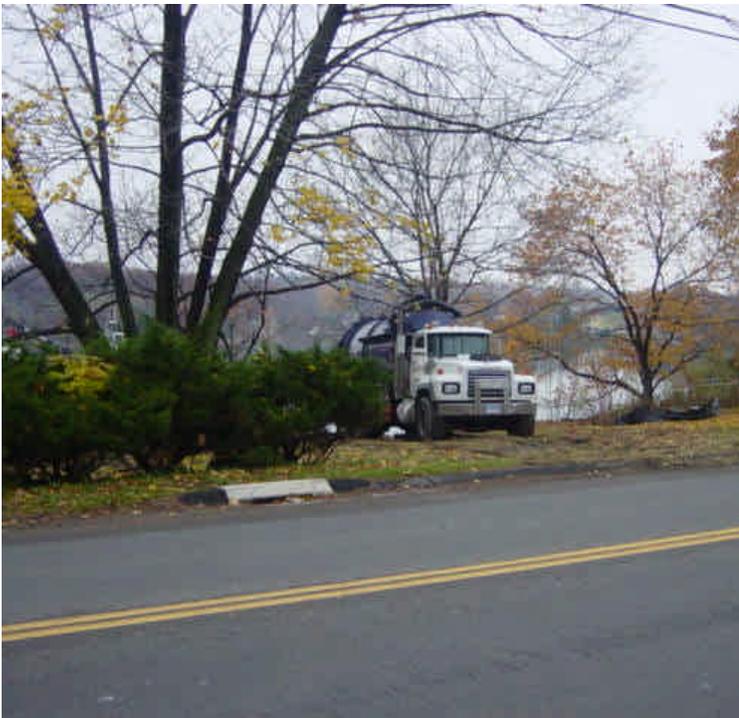
<p>Erosion and Sediment Controls Saugatuck River</p>	<p>Plastic mats are in place on the west side of the Saugatuck River (and east of Riverside Ave.) near sta. #236 to minimize ruts. Minor sediment is beginning to accumulate along the shoulder of Riverside Ave here as vacuum trucks and other vehicles exit the work area. 11/21/07</p> <p>Silt fence and haybales remain around the drilling pit area on the west side of the Saugatuck River. The drill pit was recently re-graded, leaving soils exposed. 11/21/07</p> <p>Any exposed soils have potential for airborne dust migration. Contractors are aware of the potential. Special attention should be given to the Saugatuck River</p>	<p>Place a gutter buddy/silt sack (or similar) in any catch basins located down gradient of areas where vehicles are exiting the work zone to prevent sediment from entering basin. Sweep roadway as necessary. 11/21/07</p> <p>Continue to monitor and maintain the controls to ensure they adequately contain the area. See soils section for more details. 11/21/07</p> <p>Prevent dust migration by implementing the dust control measures. If exposed soils are not to be worked within 21 days, they should be stabilized. 11/21/07</p>	<p>Needs attention.</p> <p>NA</p> <p>NA at this time.</p>

Minor amounts of sediment are beginning to accumulate along the shoulder of Riverside Ave as vacuum trucks and other construction vehicles exit this area. Catch basins are not protected.

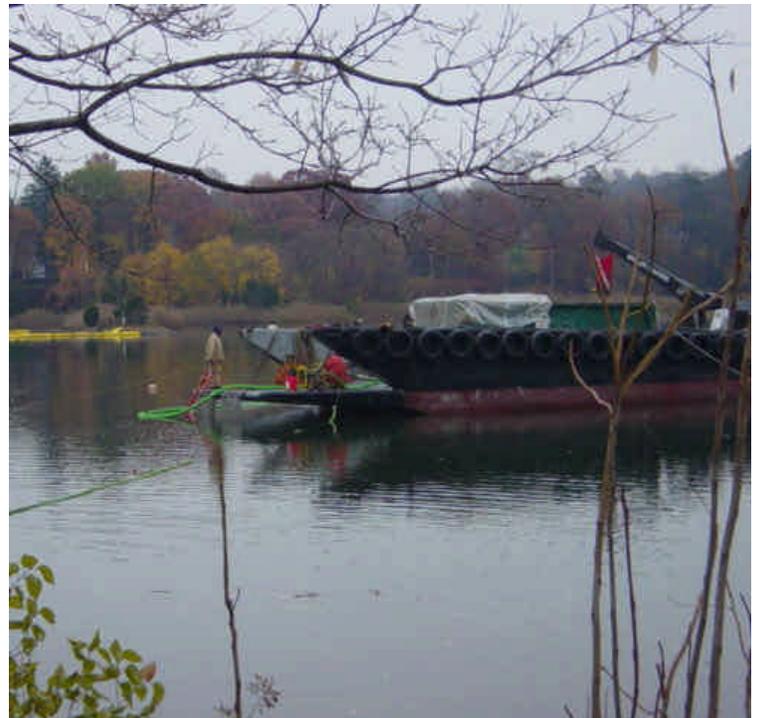
Final clean-up efforts are ongoing in the Saugatuck River as a result of previous frac-outs, and several containment booms have already been removed from the channel.

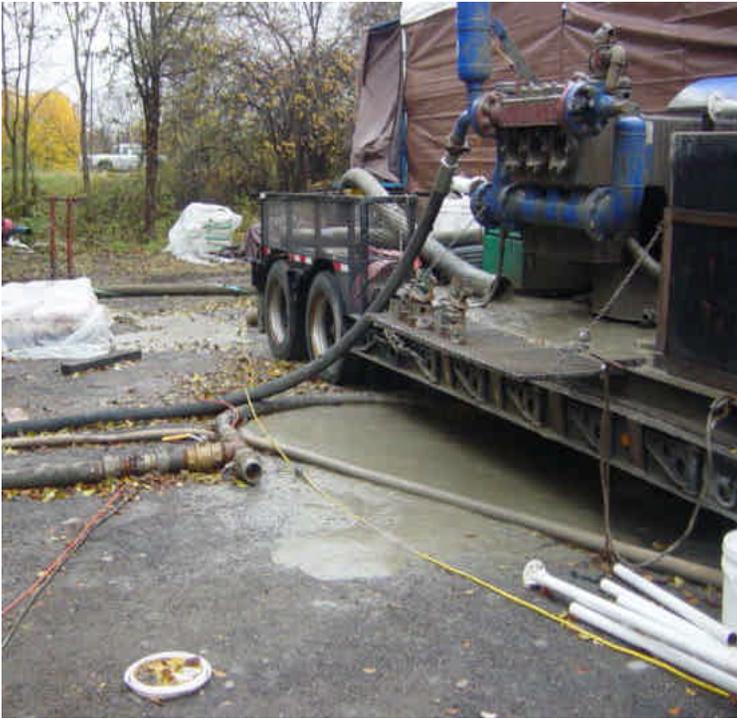
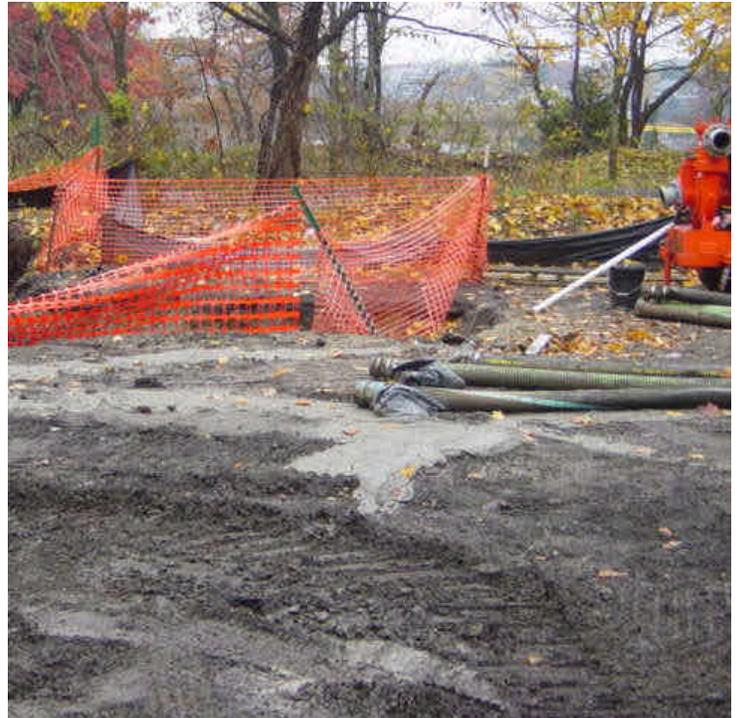
Areas of Inspection	Observation	Recommended Action	Corrected Action
		D&M. 11/21/07	
Blasting	No blasting has been proposed. 11/21/07	None 11/21/07	NA
Spills and Material Storage	<p>Reserve spill cleanup materials/kits were observed in the staging area. 11/21/07</p> <p>A small drilling mud spill was previously observed on the ground near a frac tank in the staging area on the east side of the Saugatuck (11/15). Several other spills were also observed near the bentonite reclamation machine and near the drilling pit. 11/21/07</p> <p>Sand material has been stockpiled near the entrance to the staging area on the east side of the Saugatuck River. No controls are in place around the stockpile. 11/15-11/21/07</p> <p>Several bags of Max-Gel were torn and had spilled on the ground near the entrance to the staging area on the east side. 11/08-11/21/07</p>	<p>Continue to bring spill kits to active work sites. 11/21/07</p> <p>Remove and properly dispose of slurry material to minimize unnecessary impacts. 11/21/07</p> <p>Install erosion controls to properly contain the stockpiled material. 11/15-11/21/07</p> <p>Although non-toxic, remove the spilled Max-Gel and use caution to prevent future spills and minimize unnecessary impacts. 11/08-11/21/07</p>	<p style="text-align: center;">NA</p> <p style="text-align: center;">Needs attention.</p> <p style="text-align: center;">Needs attention.</p> <p style="text-align: center;">Needs attention.</p>

Slurry residue/drilling mud has been spilled in several locations in the staging area on the east side of the Saugatuck River. Slurry spills were observed behind the bentonite reclamation machine in multiple locations and near the drilling pit. The residue previously observed near the frac tank also remains.

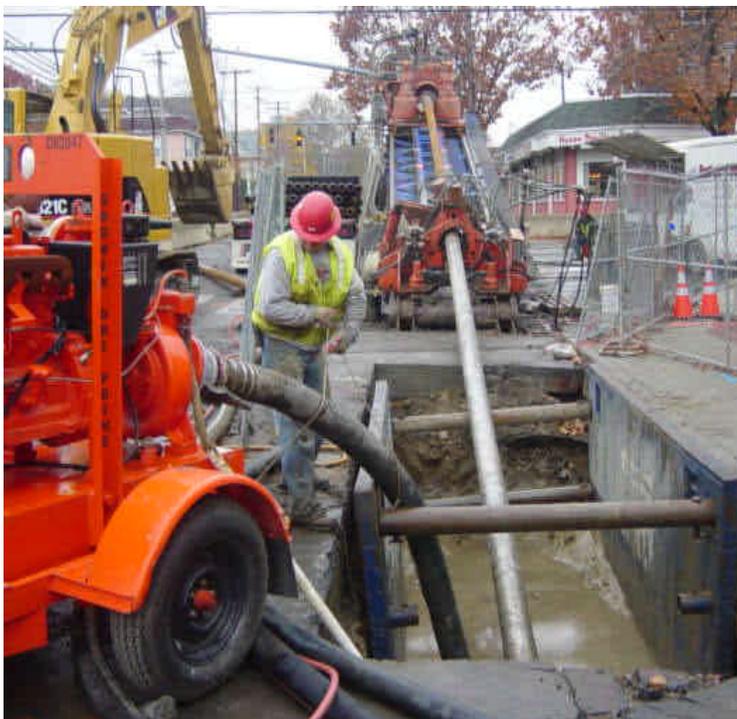
Horizontal direction drilling (HDD) operations are underway near Ash Creek. Ensure that precautions are taken and considerations are made for slurry storage capacity during large storm events.

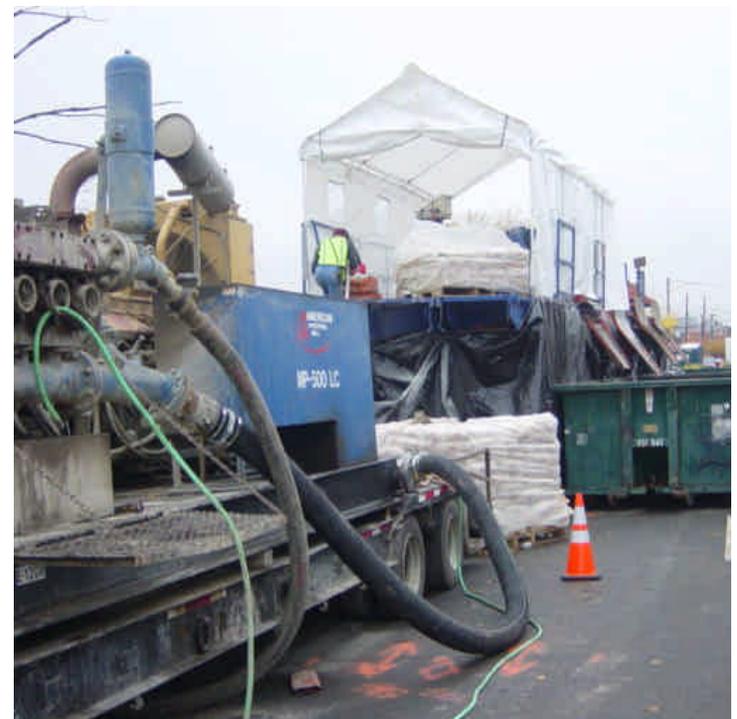
A bentonite reclamation machine has been set-up along Old Post Road/Fairfield Avenue. A roll-off dumpster has been placed to contain the processed material.
